FIRSTLIGHT HYDRO GENERATING COMPANY  
 Northfield Mountain Pumped Storage Project No. 2485  
 Turners Falls Hydroelectric Project No. 1889  
 STUDY 3.1.2

*Northfield Mountain Pumped Storage Project (No. 2485) and Turners Falls Hydroelectric Project (No. 1889)*  
STUDY 3.1.2 NORTHFIELD MOUNTAIN / TURNERS FALLS OPERATIONS IMPACTS ON EXISTING  
EROSION AND POTENTIAL BANK INSTABILITY

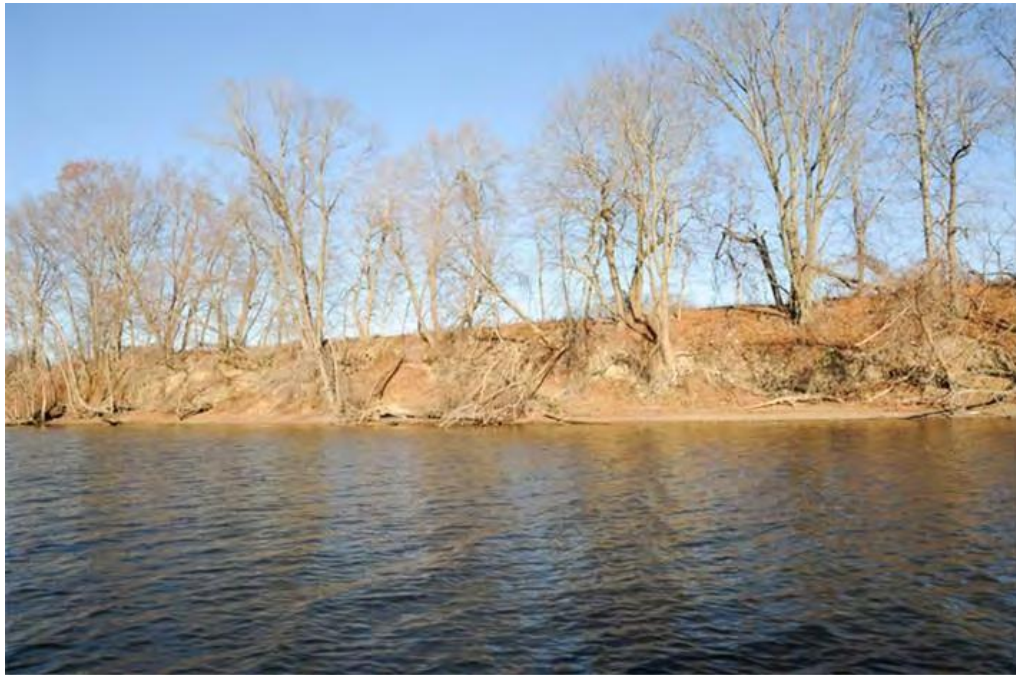
**Figure 5.5.4-3: Erosion Adjacent to Agricultural Land-use**

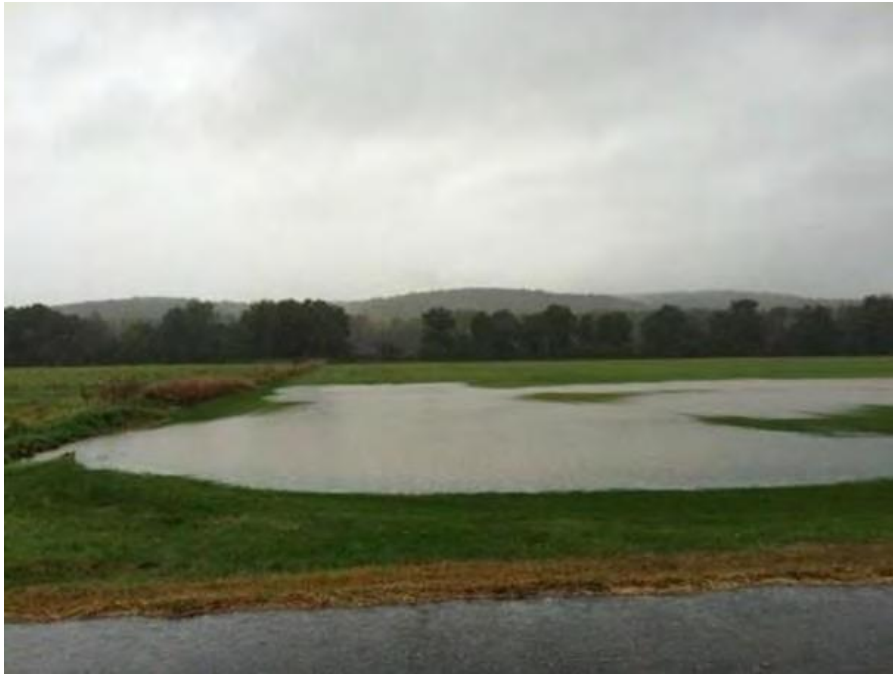
**Figure 5.5.4-7: Ponding on agricultural fields from rainfall event, September 30, 2015 (a)**

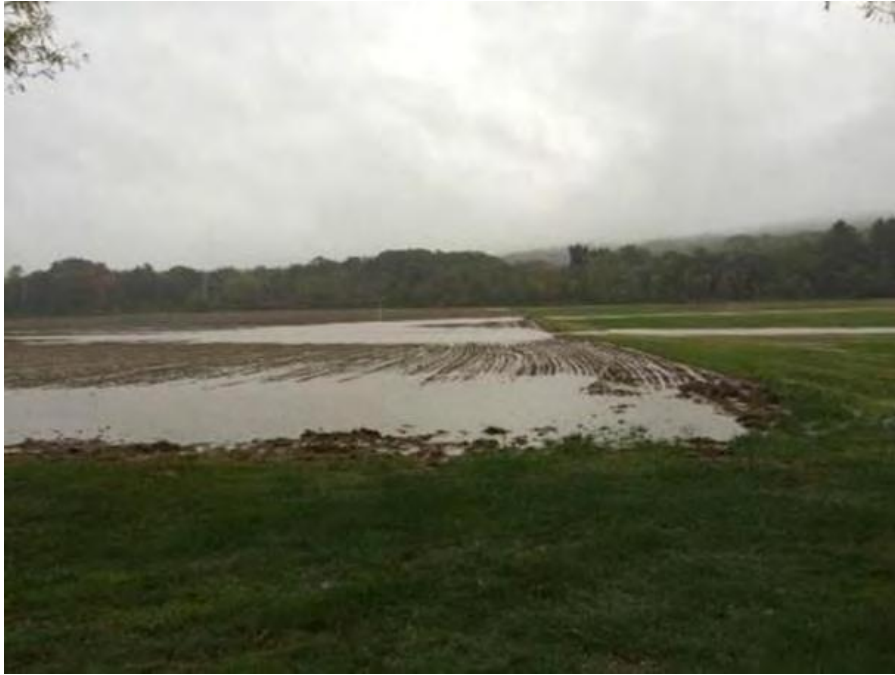
**Figure 5.5.4-9: Ponding on agricultural fields from rainfall event, September 30, 2015 (c)**

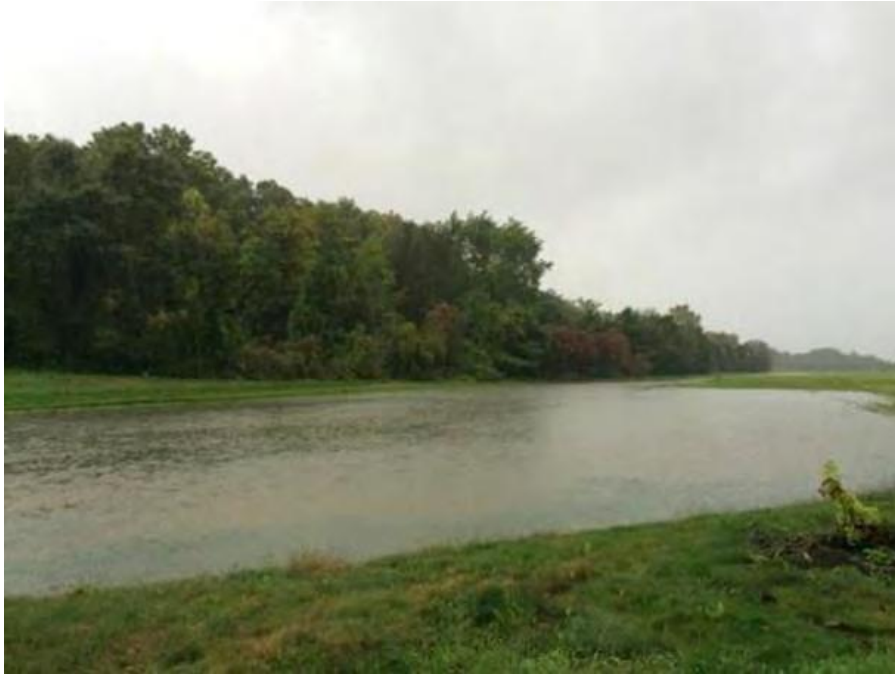
**Figure 5.5.4-11: Ponding on agricultural fields from rainfall event, September 30, 2015 (e)**

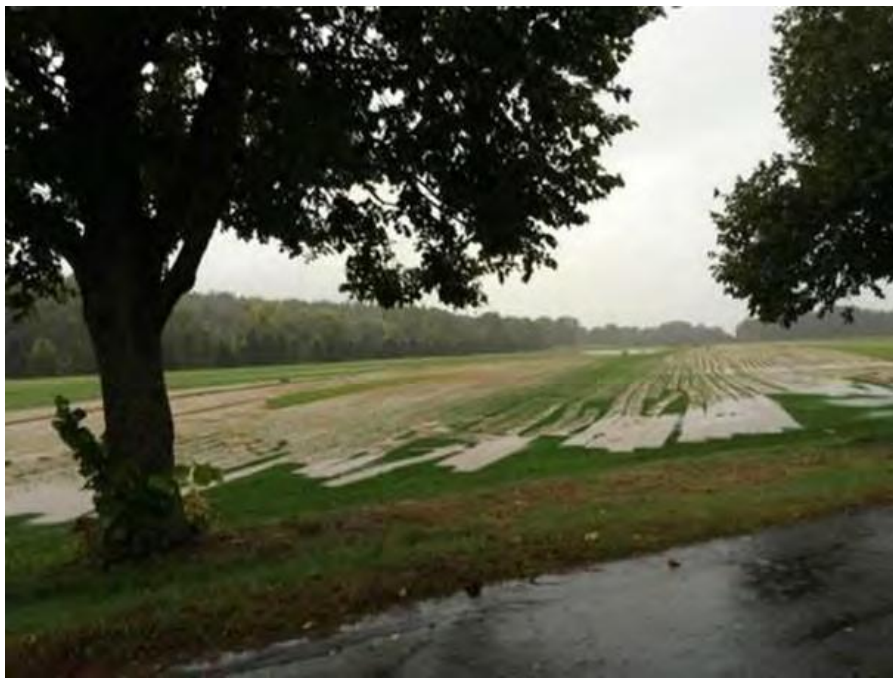
**Figure 5.5.4-12: Ponding on agricultural fields from rainfall event, September 30, 2015 (f)**

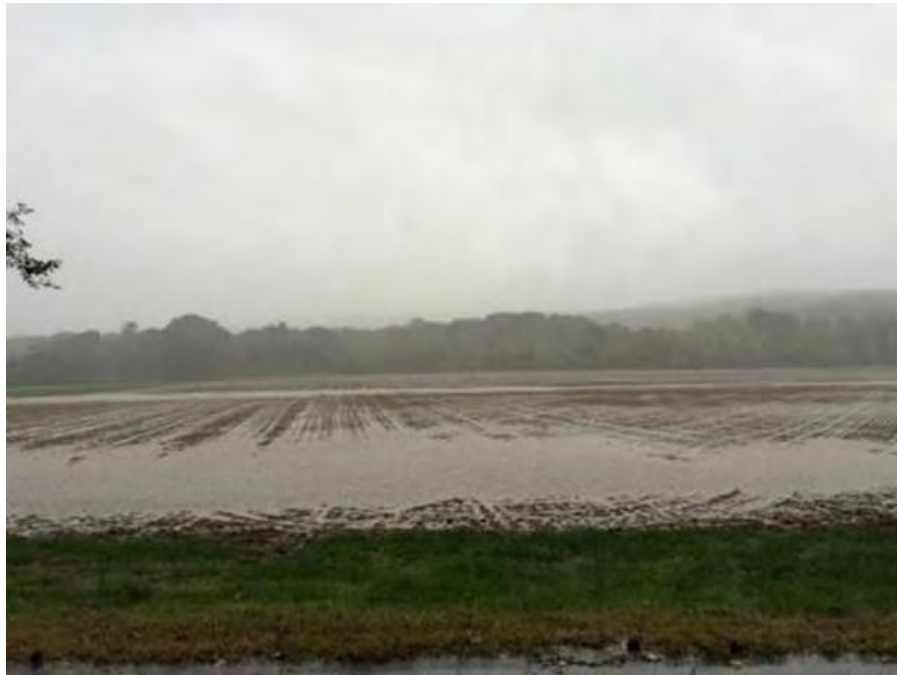
**Figure 5.5.4-13: Ponding on Agricultural Fields from Rainfall Event, September 30, 2015 (g)**

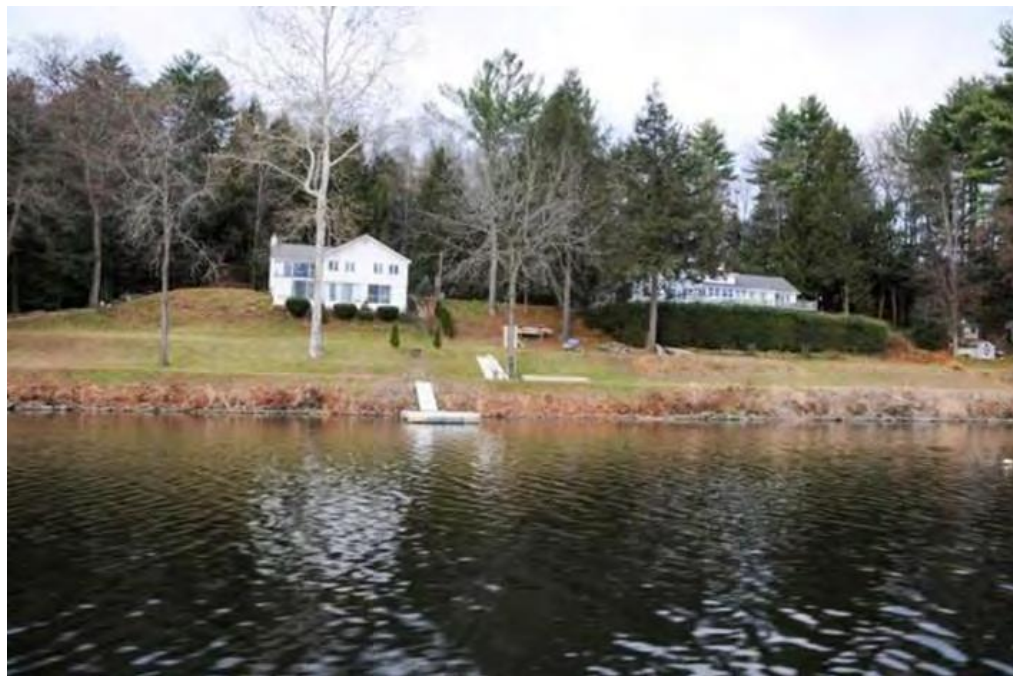
**Figure 5.5.4-15: Development thinning or removing riparian vegetation**

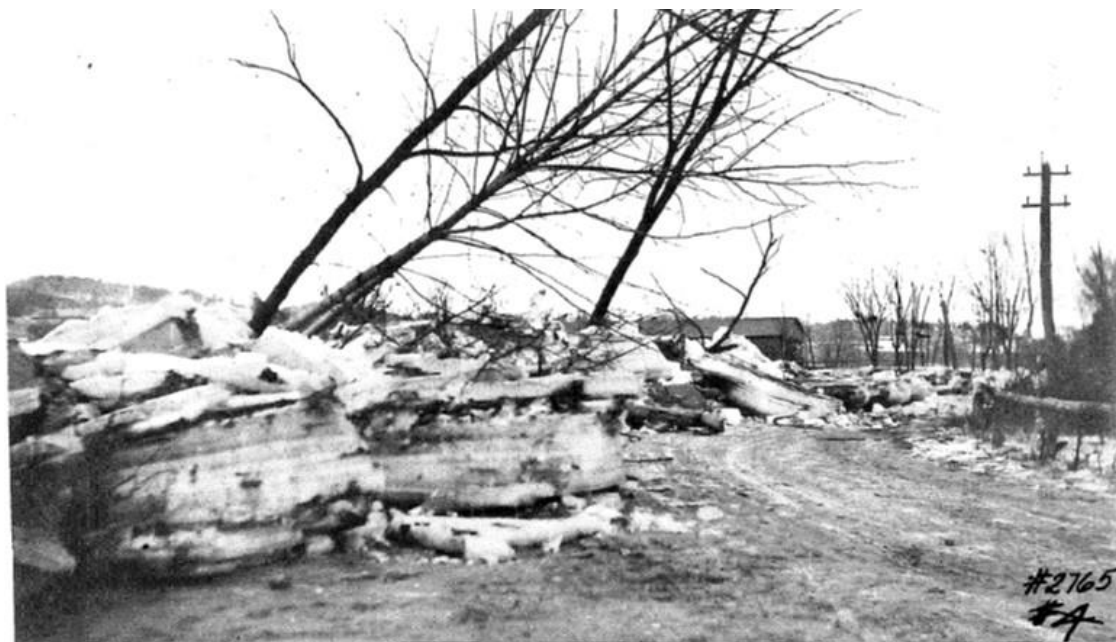
Much of the information contained in the TransCanada files consisted of photographs of ice jams, ice damage and erosion that occurred as a result of ice. One of the earliest set of photos from TransCanada showing ice was taken in 1915 at Brattleboro, VT ([Figure 5.5.5.2-1](#)), which is located in the Vernon Impoundment and just downstream of the West River confluence. Ice had moved a boat house adjacent to the river and ice had been forced over the riverbanks causing damage to trees as shown in [Figures 5.5.5.2-2](#) and [5.5.5.2-3](#).

**Figure 5.5.5.2-3 Ice along riverbanks showing damage to trees, 1915 (after TransCanada)**

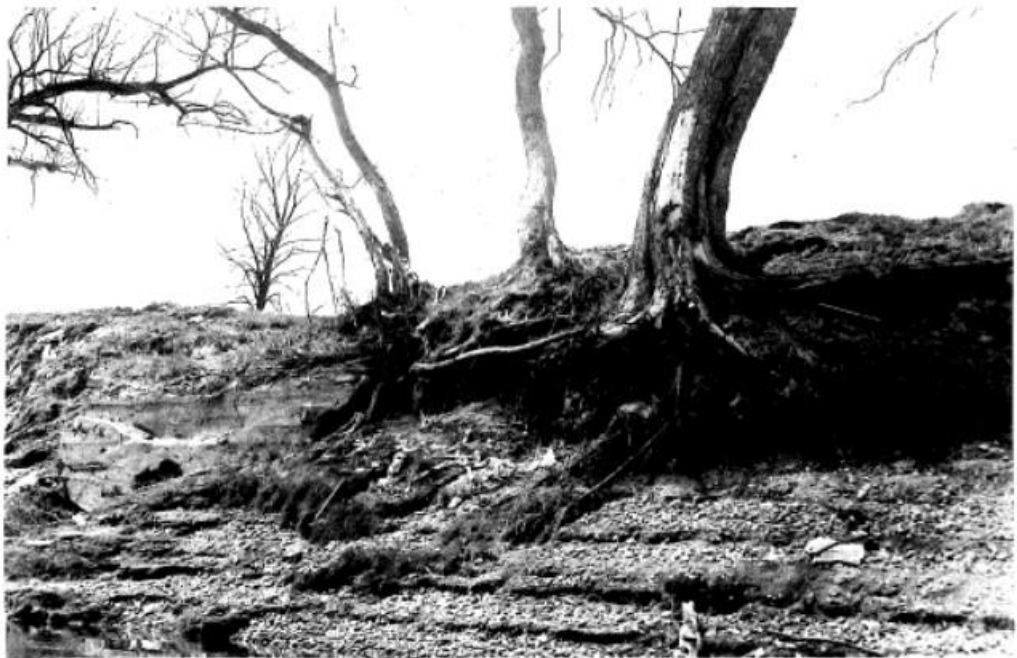
**Figure 5.5.5.2-14 Connecticut River near Windsor, VT – April 24, 1946 (TransCanada)**

Ice also has an adverse effect on riparian vegetation (as shown in previously referenced [Figure 5.5.5.2-14](#), [5.5.5.2-19](#), and [5.5.5.2-20](#)). As noted in R. Ettema, 2002:

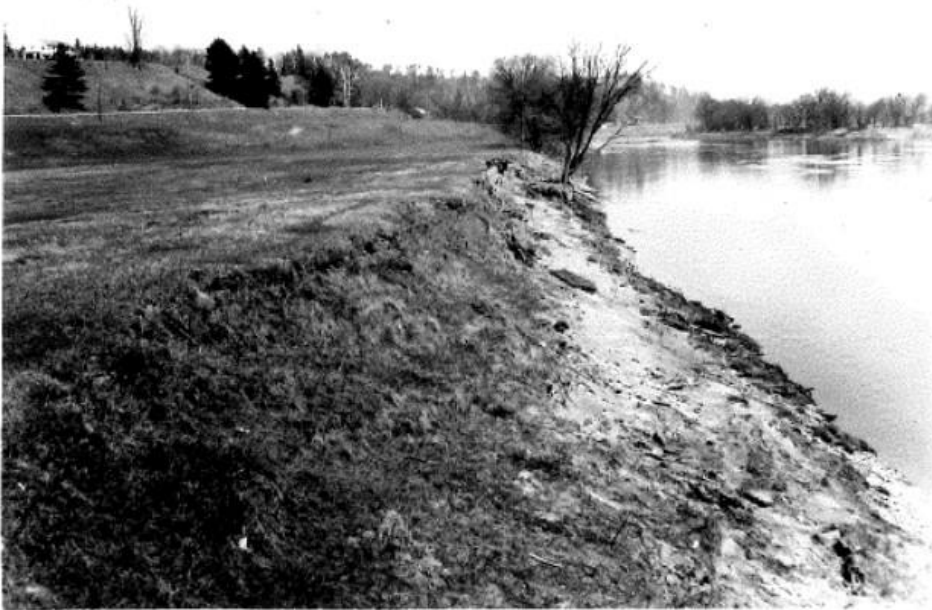
**Figure 5.5.5.2-15 Connecticut River near Windsor, VT – April 24, 1946 (TransCanada)**

Another phenomenon discussed in R. Ettema, 2002 was that ice may cause erosion to riverbanks by abrasion or gouging. The review specifically noted that “*during heavy ice runs resulting from ice-cover breakup or ice-jam release, large pieces of ice potentially may gouge and abrade channel banks. There exists significant evidence showing that ice runs may substantially affect riverbank morphology (Marusenko 1956; Hamelin 1979; Smith 1979; U.S. 1983; Doyle 1988; Wuebben 1995; Uunila 1997)*” (R. Ettema, 2002). Ice flowing downstream, or being forced into the banks, was clearly seen in historic and recent photographs shown previously in this report (see [Figures 5.5.5.2-1](#) through [5.5.5.2-4](#), [5.5.5.2-9](#) through [5.5.5.2-11](#), and [5.5.5.2-23](#)). Damage associated with these ice events can be observed in previous figures ([Figure 5.5.5.2-13](#), [5.5.5.2-15](#) through [5.5.5.2-18](#), and [5.5.5.2-22](#) through [5.5.5.2-23](#)).

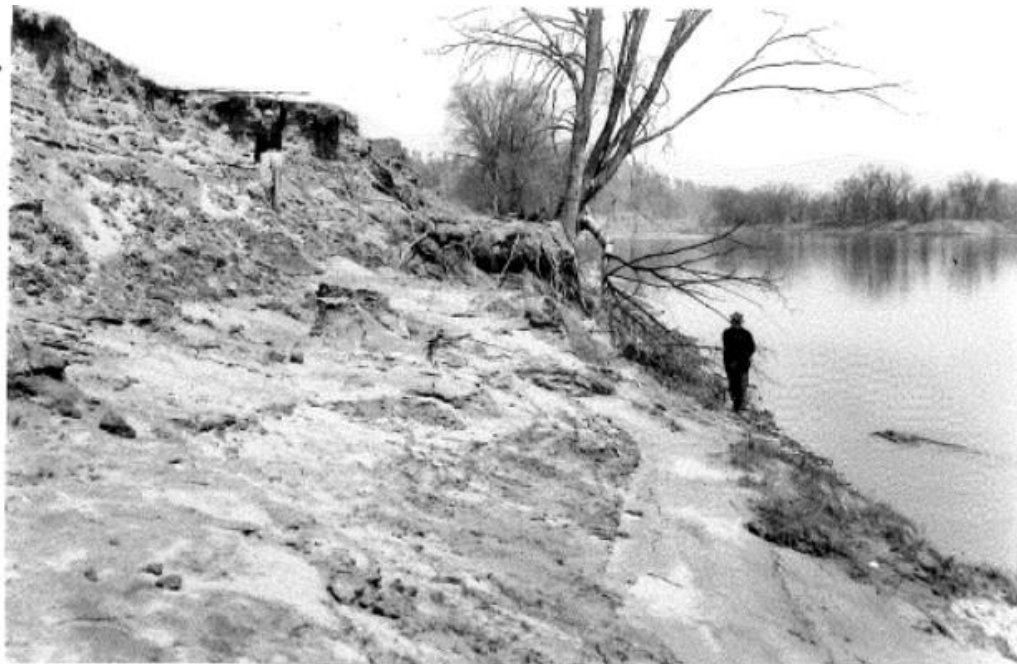
**Figure 5.5.5.2-16 Connecticut River near Windsor, VT – April 24, 1946 (TransCanada)**

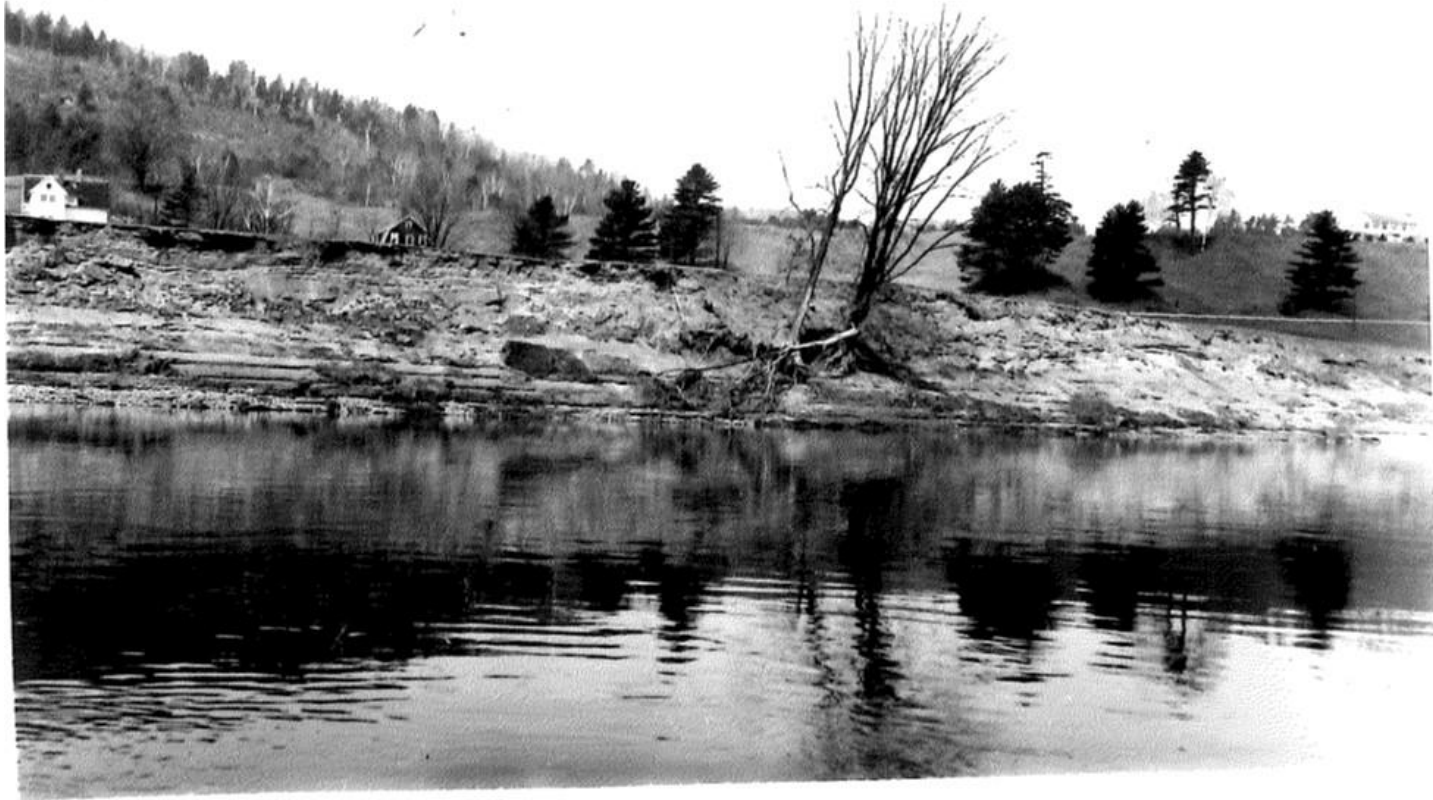
**Figure 5.5.5.2-17 Connecticut River near Windsor, VT – April 24, 1946 (TransCanada)**

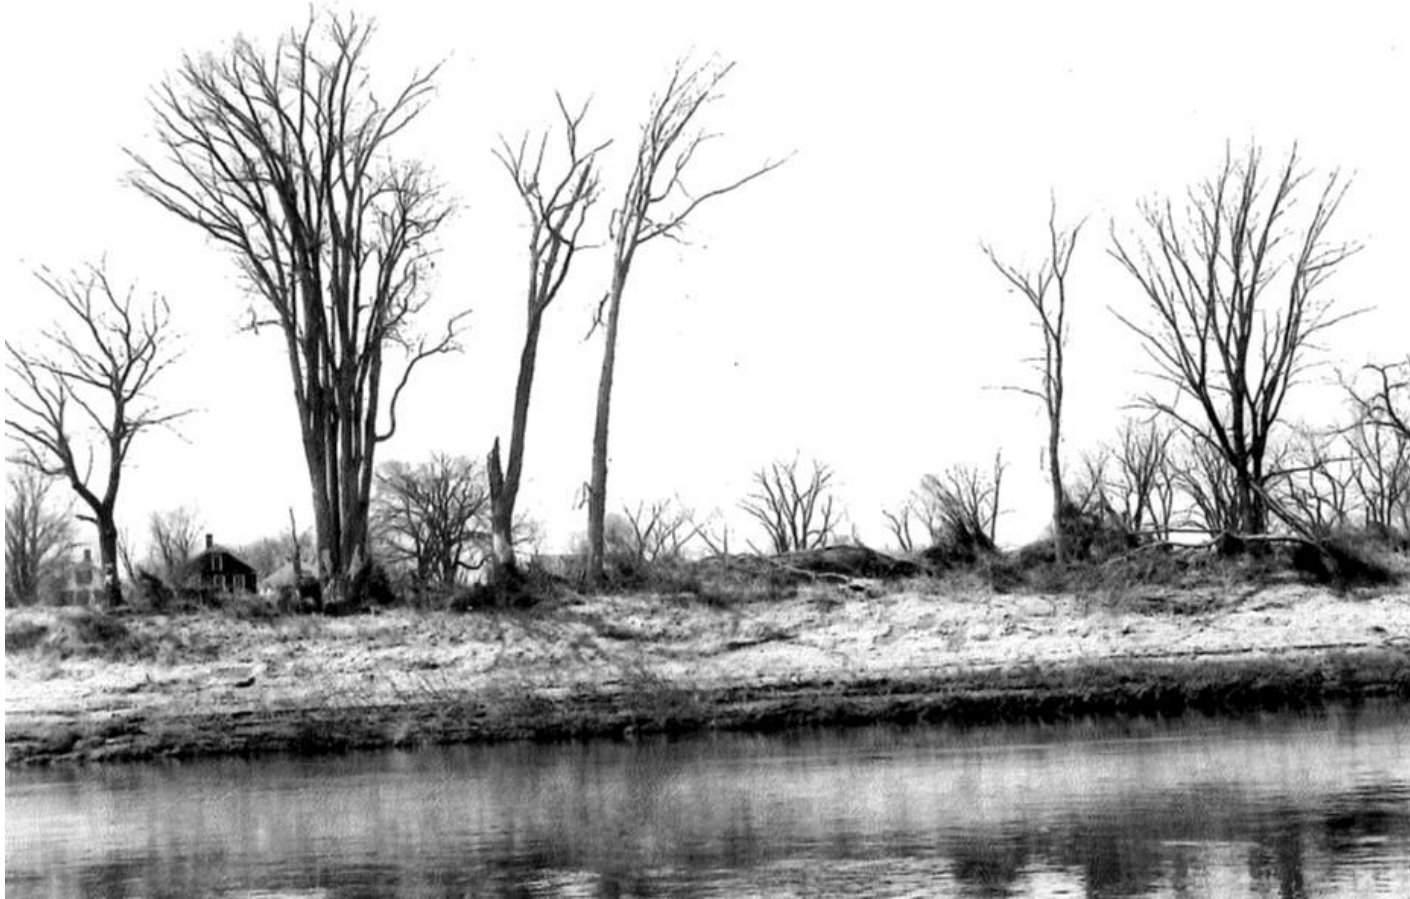
**Figure 5.5.5.2-18 Connecticut River near Windsor, VT – April 24, 1946 (TransCanada)**

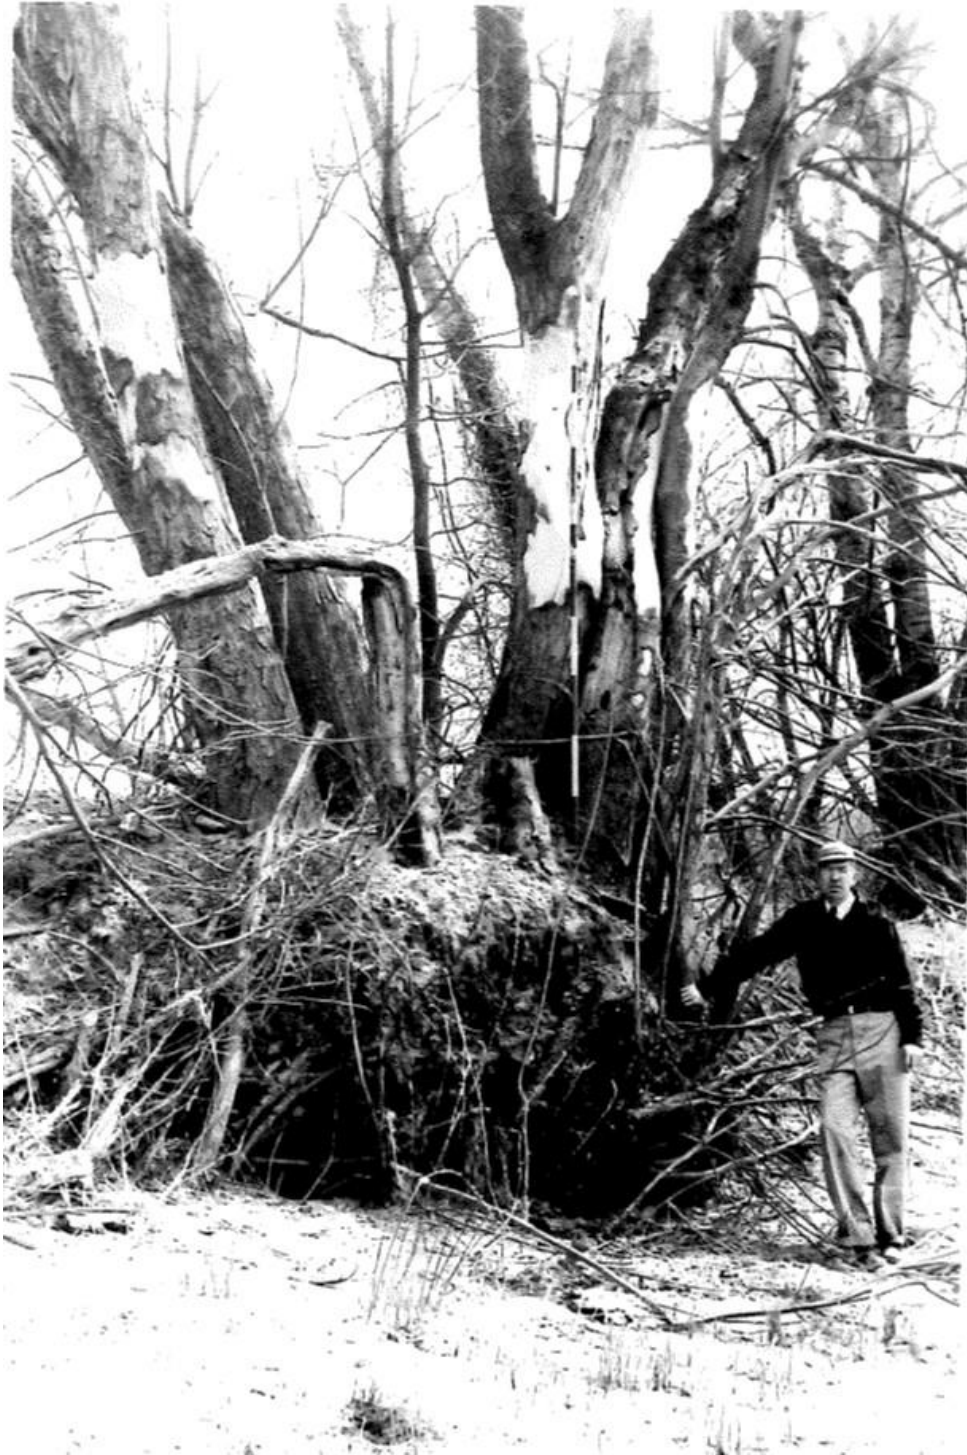
**Figure 5.5.5.2-19 Connecticut River near Cornish, NH – April 23, 1946 (TransCanada)**

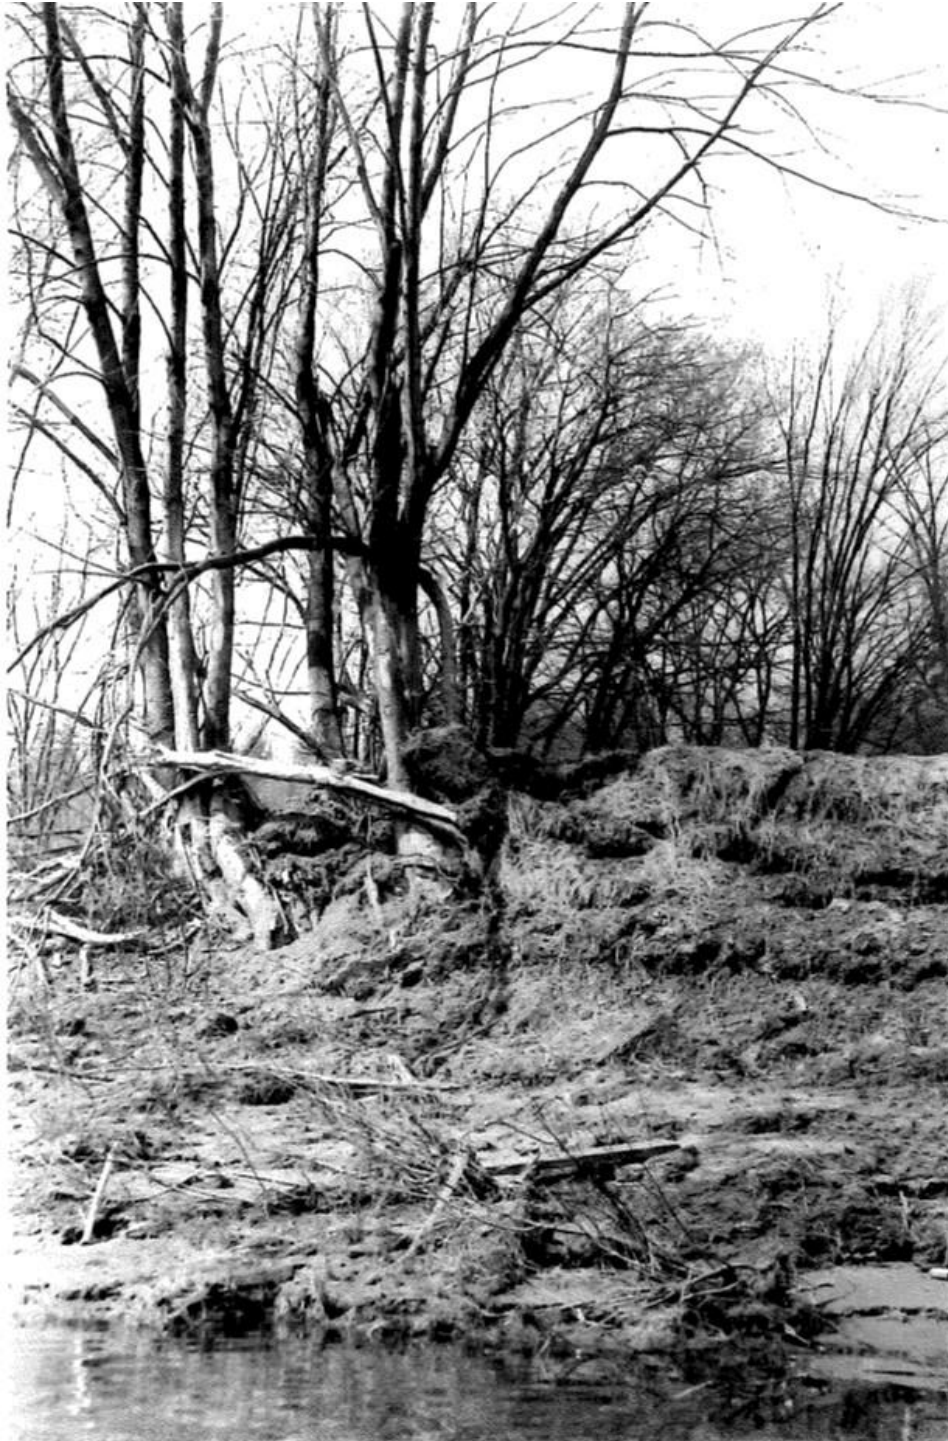
**Figure 5.5.2-20 Connecticut River near Windsor, VT – April 23, 1946 (TransCanada)**

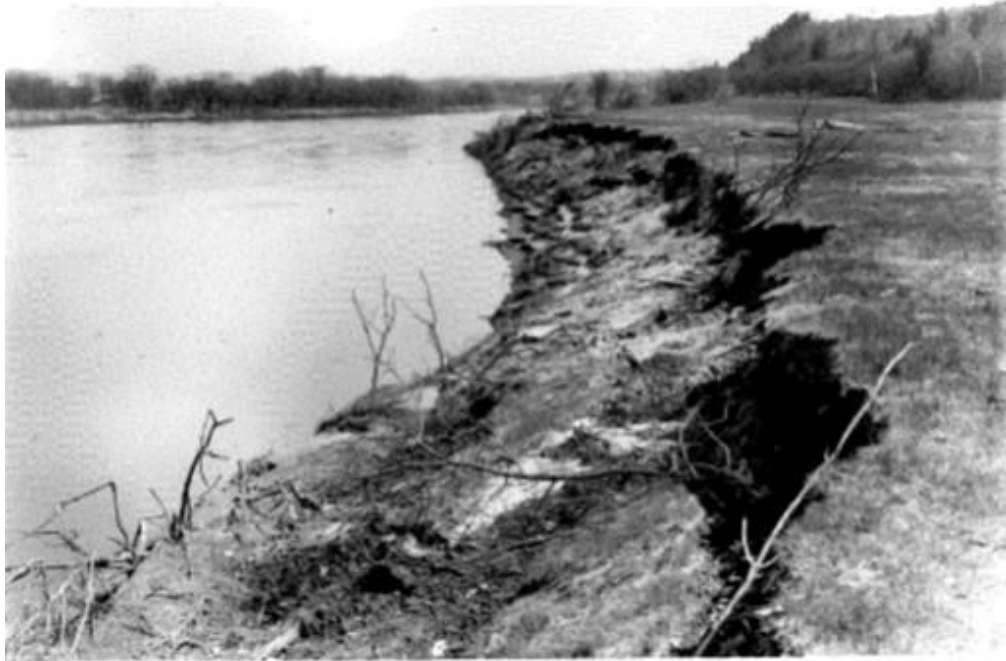
**Figure 5.5.5.2-22 Connecticut River near Cornish, NH – April 25, 1946 (TransCanada)**

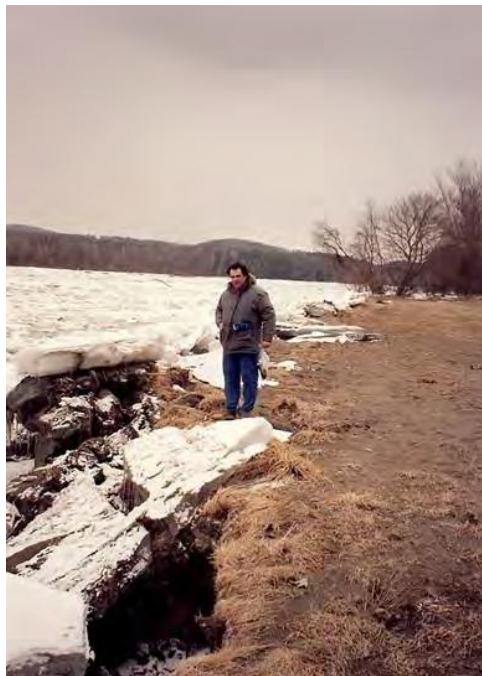
**Figure 5.5.5.2-23 Ice-Riverbank Interaction in Bellows Falls Impoundment – 1992 (TransCanada)**

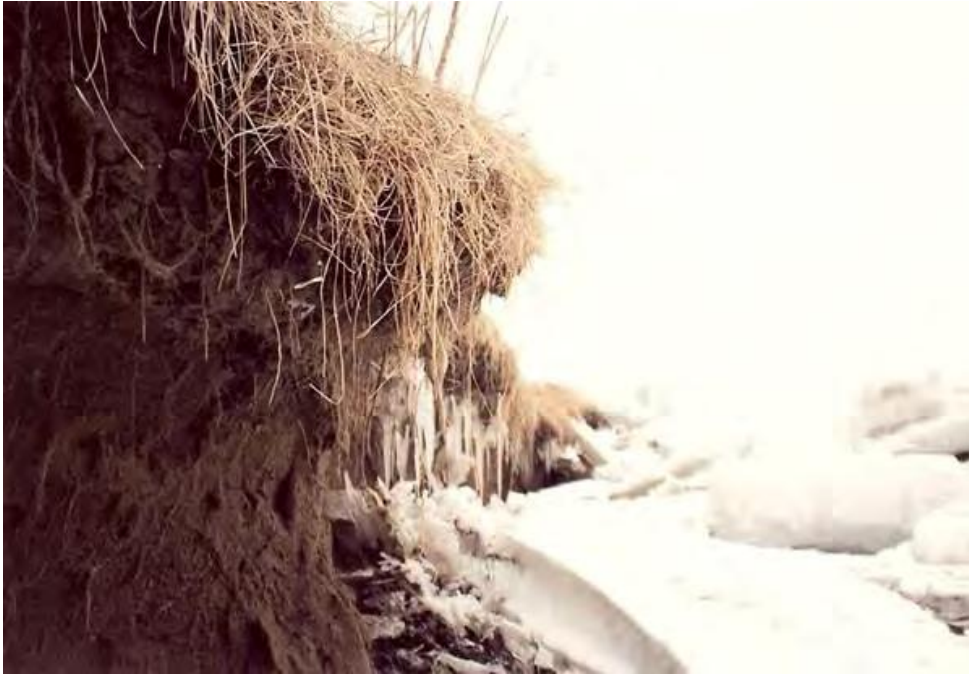
**Figure 5.5.5.3-1 Icicles Hanging from Upper Bank**

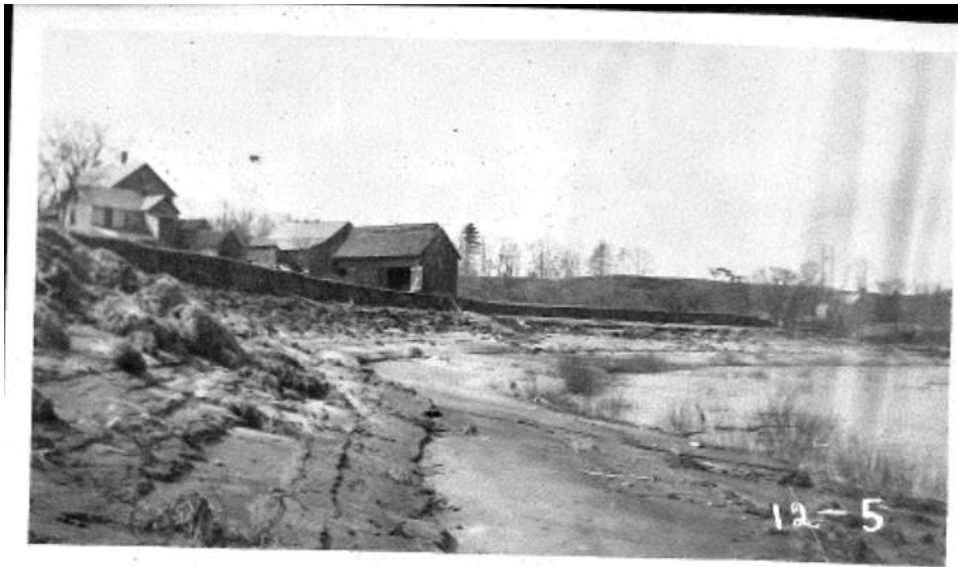
Stockwell farm below Vernon Dam. April 5, 1913.

**Figure 5.5.5-5 Eroded Bank in Turners Falls Impoundment Downstream of Vernon Dam – April 5, 1913 (TransCanada)**

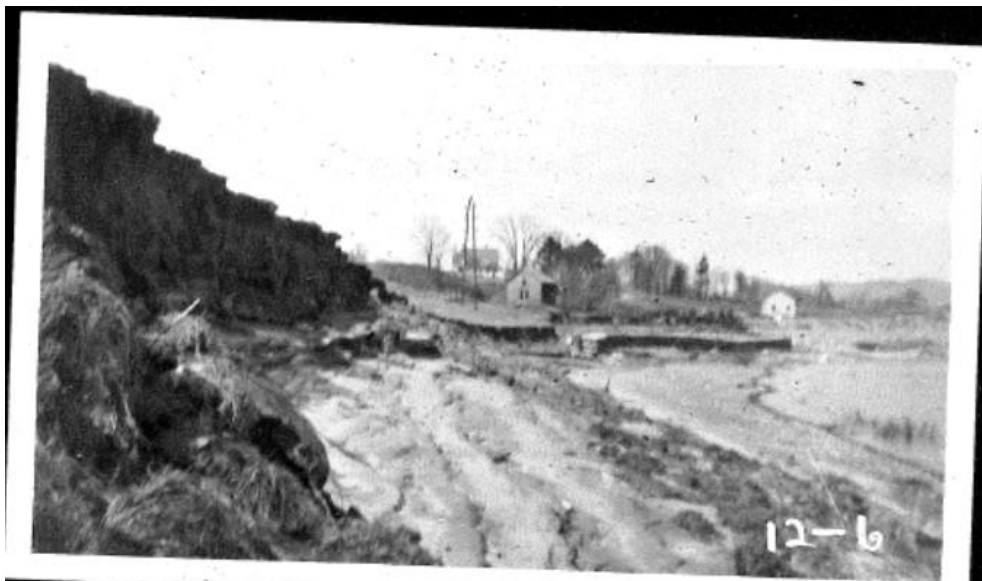
Bank of river, Vermont side, below Vernon Dam. April 5, 1913.

**Figure 5.5.5-6 Eroded Bank in Turners Falls Impoundment Downstream of Vernon Dam – April 5, 1913 (TransCanada)**

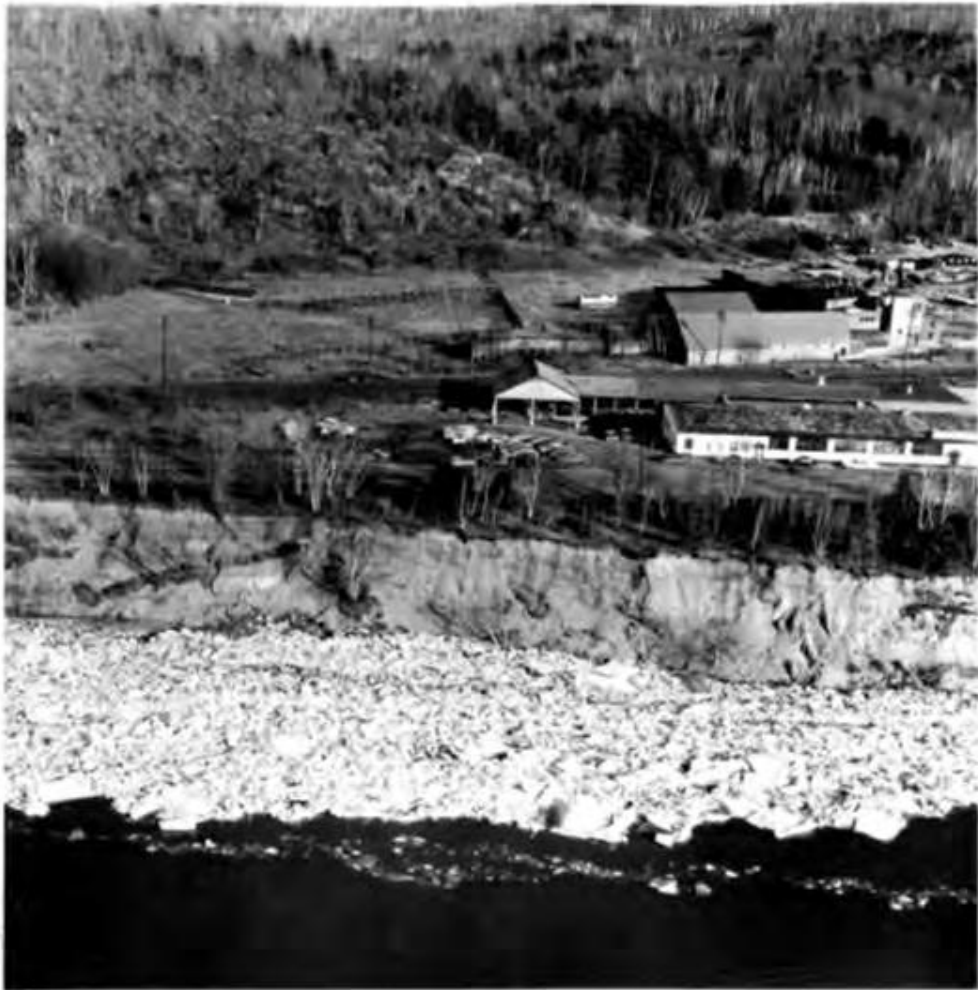
A - 3

March 25, 1968 - Eroded banks on N.E.P.  
property just north of Gray banks.

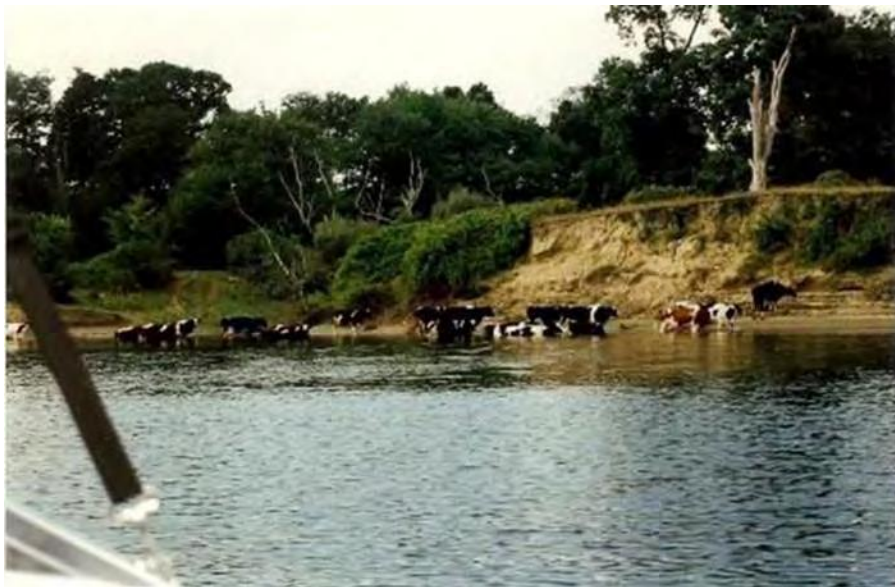
Along agricultural fields, paths are frequently created by animals traveling between fields and the river. Examples of this activity are shown in [Figure 5.5.6-3](#) and again in [Figures 5.5.6-4](#) through [5.5.6-12](#). [Figure 5.5.6-13](#) shows the location where each of the photos in [Figures 5.5.6-4](#) through [5.5.6-12](#) were taken. At the agricultural field found in [Figures 5.5.6-4](#) through [5.5.6-12](#) it was observed that there were a number of animal paths over the length of the field. Based on the width of the riparian zone adjacent to this particular field, the animal paths were found where the riparian zone was narrow while no animal paths were observed where the riparian zone was wider.

**Figure 5.5.6-3: Cattle using riverbank area along Connecticut River – Flagg erosion site near Kidds Island, Turners Falls Impoundment**

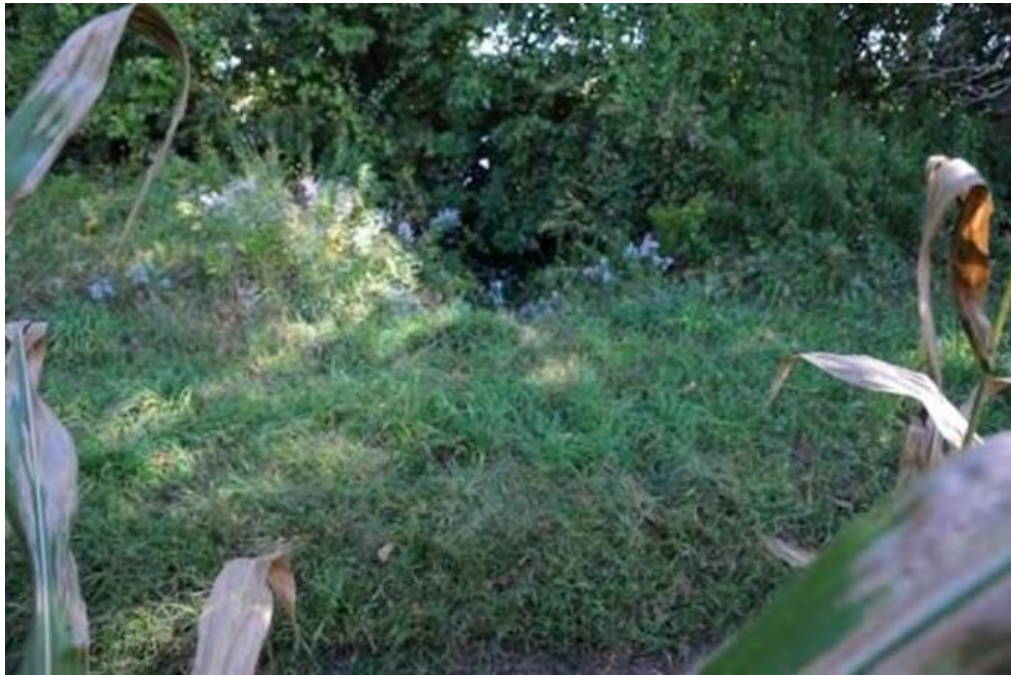
**Figure 5.5.6-4: Animal path from river to field, Photo 101**

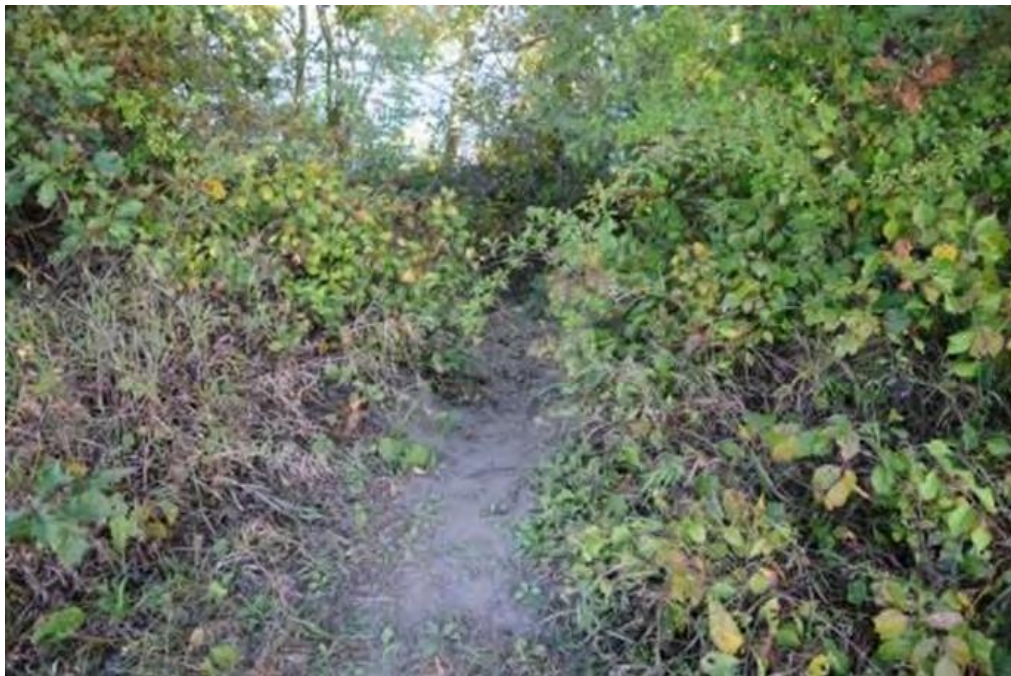
**Figure 5.5.6-5: Animal path from river to field, Photo 109**

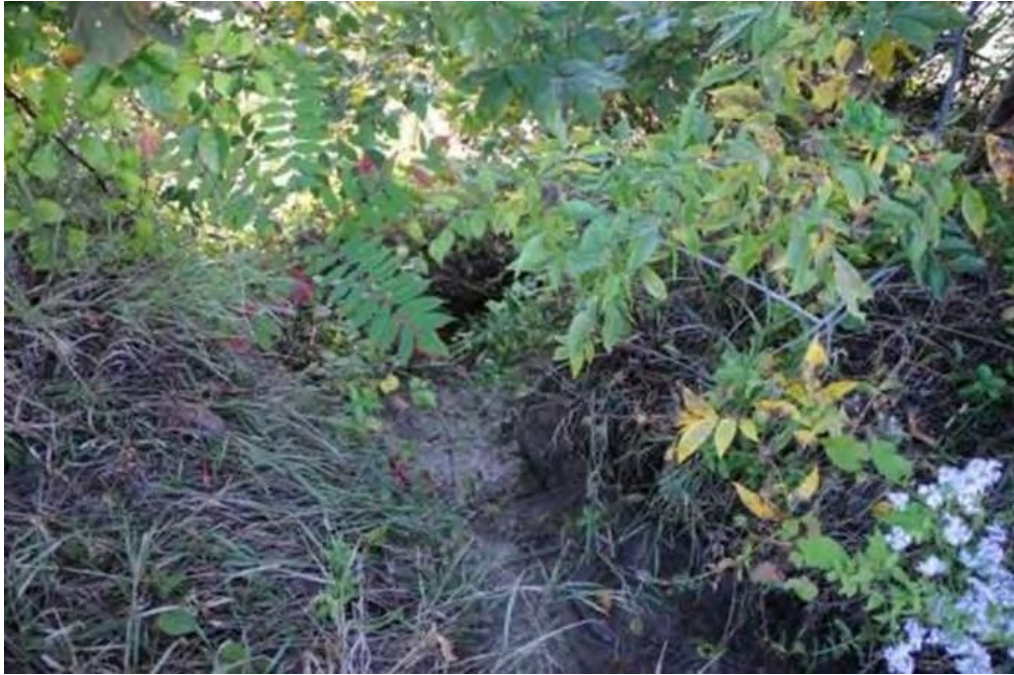
**Figure 5.5.6-6: Animal path from river to field, Photo 117**

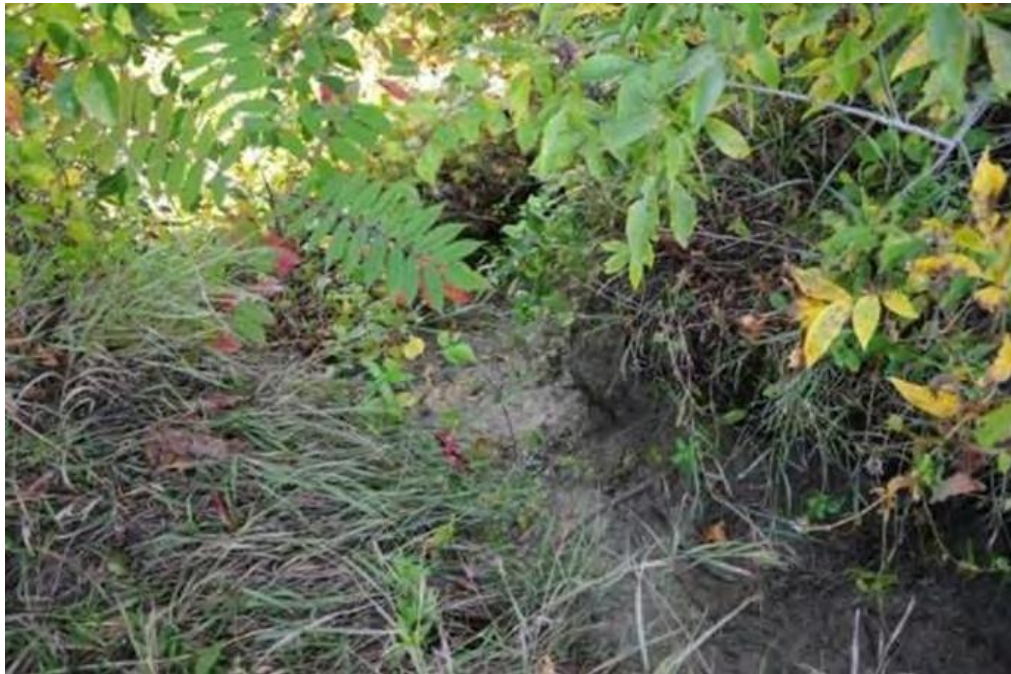
**Figure 5.5.5-6-7: Animal path from river to field, Photo 119**

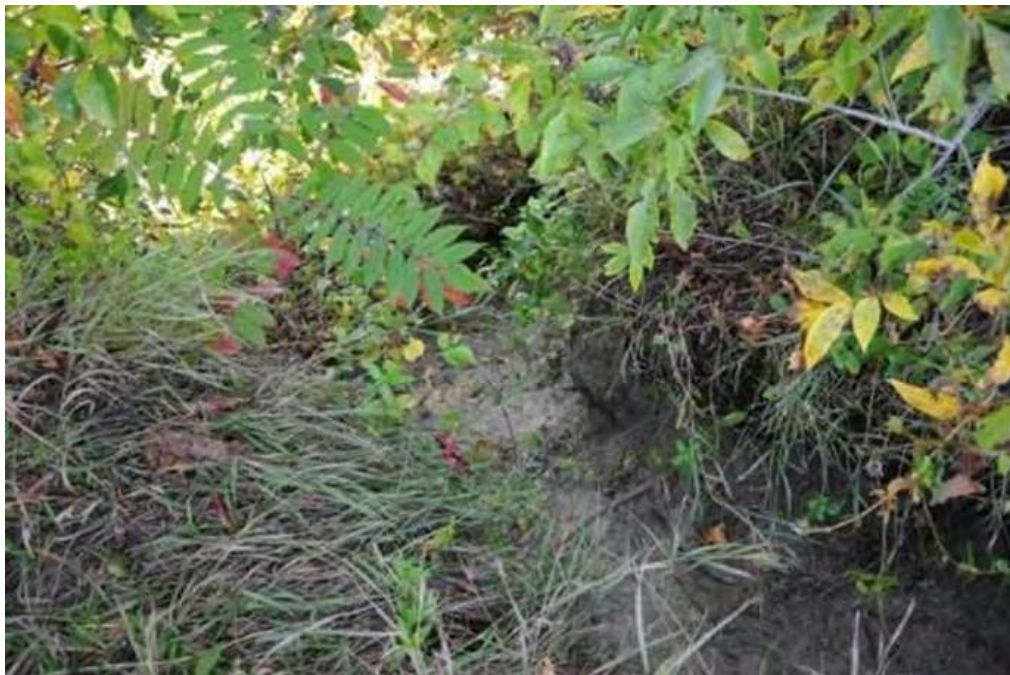
**Figure 5.5.6-8: Animal path from river to field, Photo 120**

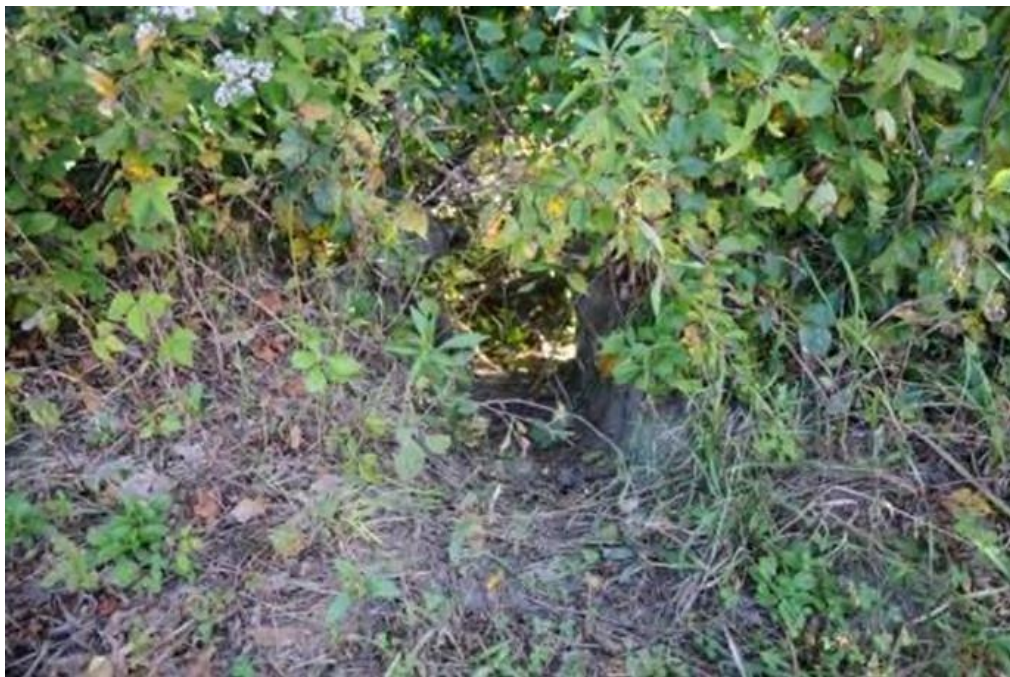
**Figure 5.5.6-9: Animal path from river to field, Photo 124**

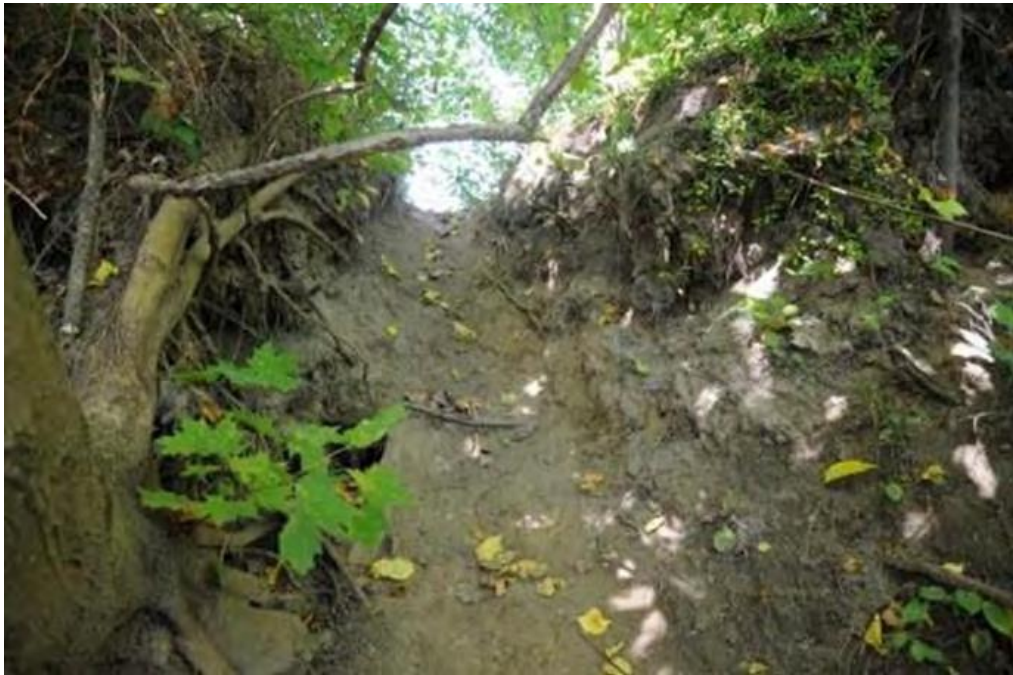
**Figure 5.5.6-10: Animal path from river to field, Photo 128**
