FIRSTLIGHT HYDRO GENERATING COMPANY  
 Northfield Mountain Pumped Storage Project No. 2485  
 Turners Falls Hydroelectric Project No. 1889  
 STUDY 3.1.2

*Northfield Mountain Pumped Storage Project (No. 2485) and Turners Falls Hydroelectric Project (No. 1889)*  
STUDY 3.1.2 NORTHFIELD MOUNTAIN / TURNERS FALLS OPERATIONS IMPACTS ON EXISTING  
EROSION AND POTENTIAL BANK INSTABILITY

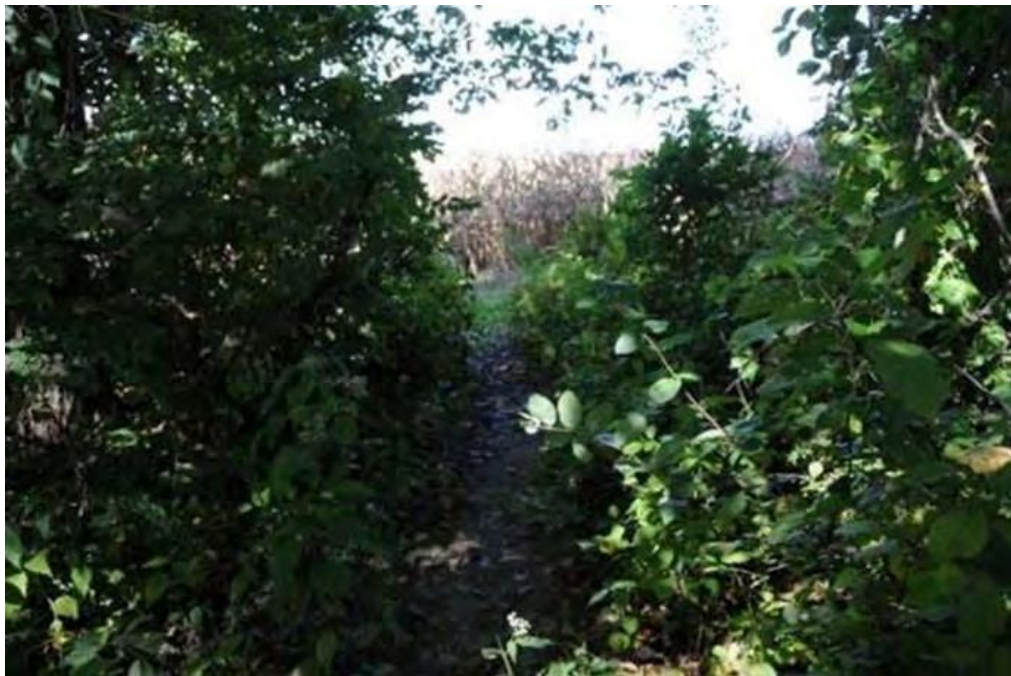
**Figure 5.5.6-11: Animal path from river to field, Photo 130**

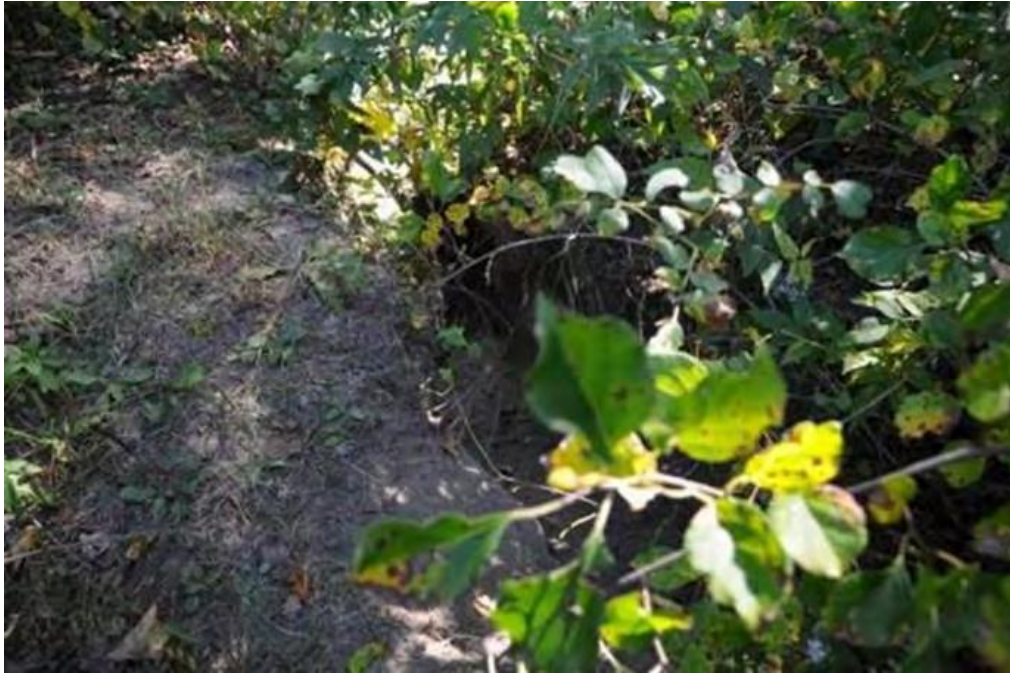
**Figure 5.5.6-12: Animal path from river to field, Photo 135**

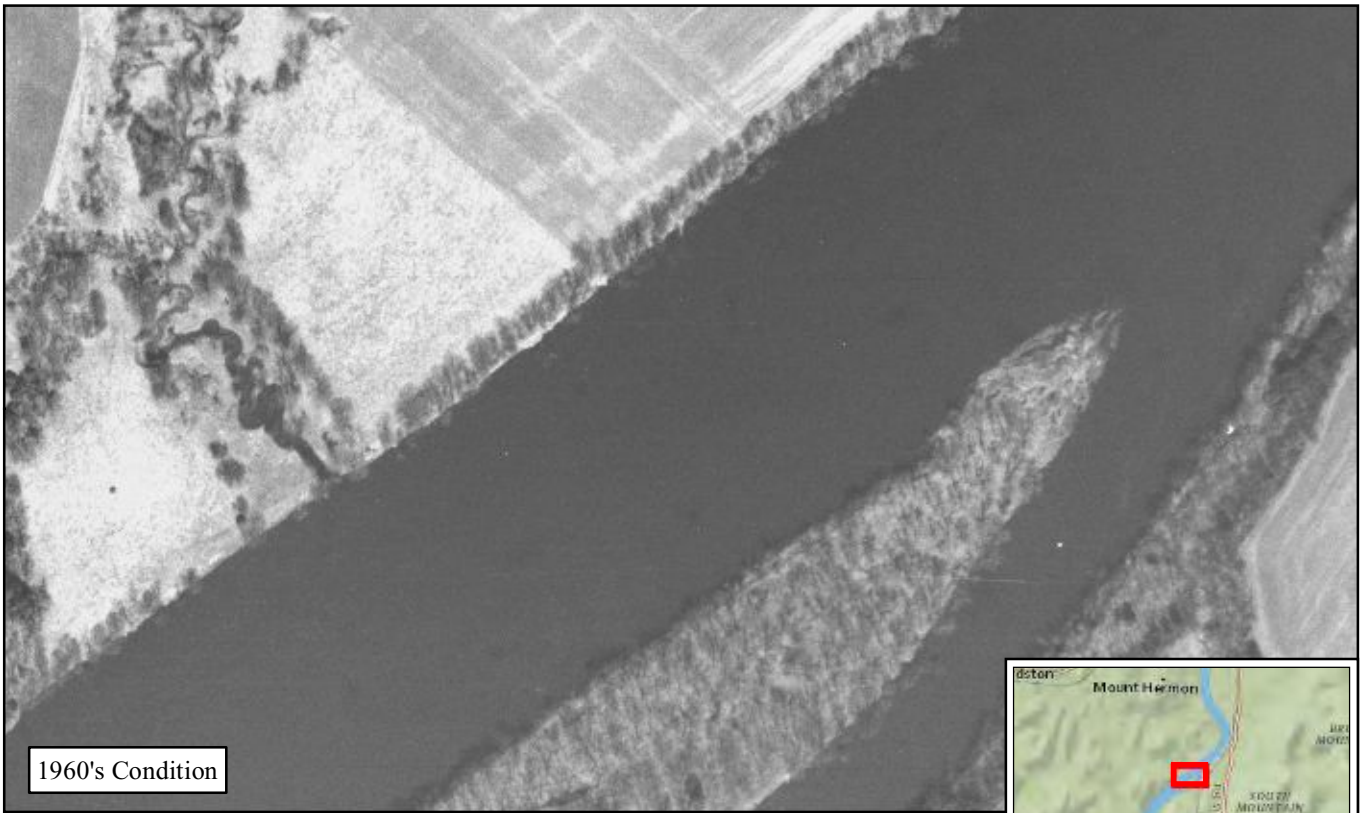
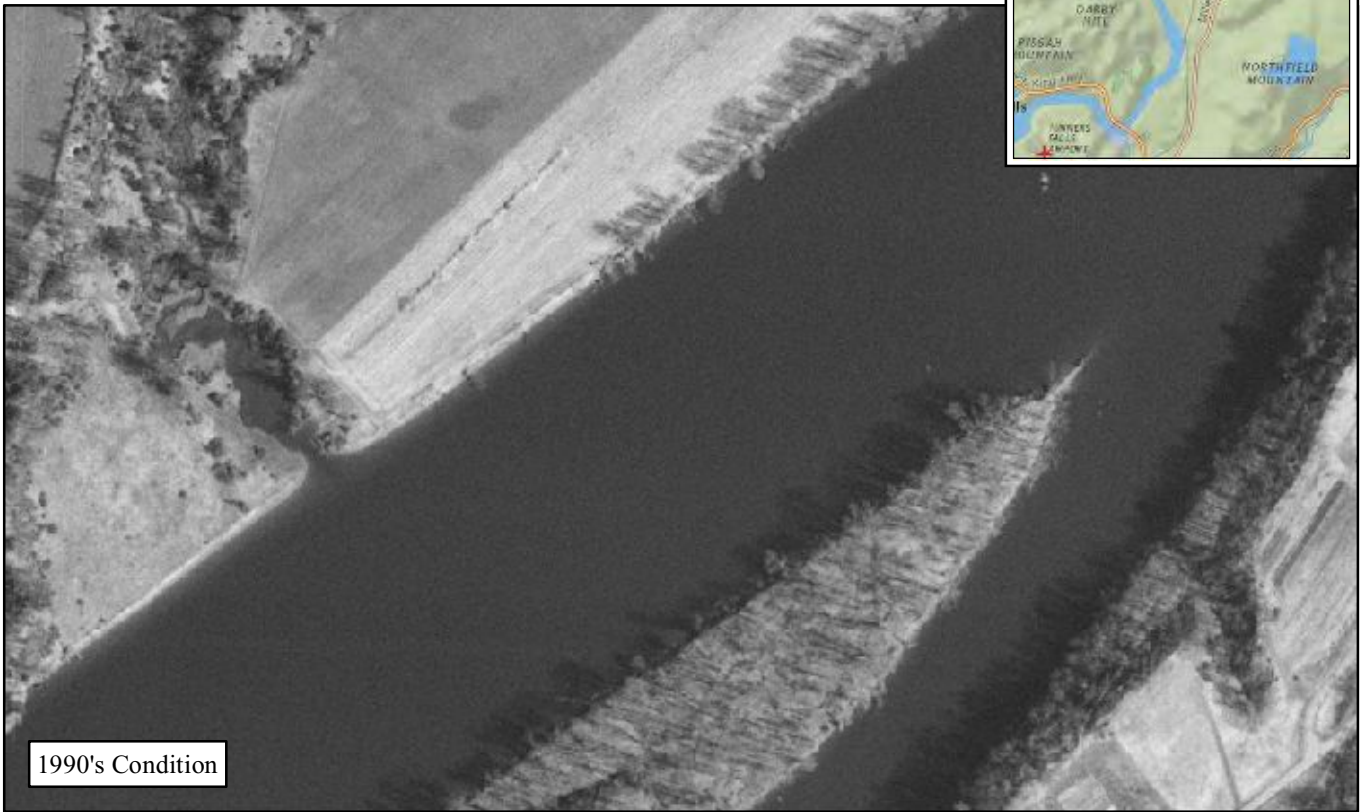
Figure 6.1.4.1-3:  
 TFI USACE Index Site 255  
 1960's and 1990's Condition

From the 103 erosion sites initially identified, six index sites were established for detailed study. Of the six index sites selected, only one (Site 255) was located in the TFI. Site 255 is located in Gill, MA on the right bank of the river (looking downstream) adjacent to Kidds Island ([Figure 6.1.4.1-2](#)). This site is located in an agricultural area located upstream of a tributary (Otter Run Brook). [Figure 6.1.4.1-3](#) show the study site using 1960's and 1990's aerial photography. As observed in the figure, a very narrow riparian vegetation zone is present in the 1960's photograph with riparian vegetation being absent in the 1990's imagery. Another factor to consider in evaluating Site 255 is that this area of the TFI was heavily utilized for recreation by people who would camp on and boat in the vicinity of the island ([Figure 6.1.4.1-4](#)). Boat traffic and riverbank erosion caused by boat waves was studied in the 1990s ("Connecticut River Riverbank Management Master Plan (DRAFT)," June 1991, Northrop, Devine & Tarbell). Regarding boat traffic, the report states, "riverbank use was most intense at the Otter Run Brook area where 36 boats passed in one thirty-minute period while 13 boats were beached on the shore and 50 people were counted along the riverbank/beach area." They noted erosion associated with boat waves in this part of the river,

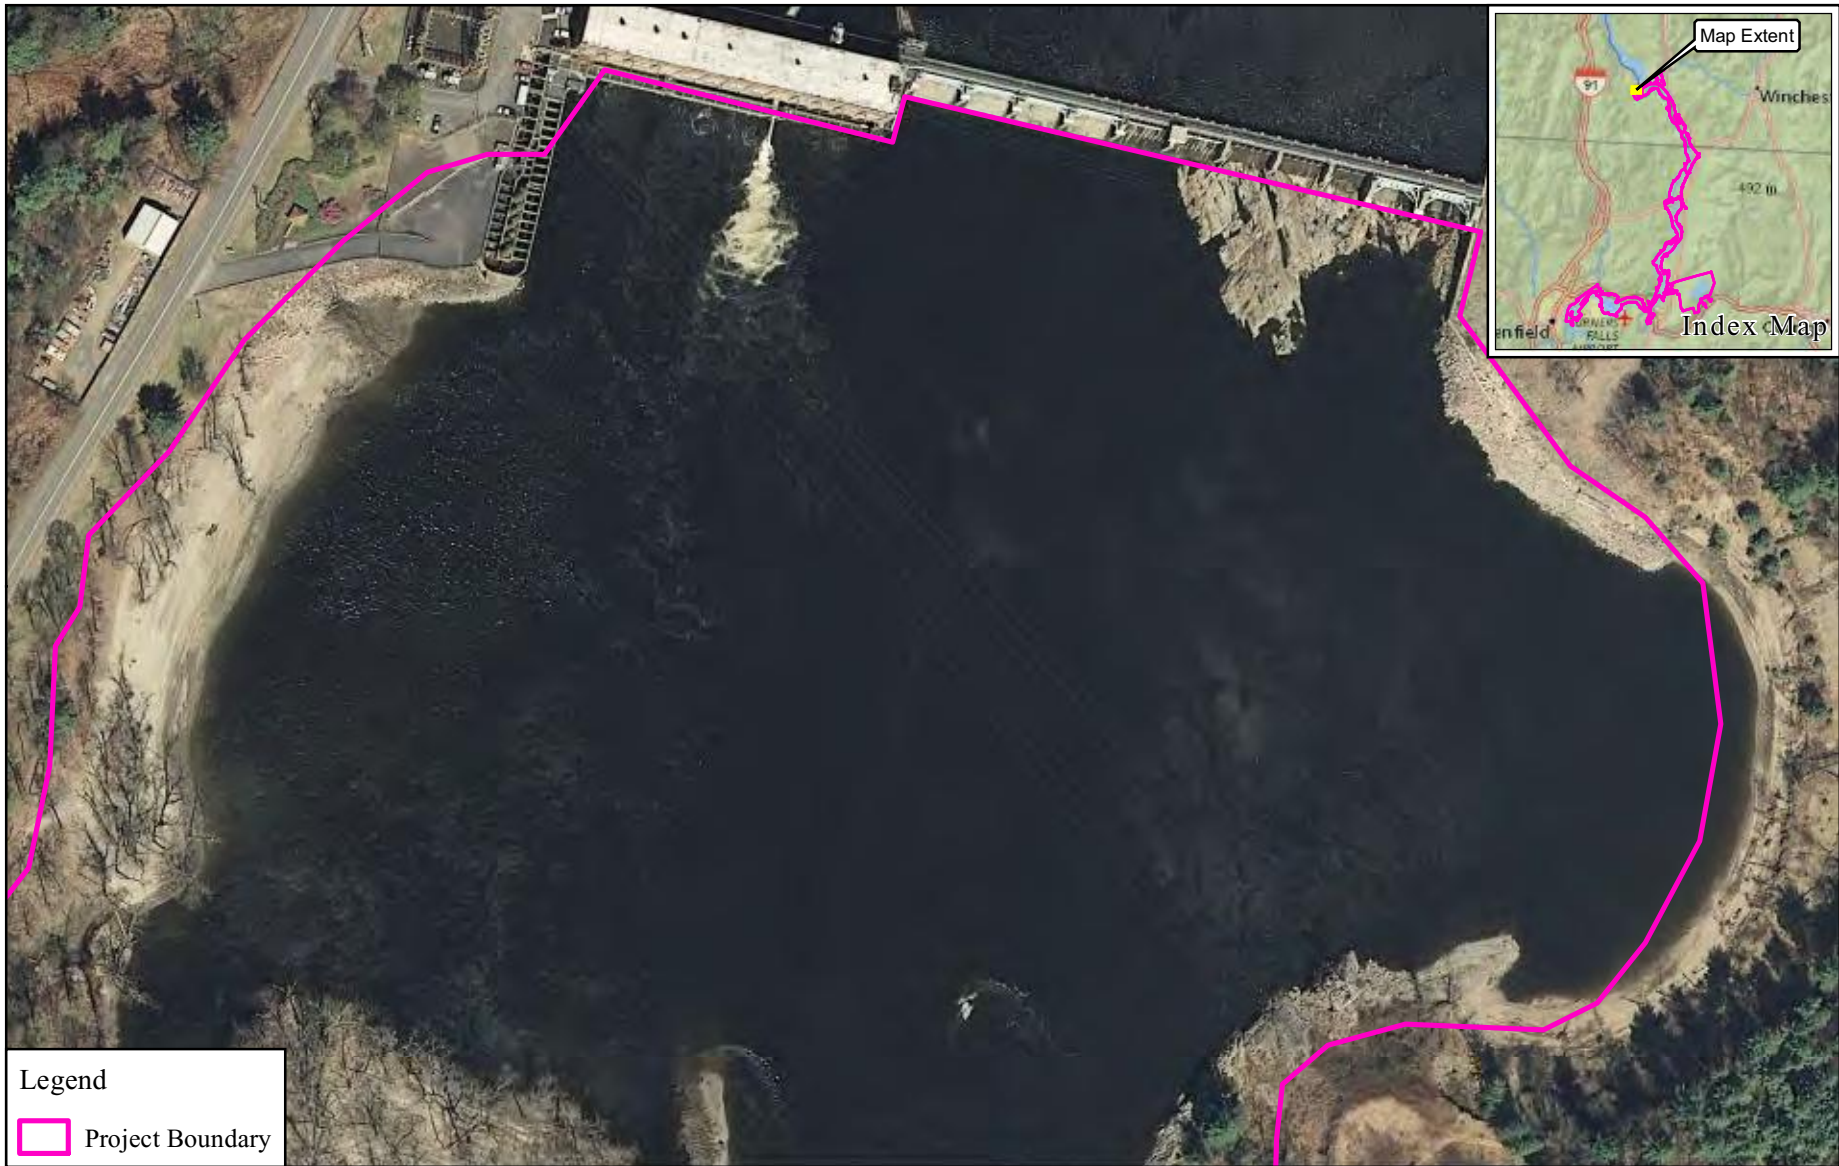
<p>FIRSTLIGHT HYDRO GENERATING COMPANY Northfield Mountain Pumped Storage Project No. 2485 Turners Falls Hydroelectric Project No. 1889 <b>STUDY 3.1.2</b></p>	<p>Vernon Dam 2008-2010 Imagery (Source: NH GRANIT)</p>

The most significant erosion feature in the Turners Falls Impoundment is located immediately downstream of Vernon Dam on the left bank (looking downstream). As discussed in S&A 2012, erosion occurs in this location due to the large eddy that forms from flow releases through Vernon Dam gates on the left side of the structure.

The 1952 photograph shows that the top of left bank is near the project boundary line (indicated in fuchsia). Recent photographs show that erosion has progressed beyond the line such that the bottom of the upper bank is beyond the line. The 2008-2010 and the Online Imagery were taken at relatively high flow conditions and show the turbulence and eddying associated with the release of flow through the left gates of Vernon Dam as well as the general turbulence in this reach of the river at these levels of flow.

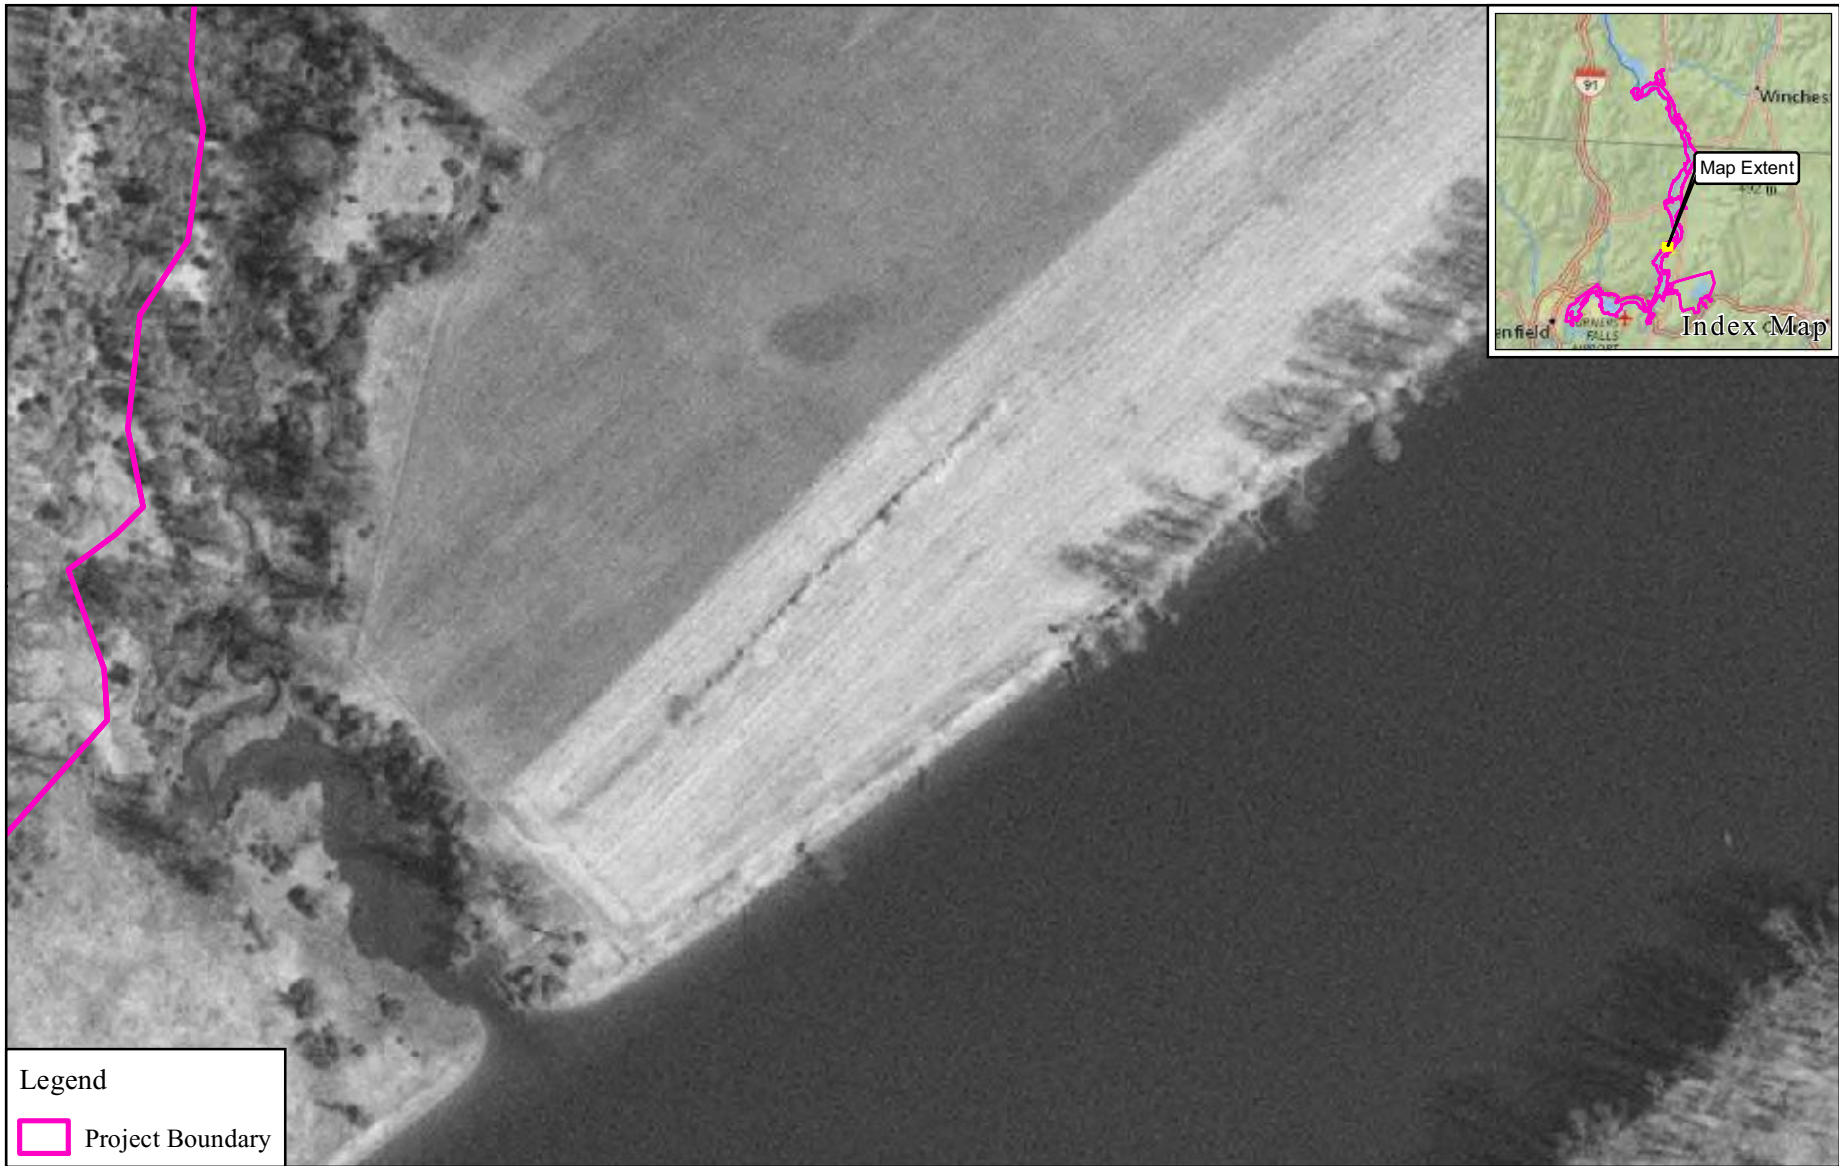
Flagg (upstream of Otter Run)  
1990's Imagery  
(Source: MassGIS)

The right bank upstream of Otter Run follows the same pattern as the segment downstream from 1952 through the 1990s photographs with sparse riverbank vegetation in the 1950s and 1960s and virtually no riparian vegetation and erosion evident in the 1990s. This upstream site was stabilized in 2000 as part of the Flagg site through the ECP. This segment of the site was fenced off without access to cattle and is now densely vegetated and has a rock toe with aquatic vegetation growing on the lower riverbank. The riparian vegetation can be seen in the recent photographs.

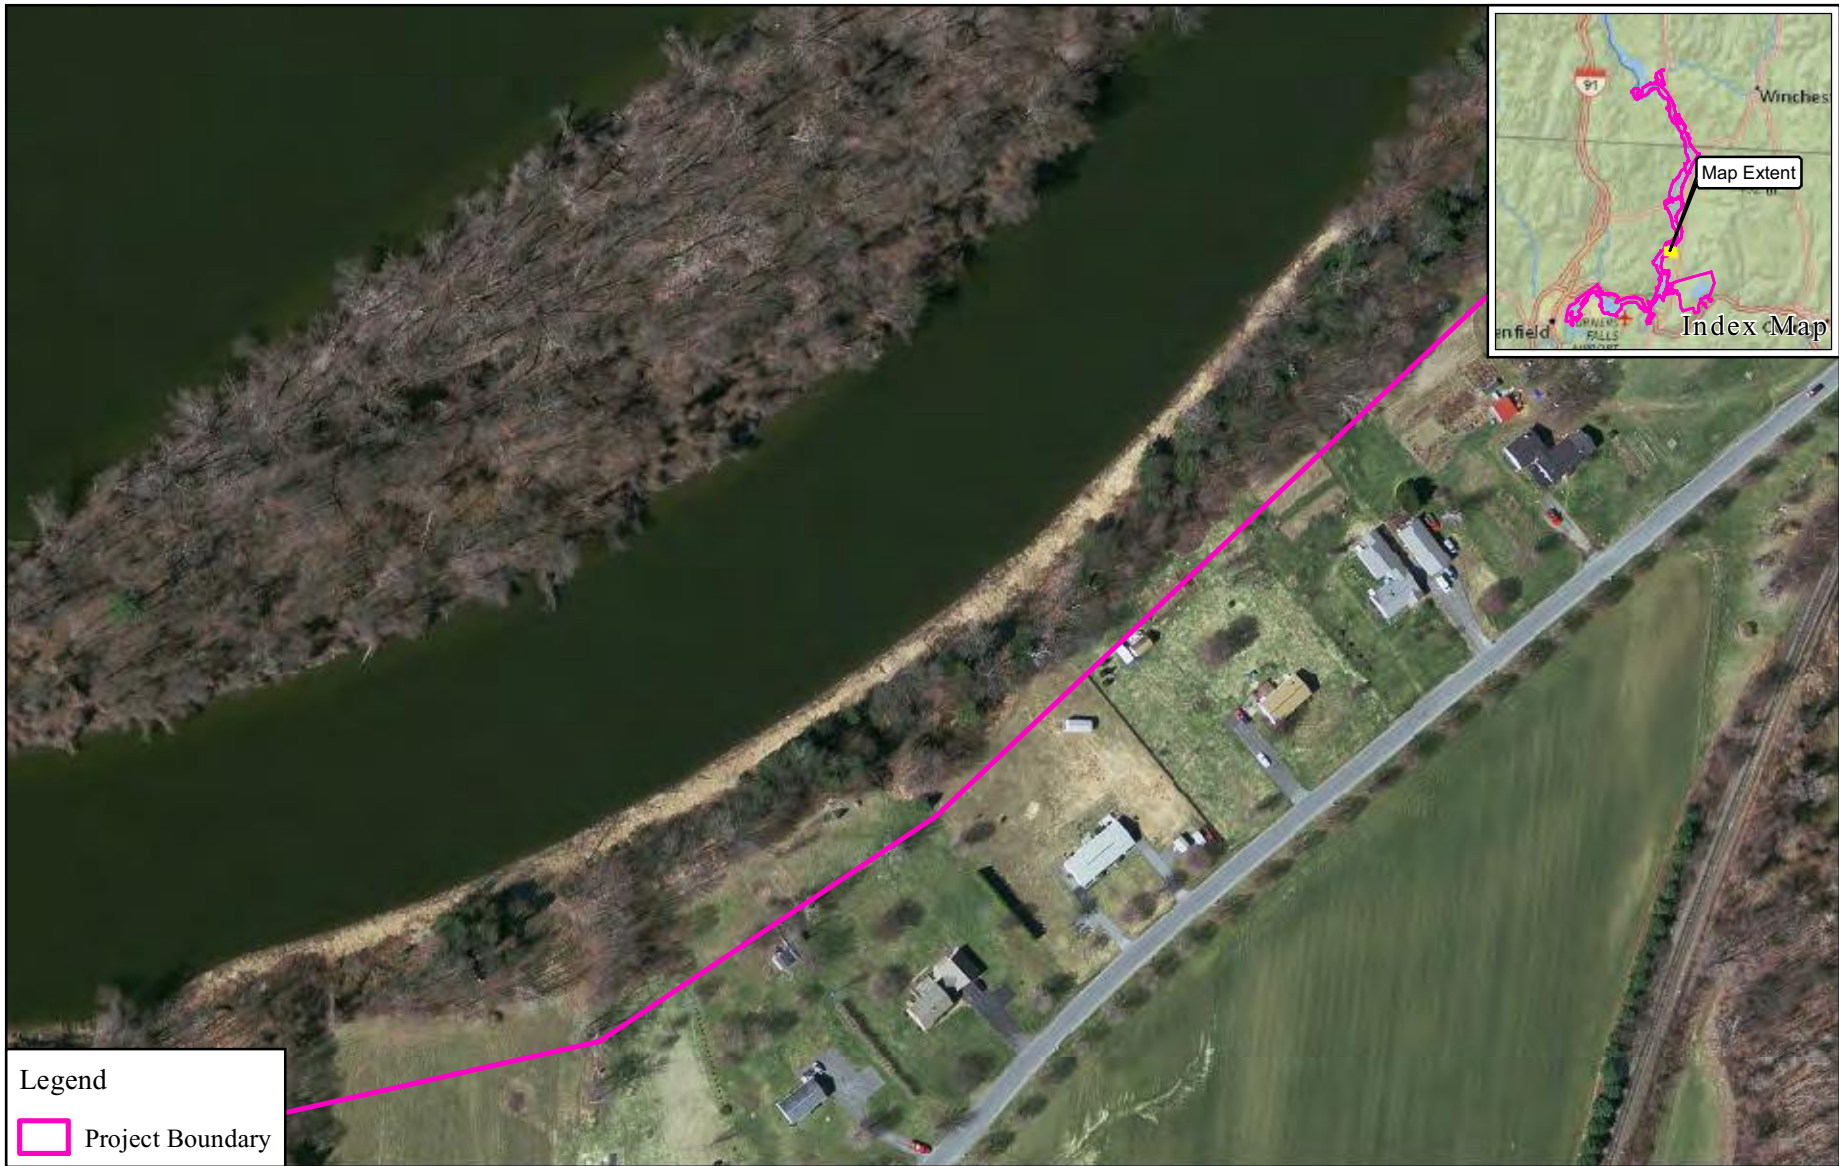
Skalski  
2008-2010 Imagery  
(Source: MassGIS)

The left bank of the river in the vicinity of Kidds Island has a band of riparian vegetation in the 1952, 1960s and 1990s photographs. While not apparent in the photographs, erosion had been occurring along this bank and was identified in the ECP and stabilized in 2004 as the Skalski site as can be seen in the more recent photographs with a rock toe and vegetated upper bank.

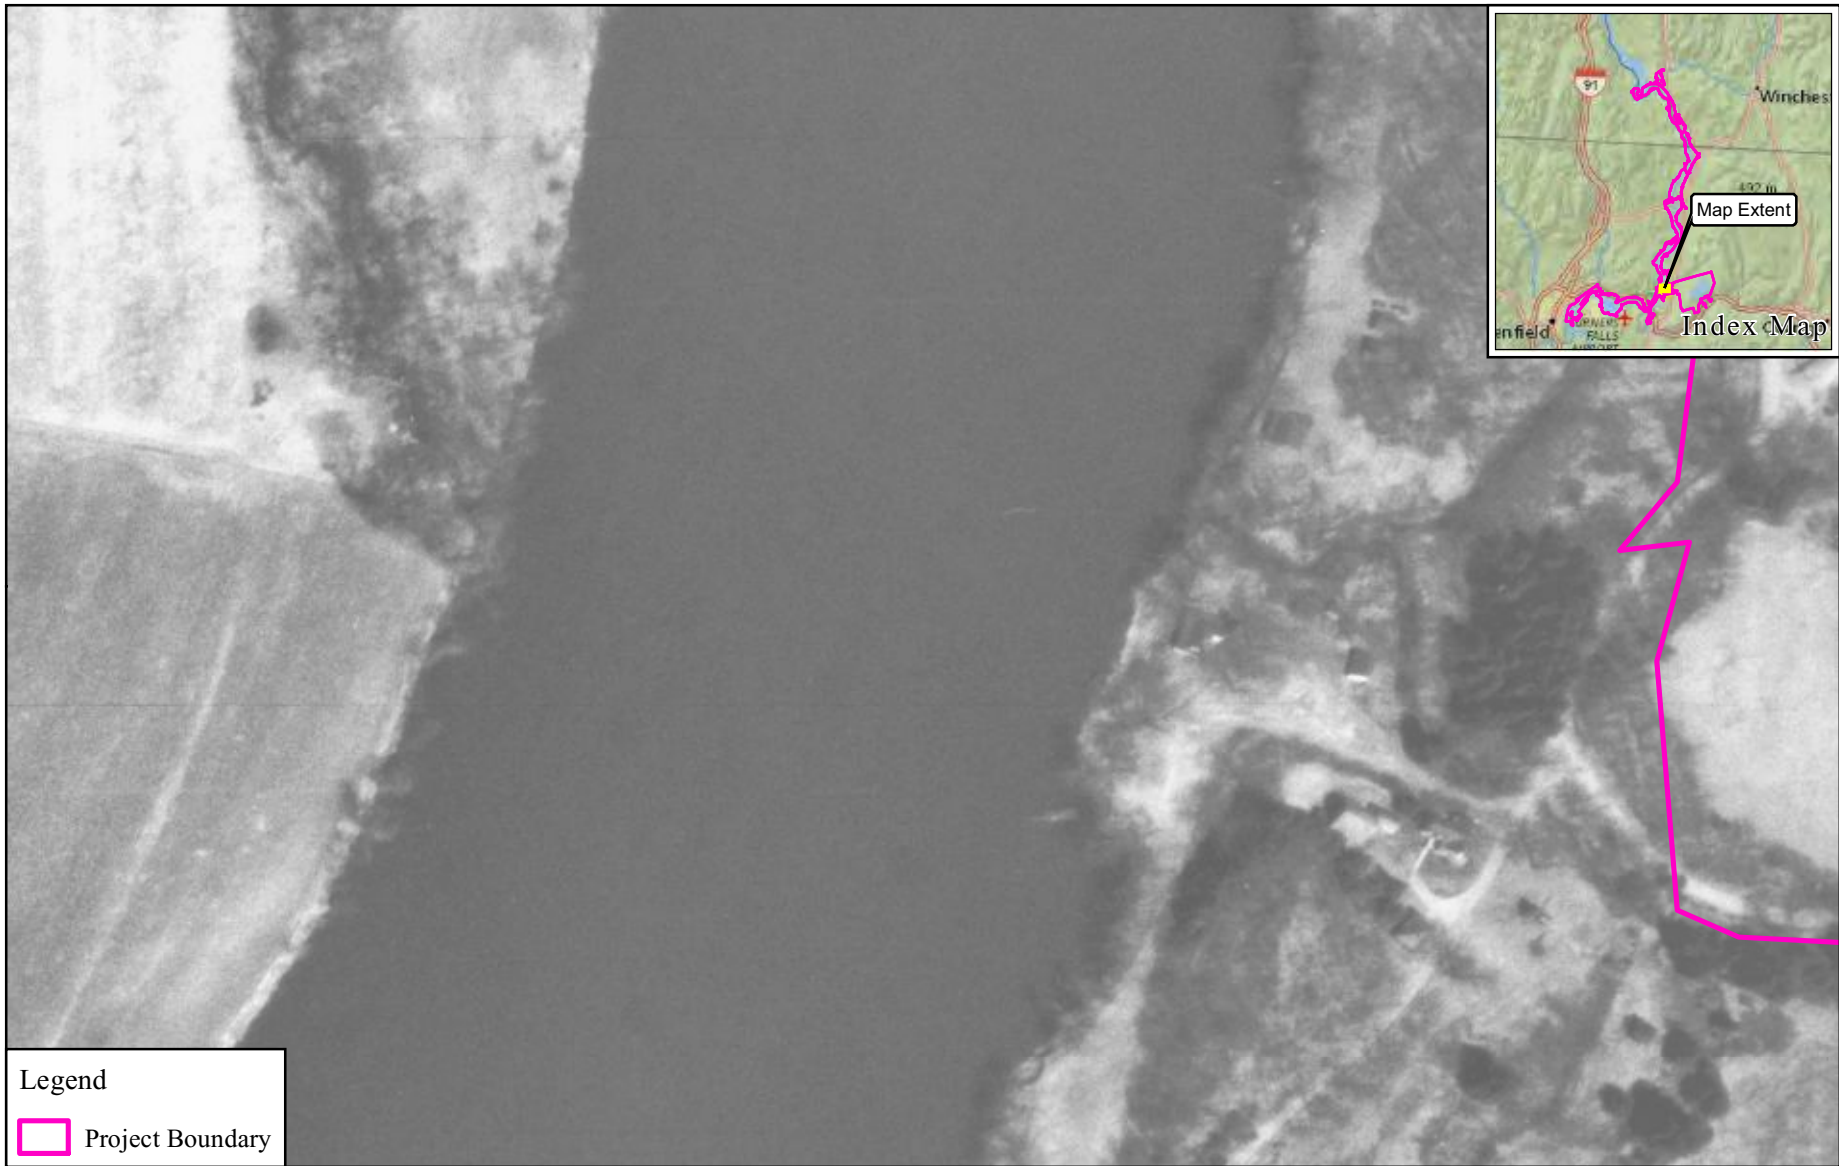
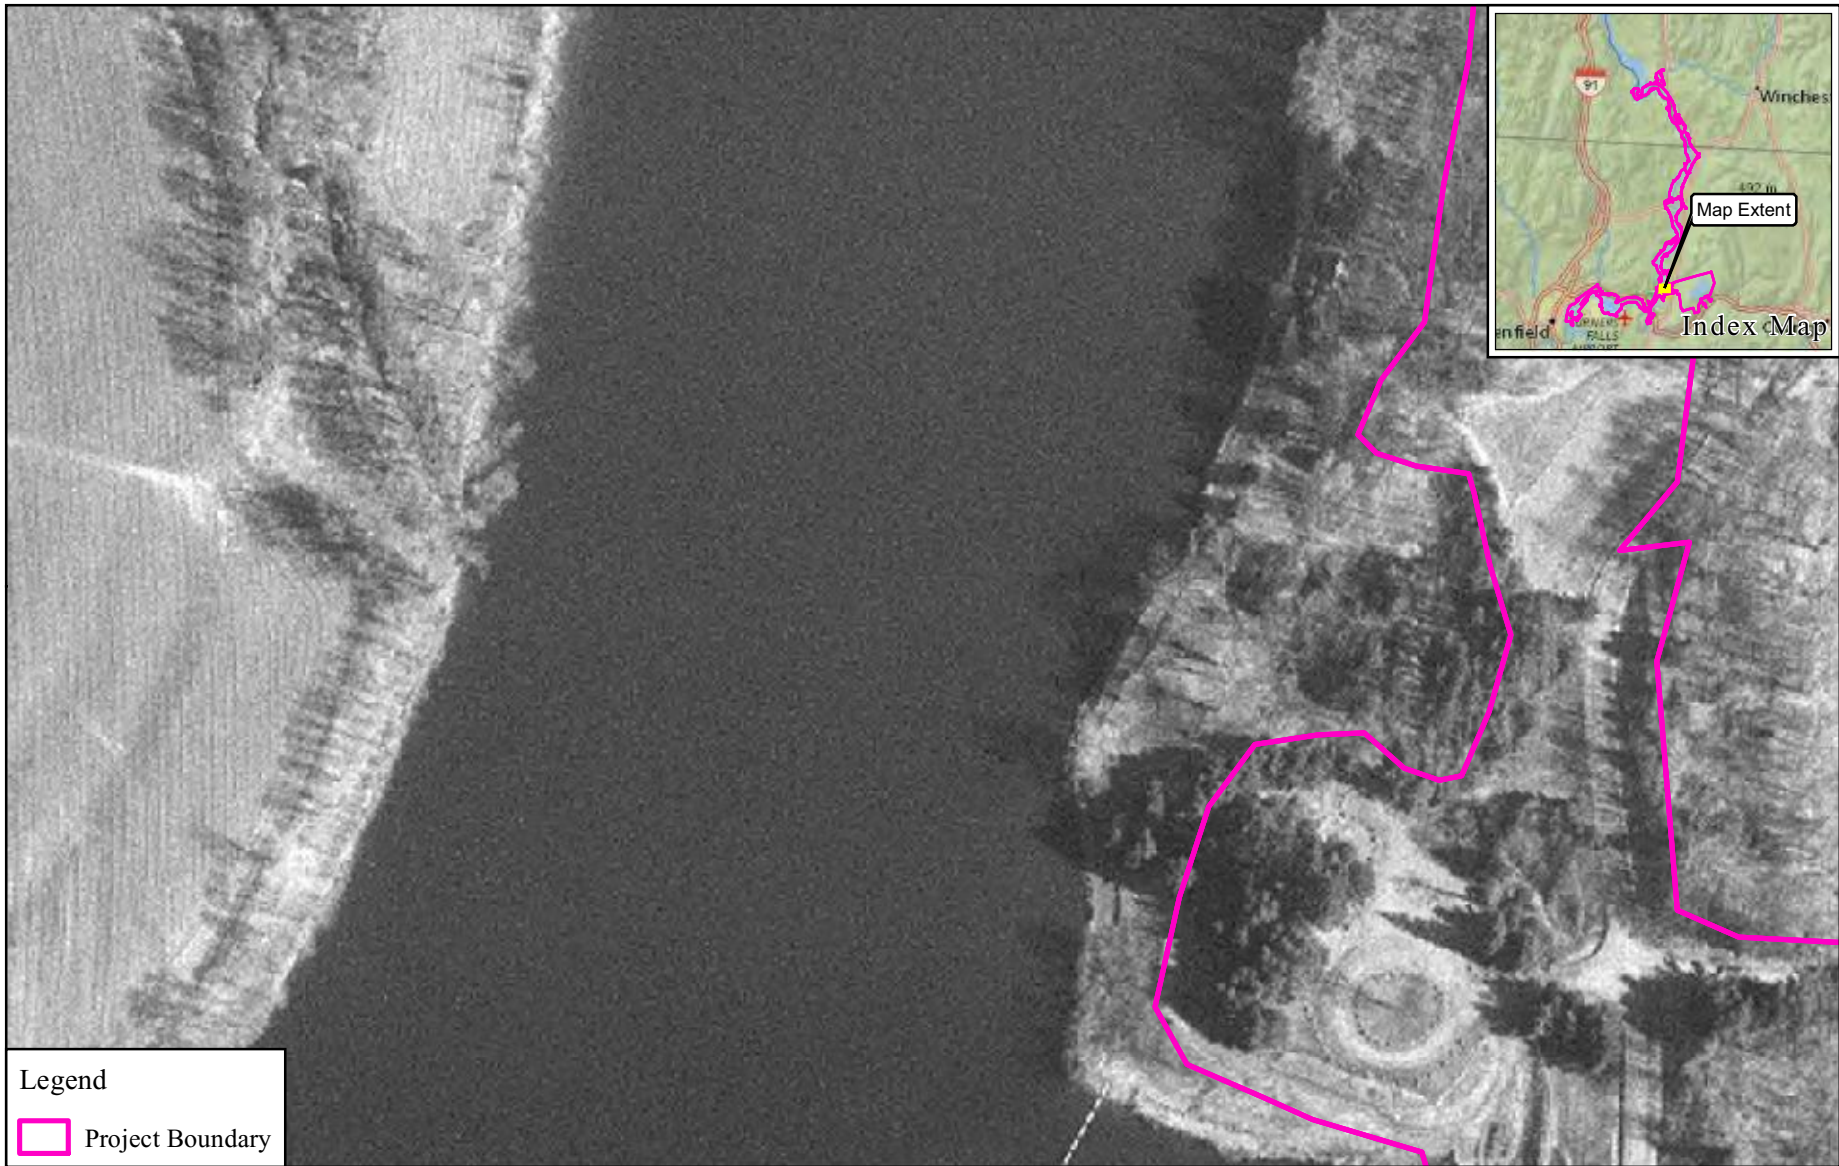
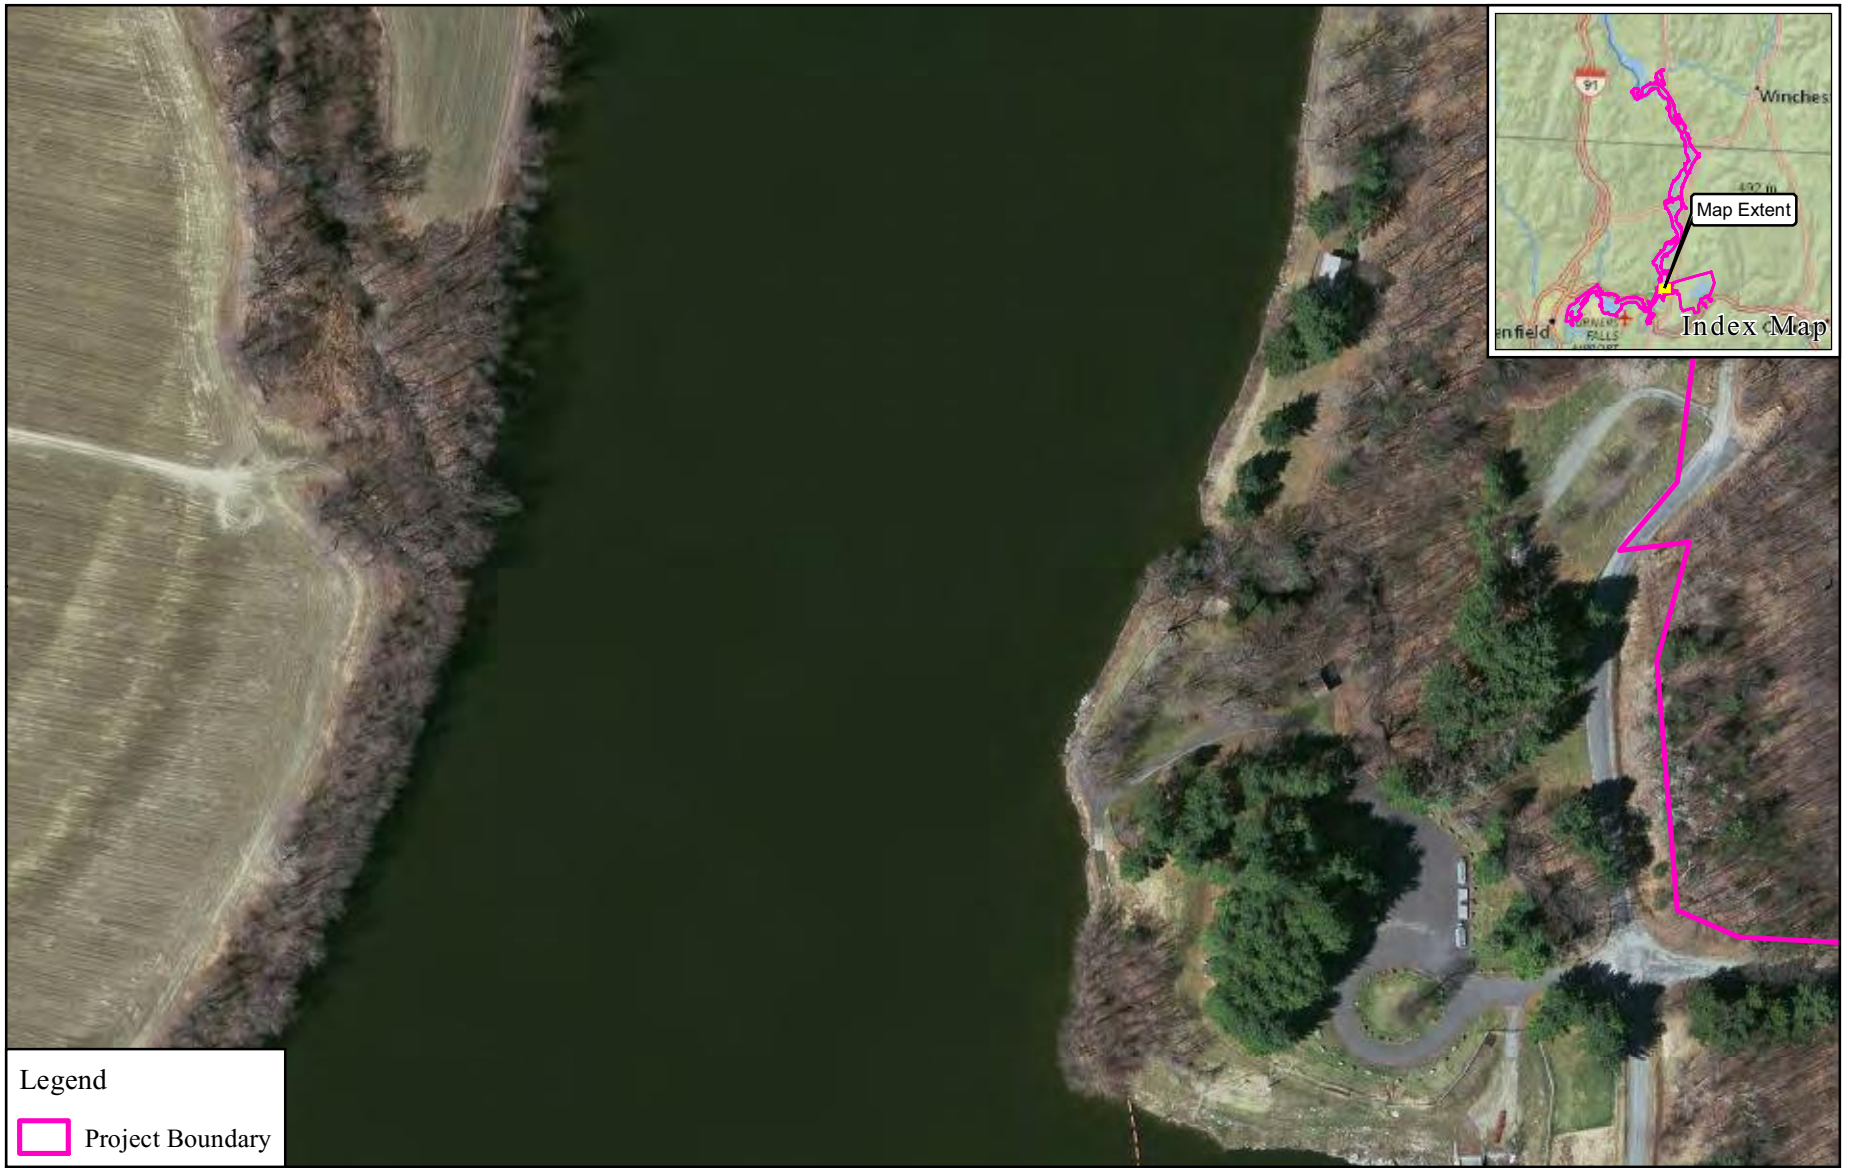
The right bank of the river in this location is eroded and has little riparian vegetation in the 1952 and 1960s photographs. The lower part of the photograph of the right bank was stabilized using rock (see discussion of tailrace in next segment) while the upper part of the photograph of the right bank was selected as the Upper Split River site and was stabilized in 2010 using a gravel beach and large woody debris as can be seen on the 2014 photograph.
