FIRSTLIGHT HYDRO GENERATING COMPANY  
 Northfield Mountain Pumped Storage Project No. 2485  
 Turners Falls Hydroelectric Project No. 1889  
 STUDY 3.1.2

*Northfield Mountain Pumped Storage Project (No. 2485) and Turners Falls Hydroelectric Project (No. 1889)*  
STUDY 3.1.2 NORTHFIELD MOUNTAIN / TURNERS FALLS OPERATIONS IMPACTS ON EXISTING  
EROSION AND POTENTIAL BANK INSTABILITY

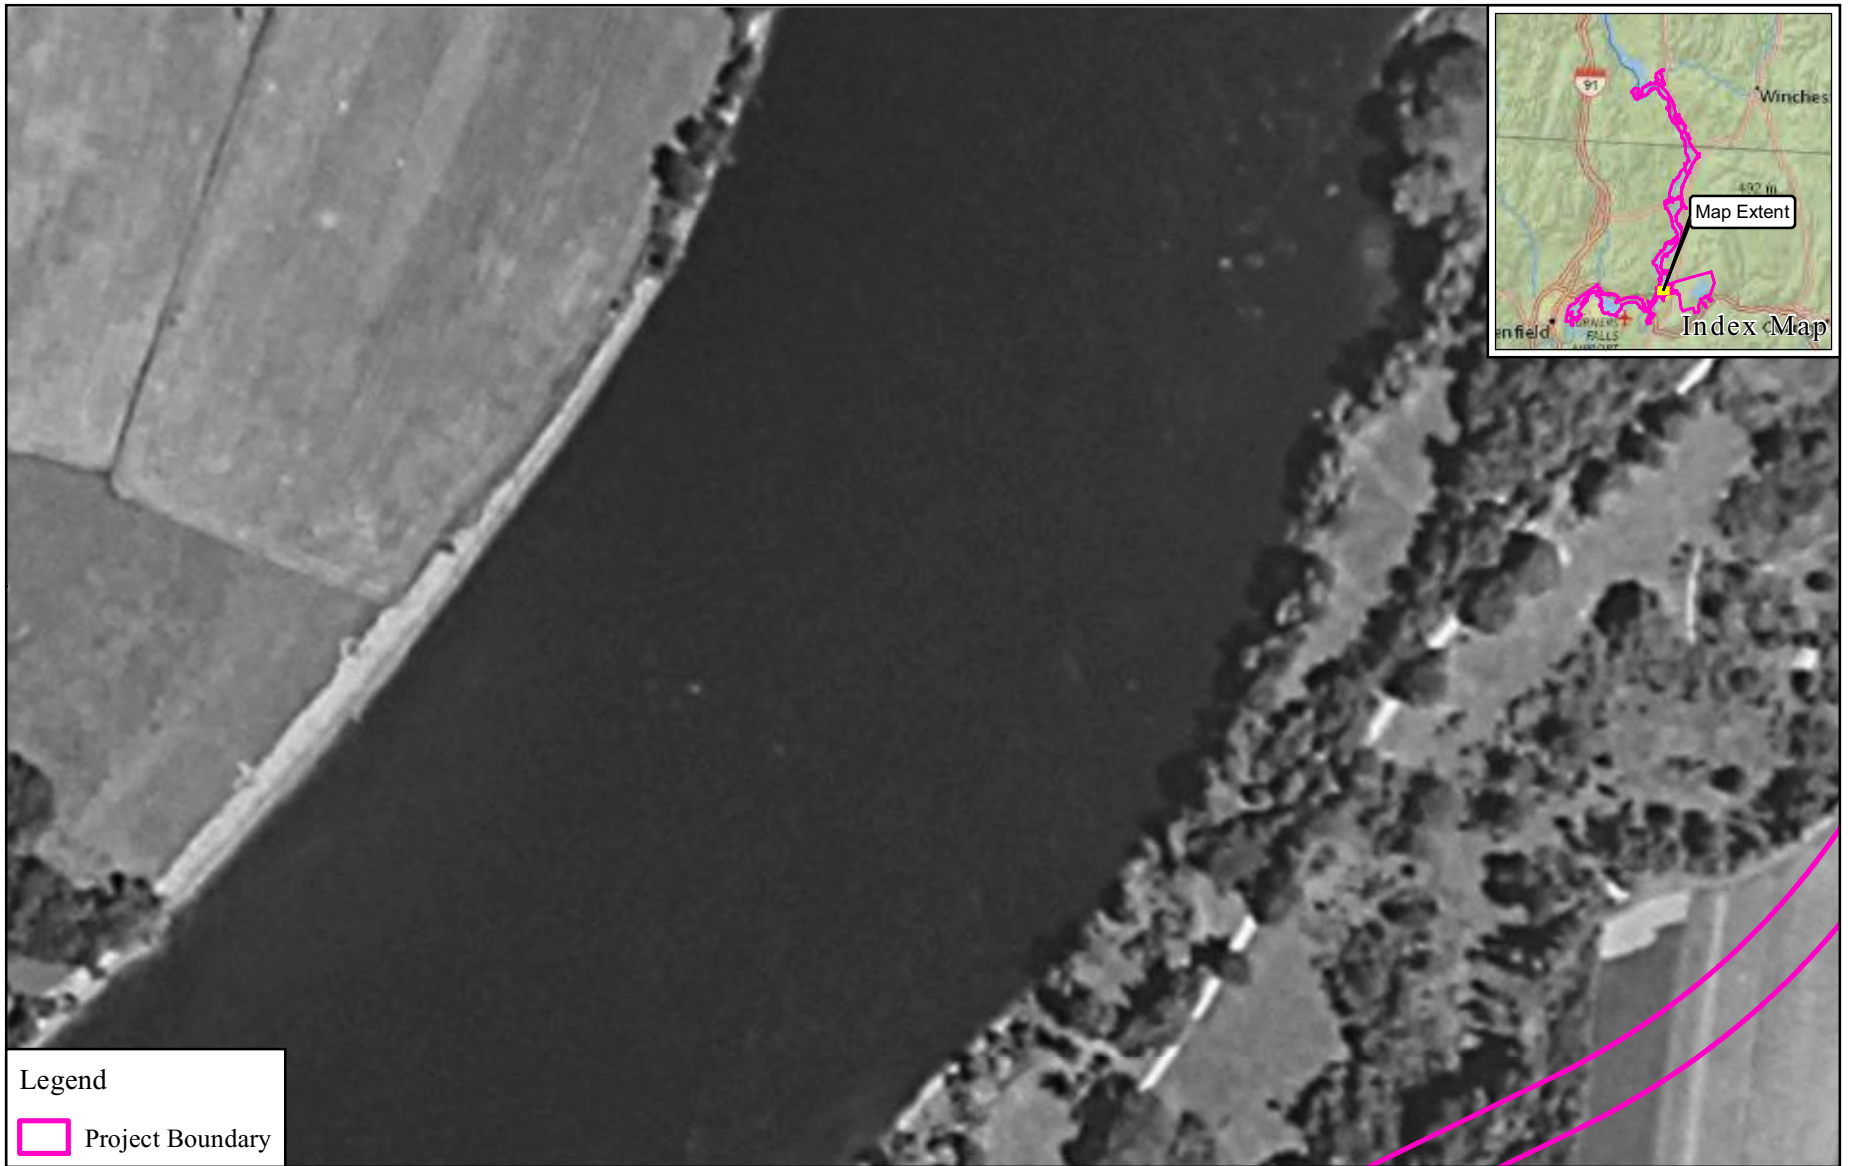
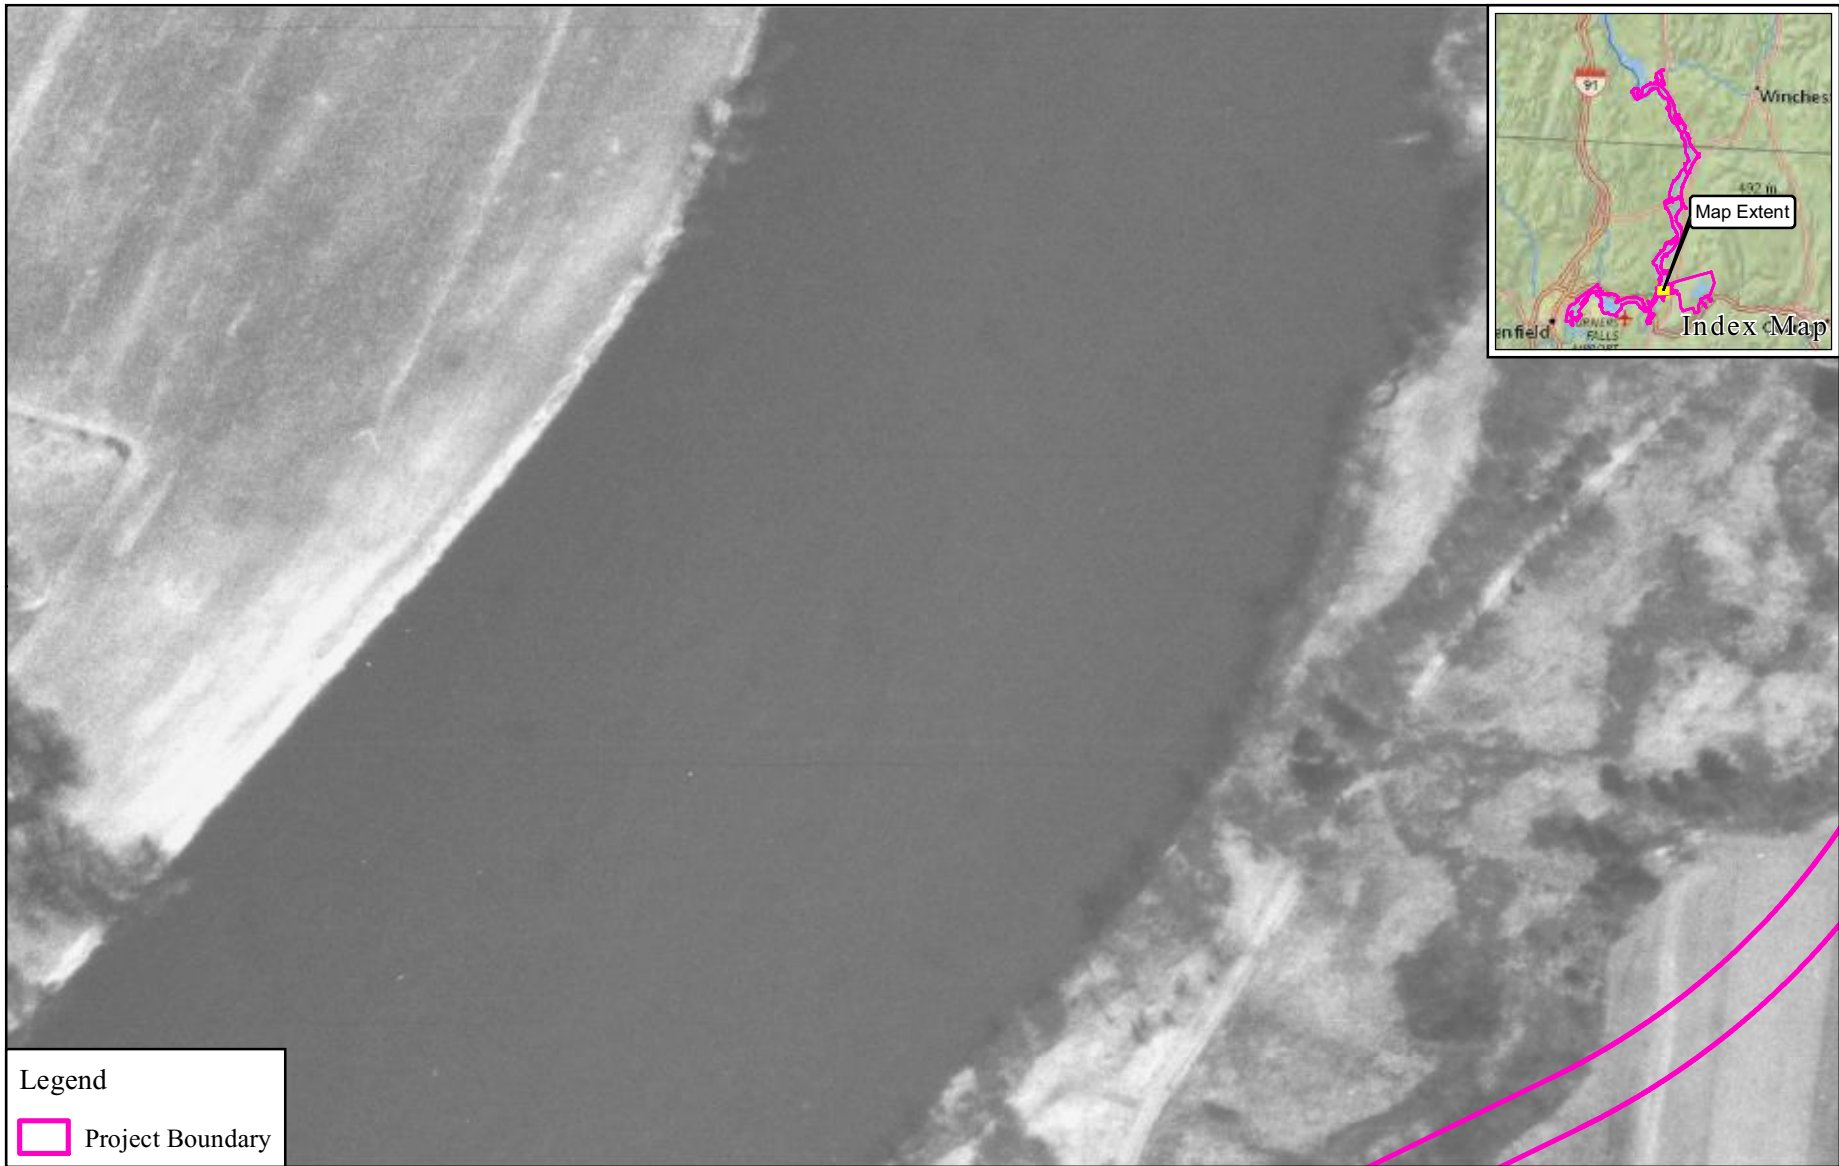
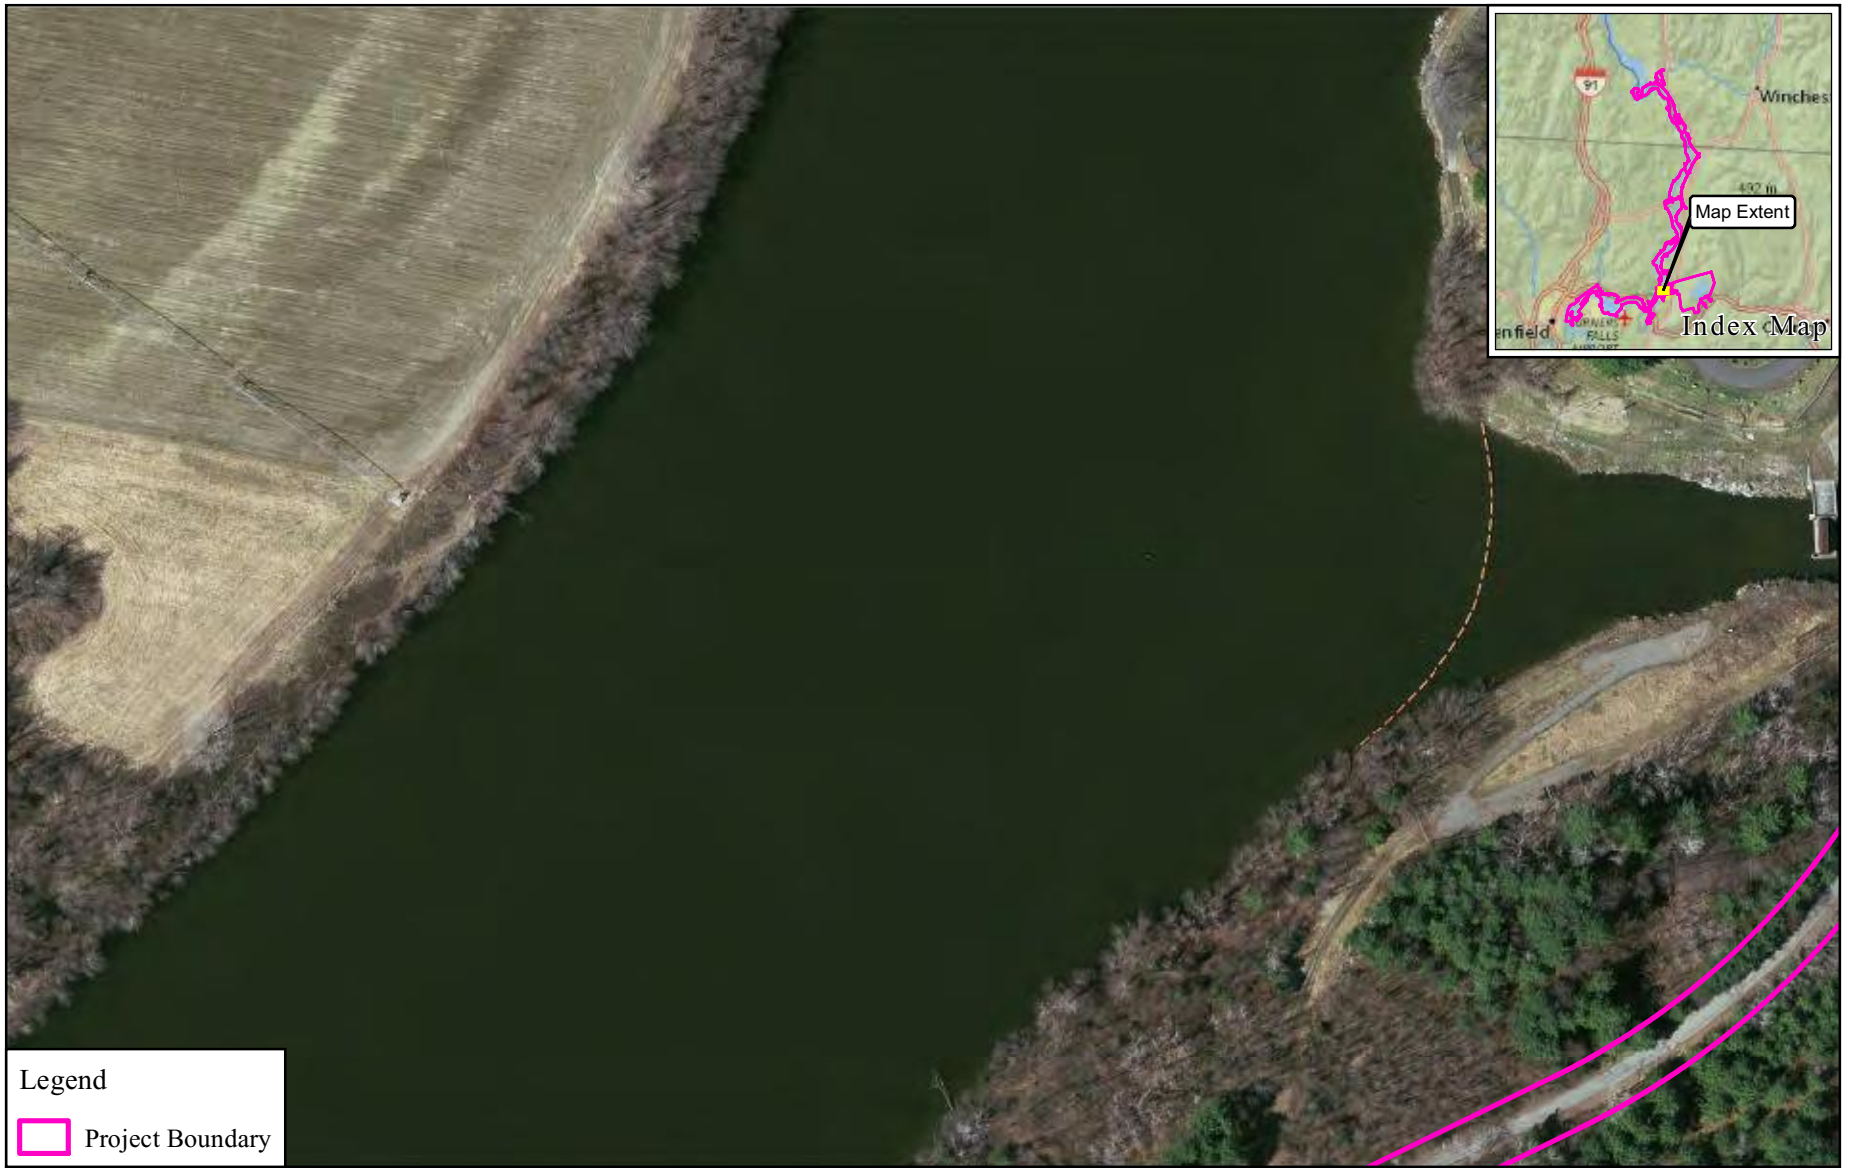
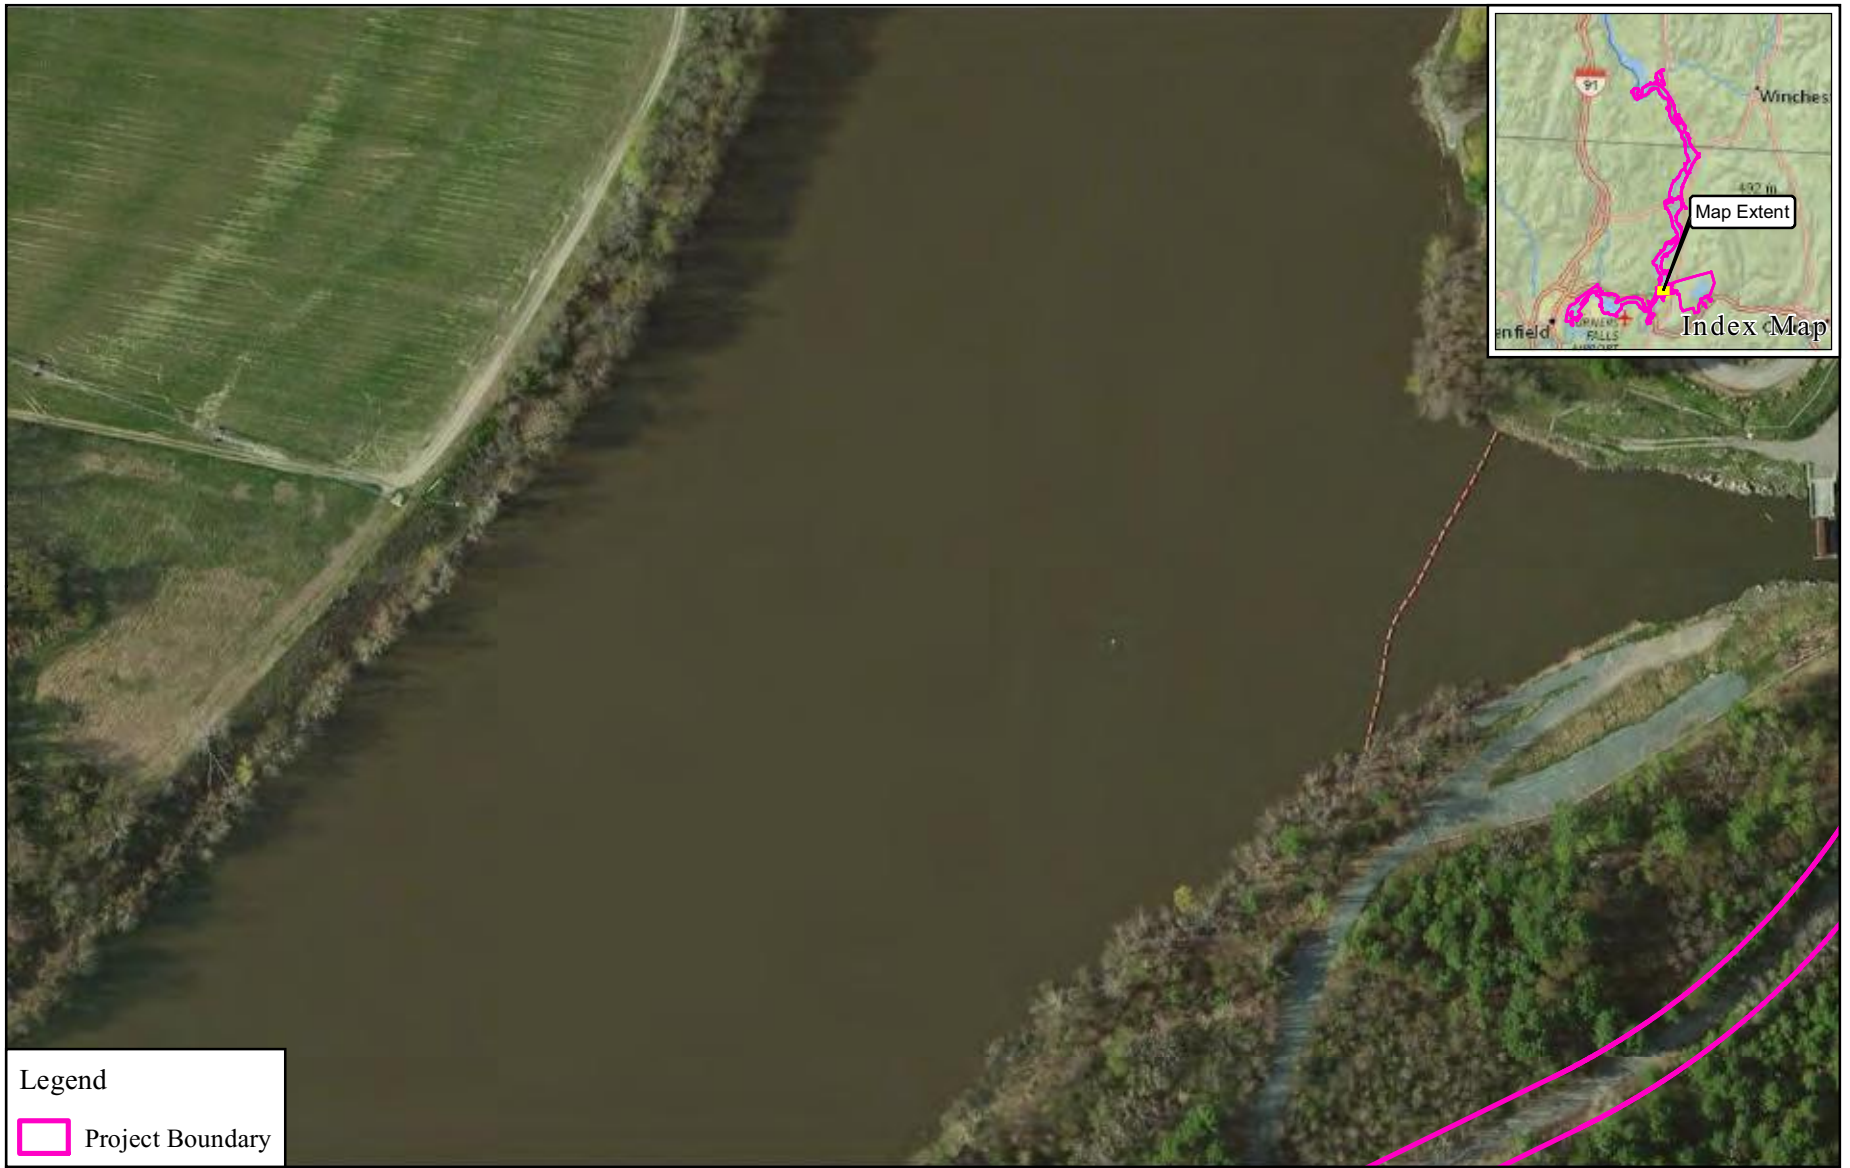
The right bank across the river from the future tailrace for Northfield Mountain appears to be eroded and devoid of riparian vegetation in the 1952 and 1960s photographs, before the construction of the project. Rock from project construction was used to stabilize this eroded bank during the construction process. The rock has stabilized the toe of the bank and riparian vegetation has become established above the rock.

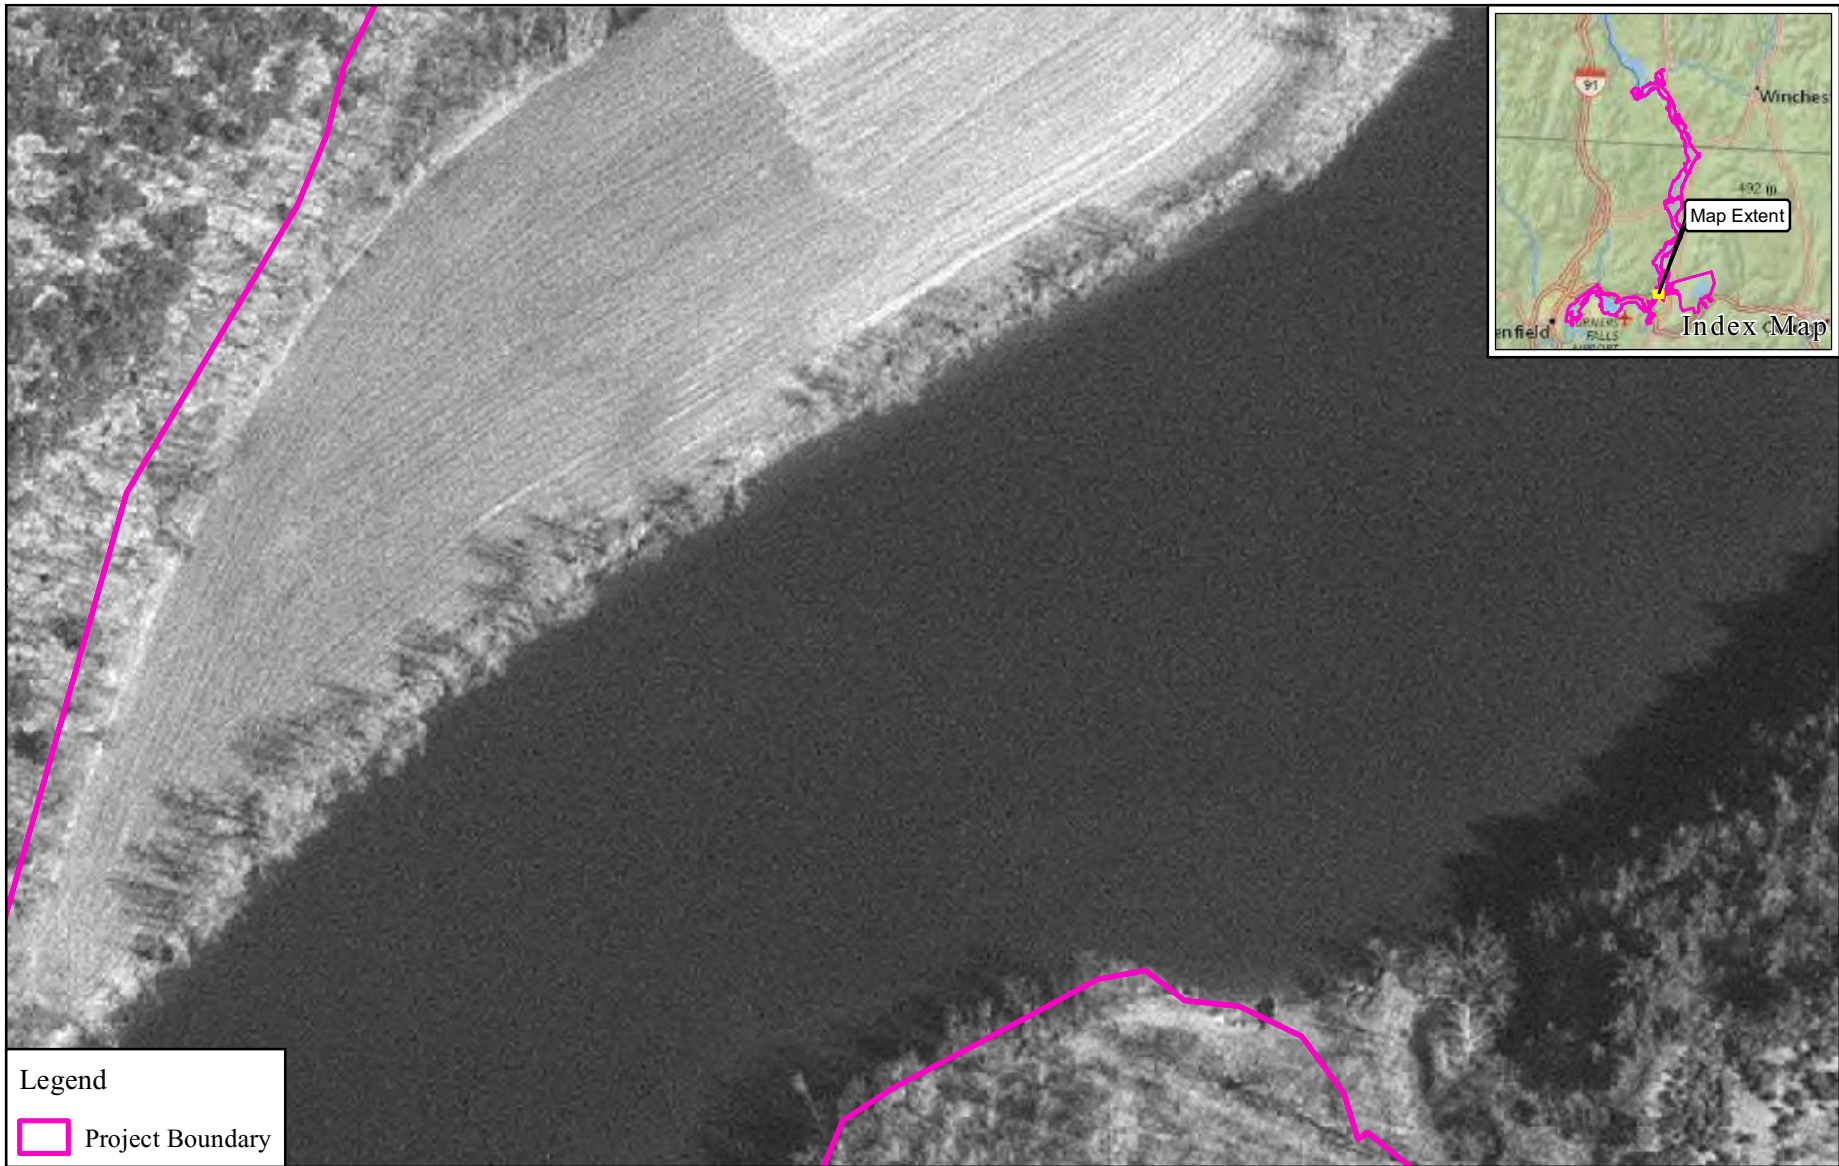
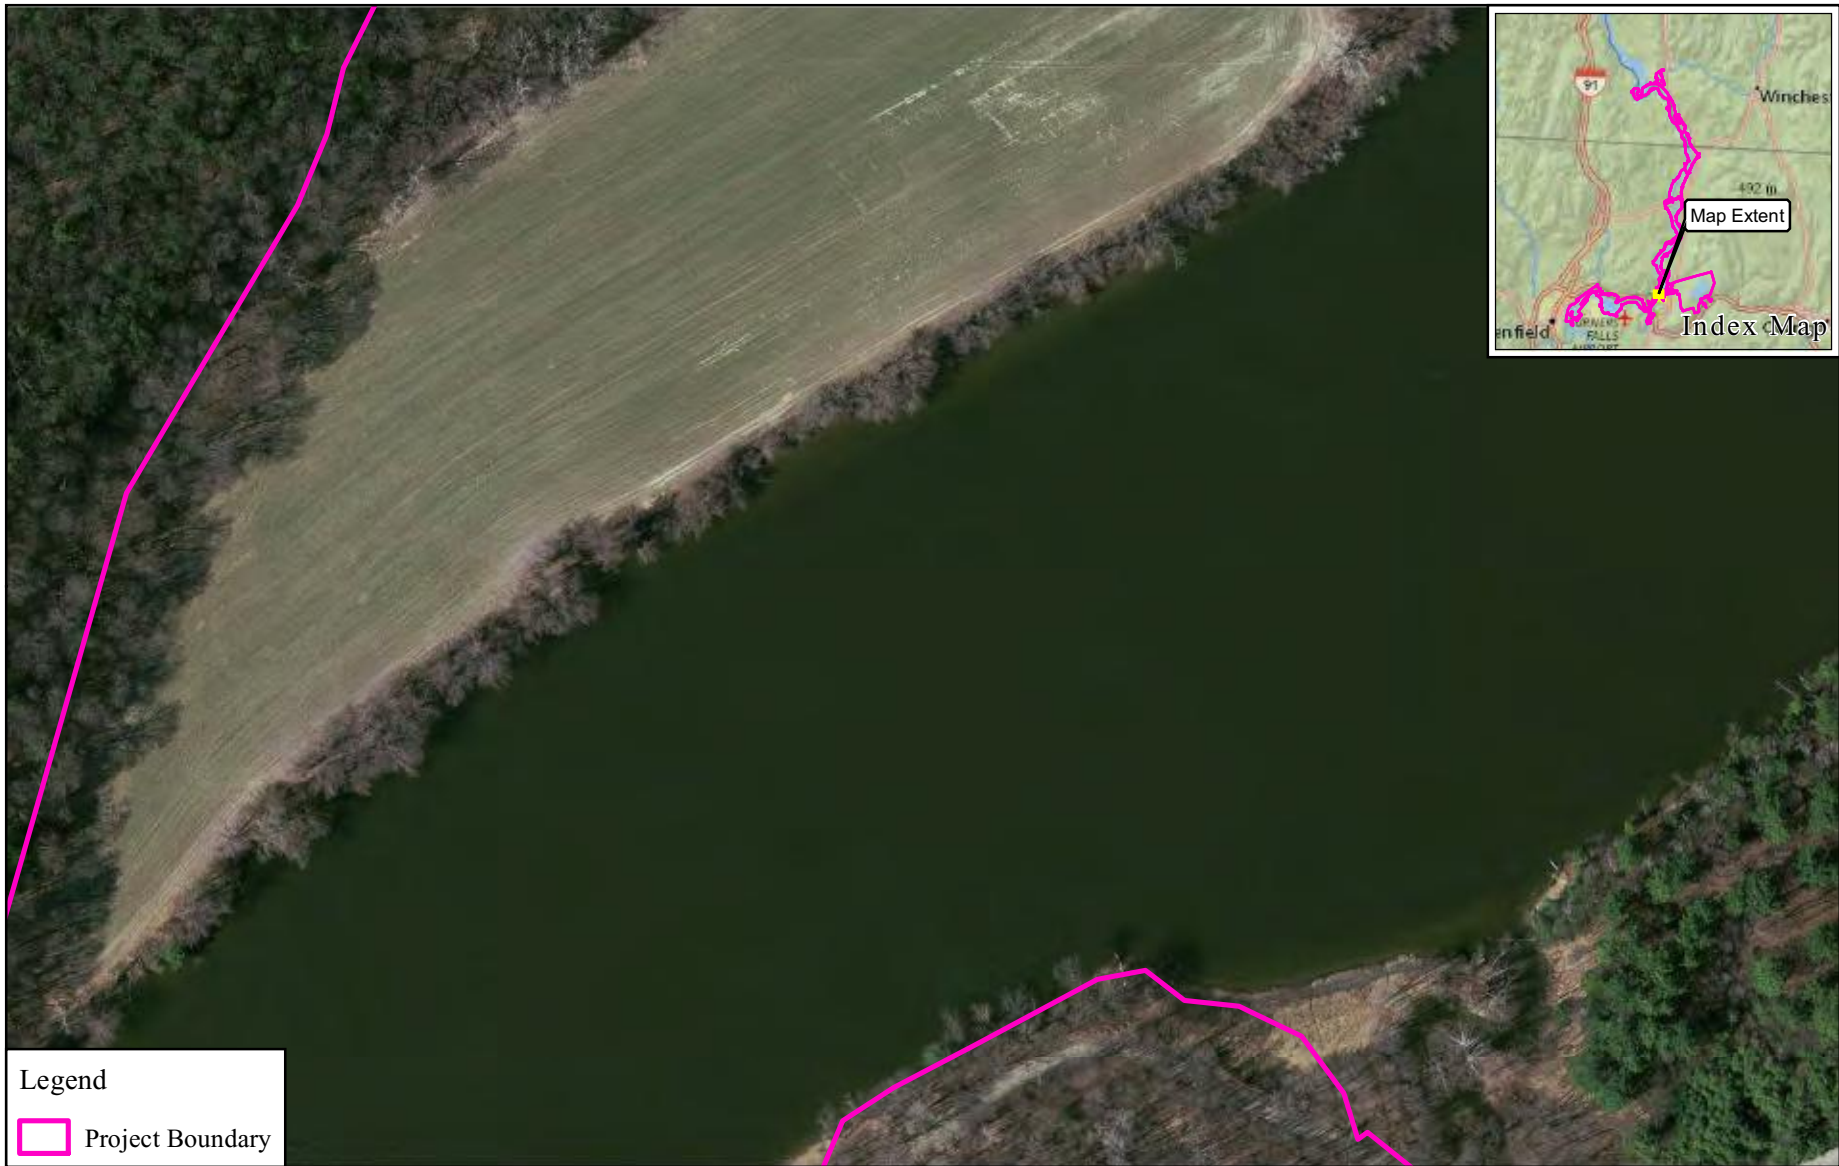
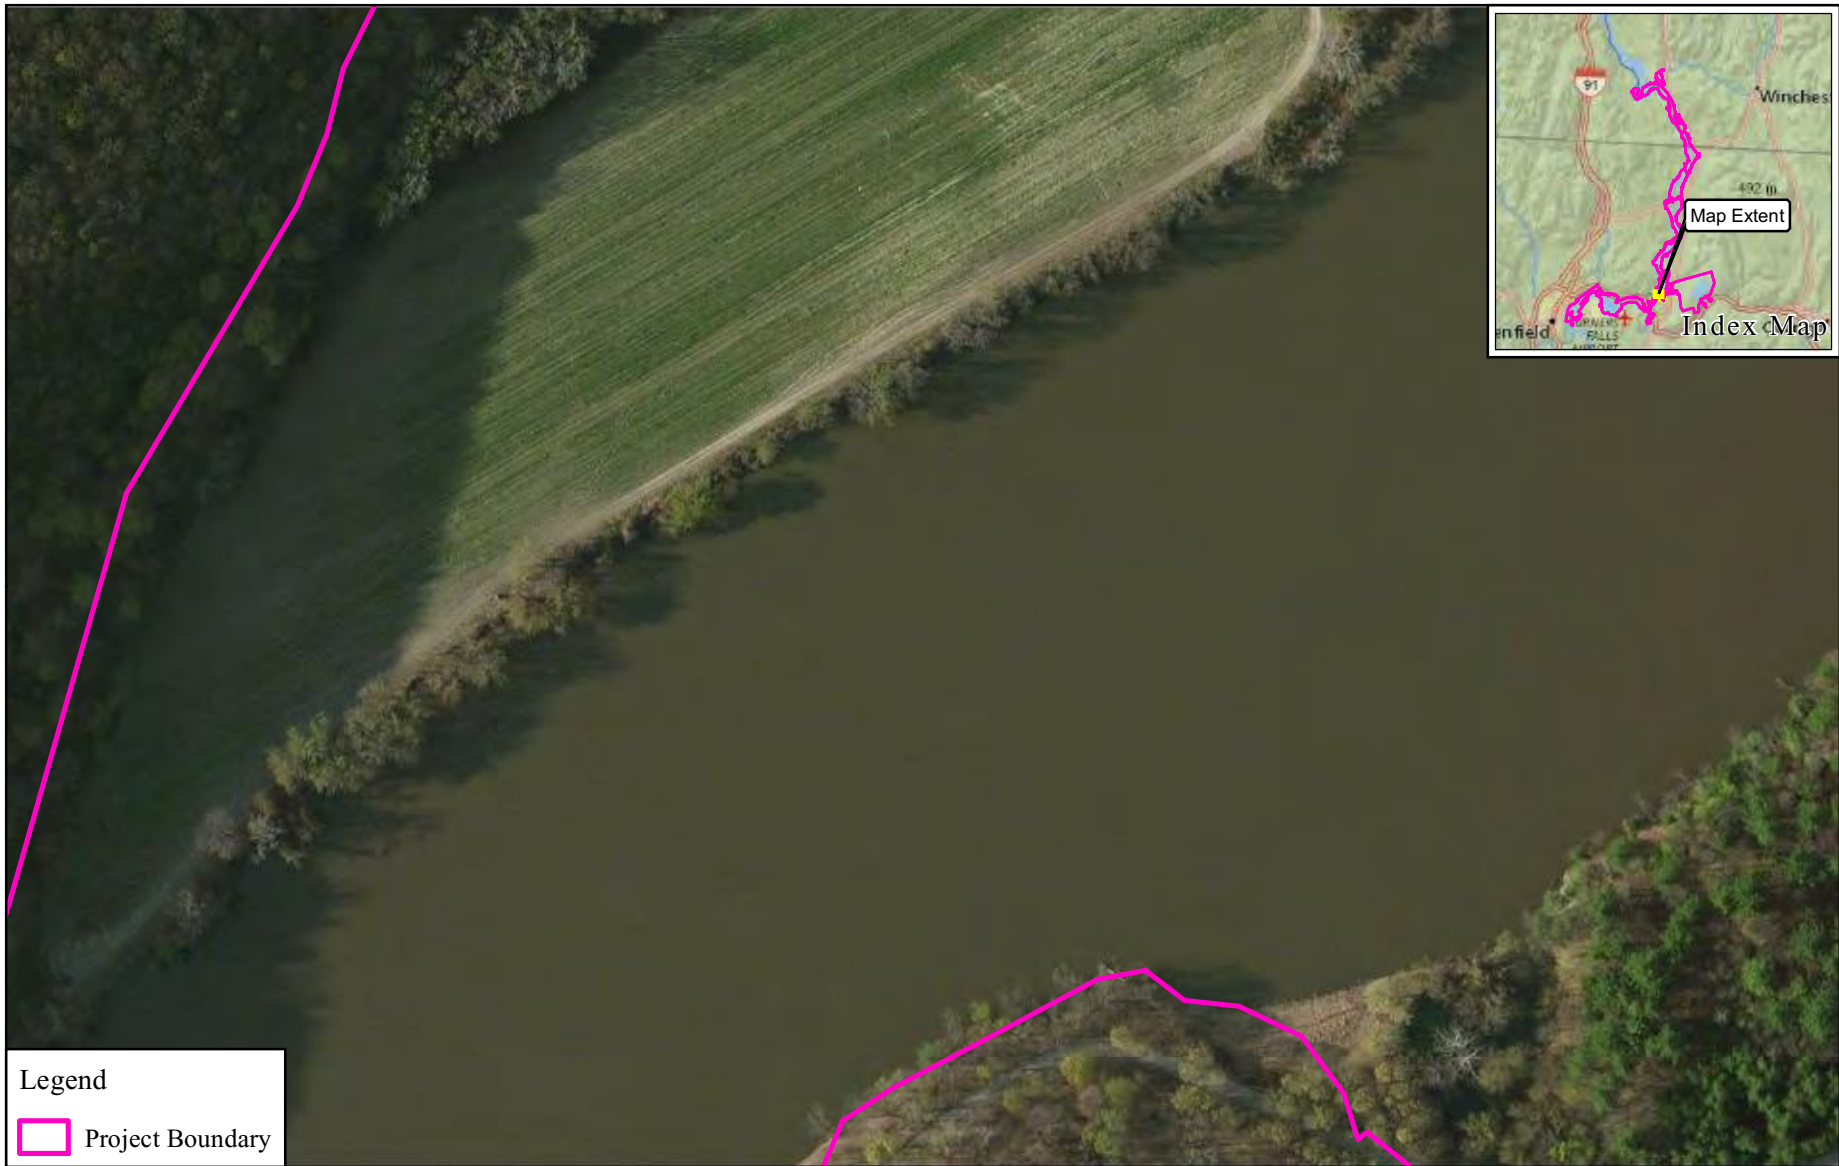
The right bank in the 1952 photograph is sparsely vegetated with apparent erosion as is a segment of the left bank. By the 1960s photographs erosion of the left bank segment is apparent while the right bank remains sparsely vegetated with some erosion. The right bank sight is called the Lower Split River site which was stabilized in 2009 and the left bank segment is called Durkee Point and was stabilized in 2003, both through implementation of the ECP.

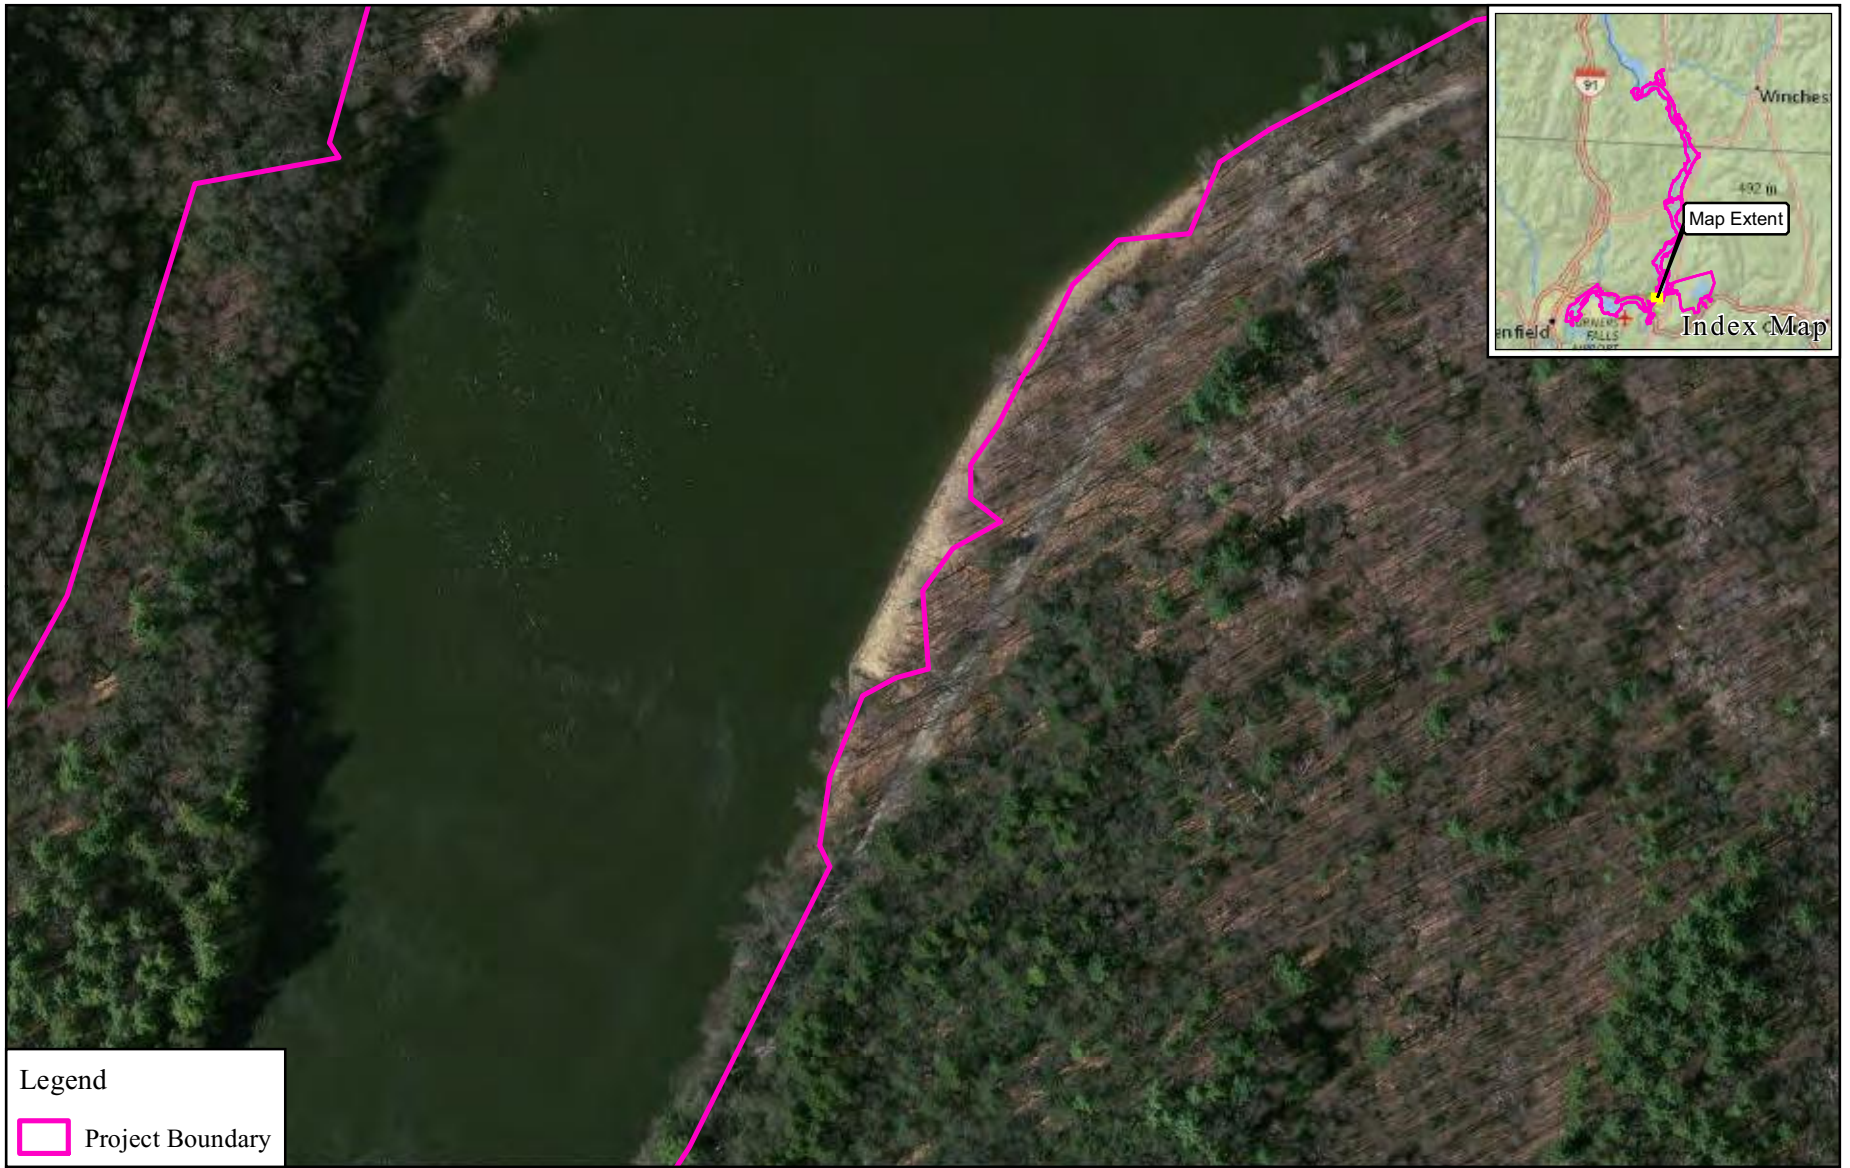
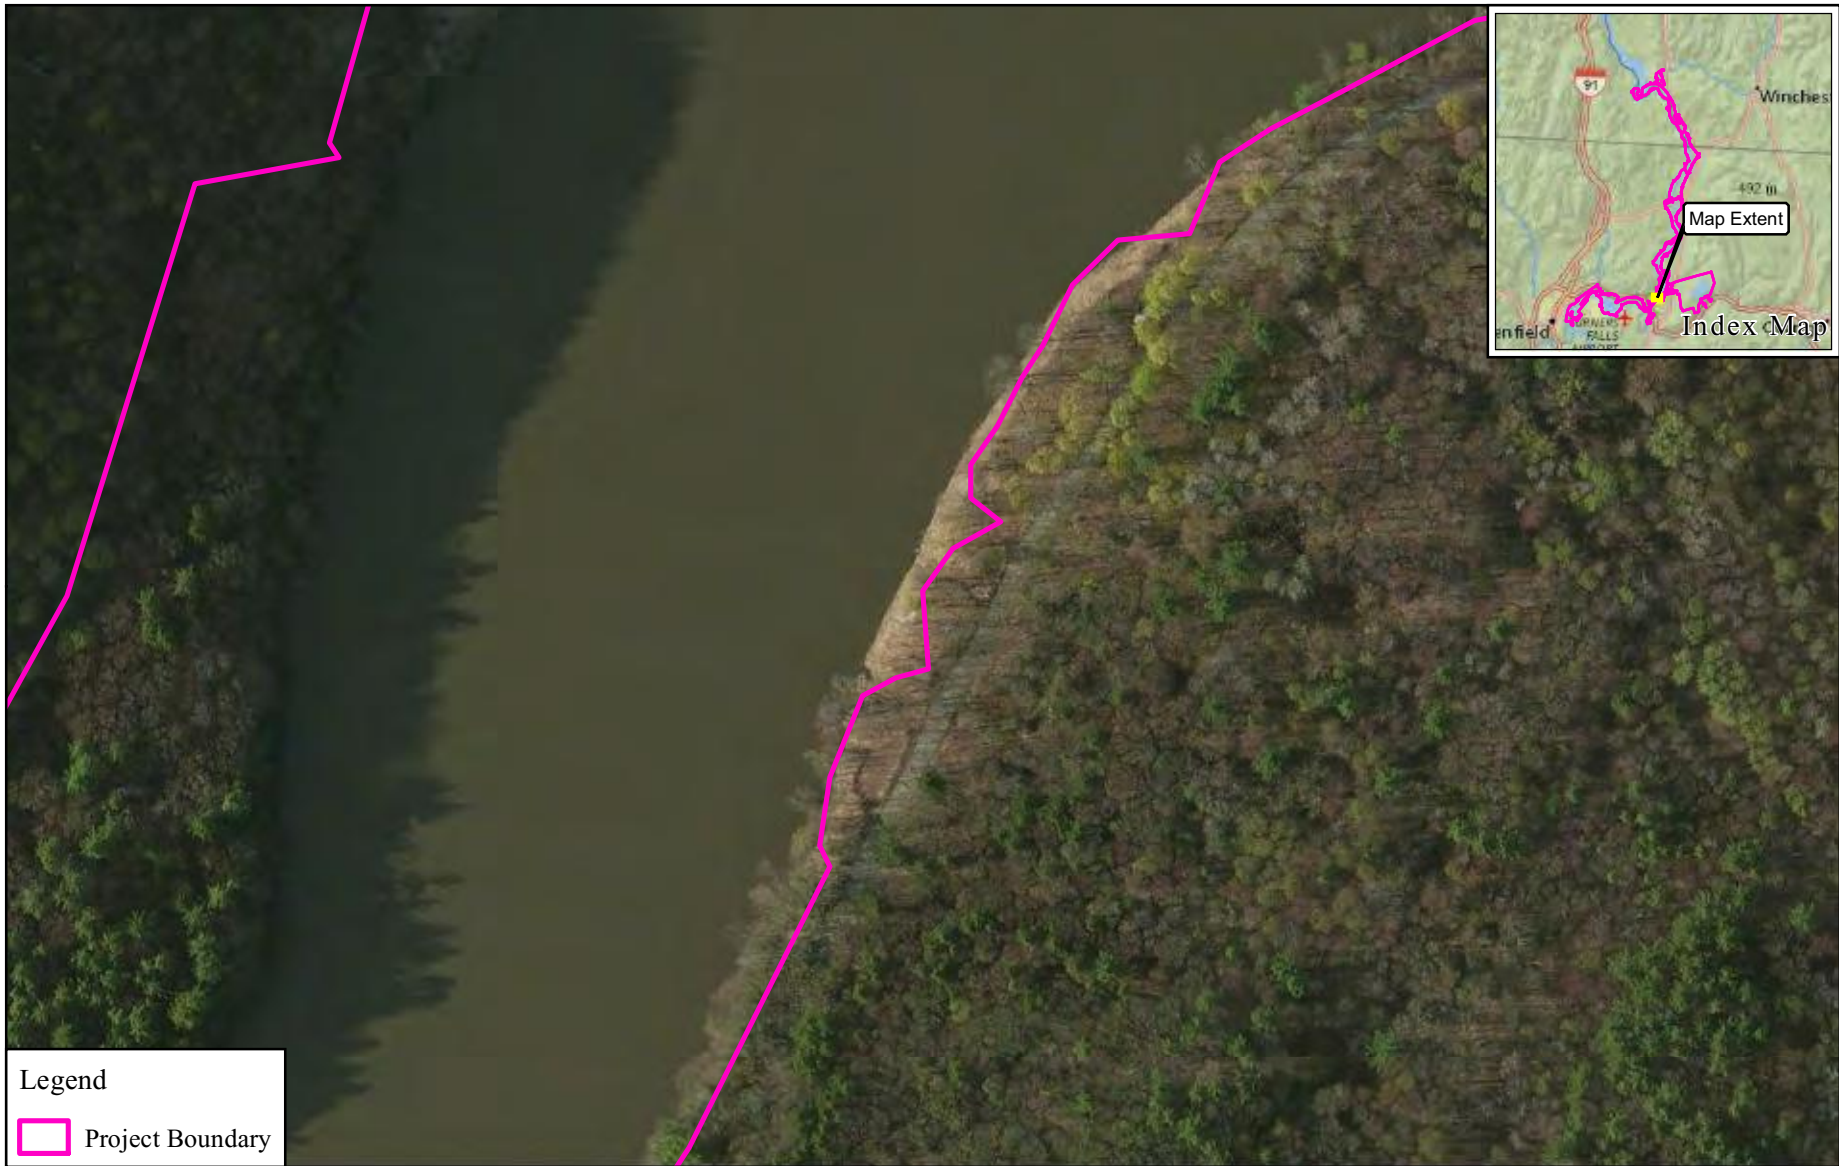
On the inside of the bend along the left bank erosion has occurred over time with the bank moving landward compared to the project boundary line as noted in changes in the bank from the 1952 to 1960s and subsequent photographs. This area was stabilized in 2003 through the ECP and is called the River Road Site.
