FIRSTLIGHT HYDRO GENERATING COMPANY  
 Northfield Mountain Pumped Storage Project No. 2485  
 Turners Falls Hydroelectric Project No. 1889  
 STUDY 3.1.2

*Northfield Mountain Pumped Storage Project (No. 2485) and Turners Falls Hydroelectric Project (No. 1889)*  
STUDY 3.1.2 NORTHFIELD MOUNTAIN / TURNERS FALLS OPERATIONS IMPACTS ON EXISTING  
EROSION AND POTENTIAL BANK INSTABILITY

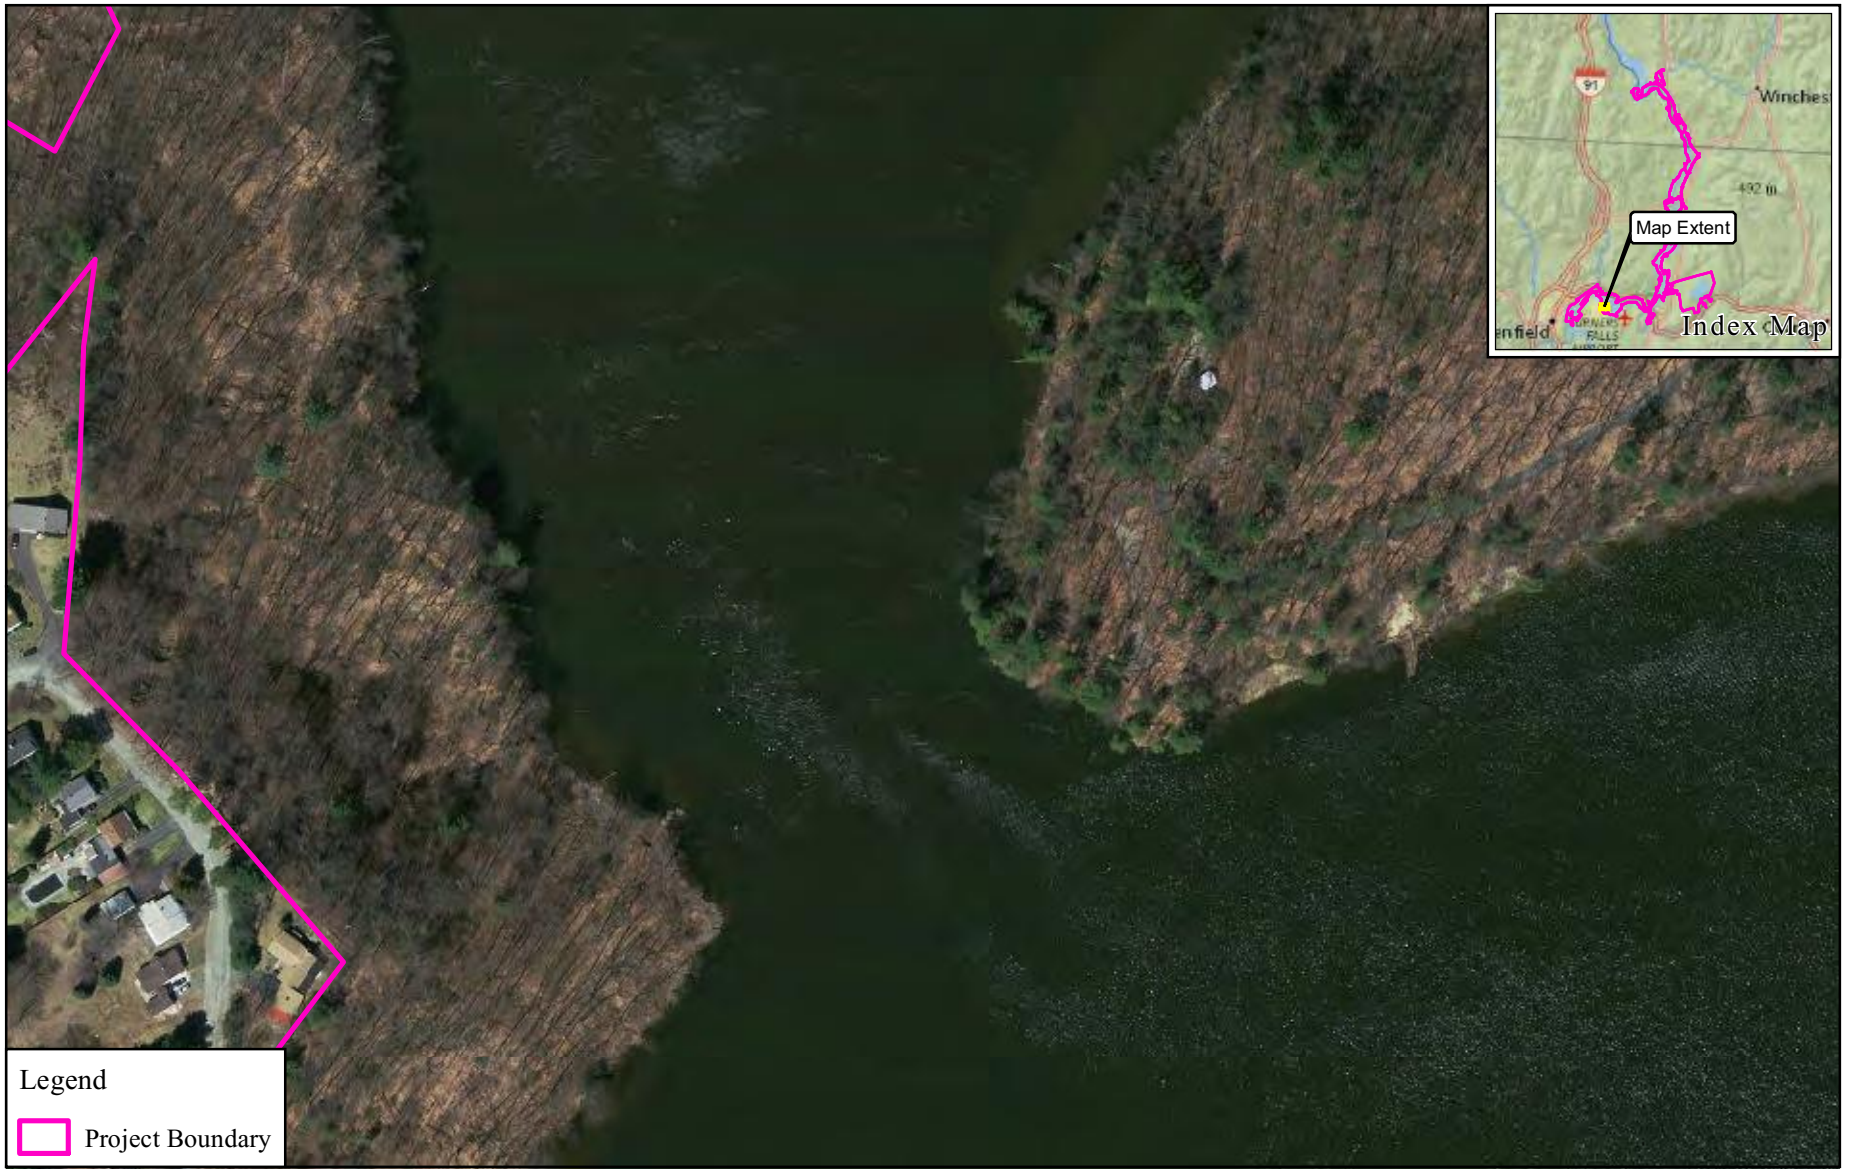
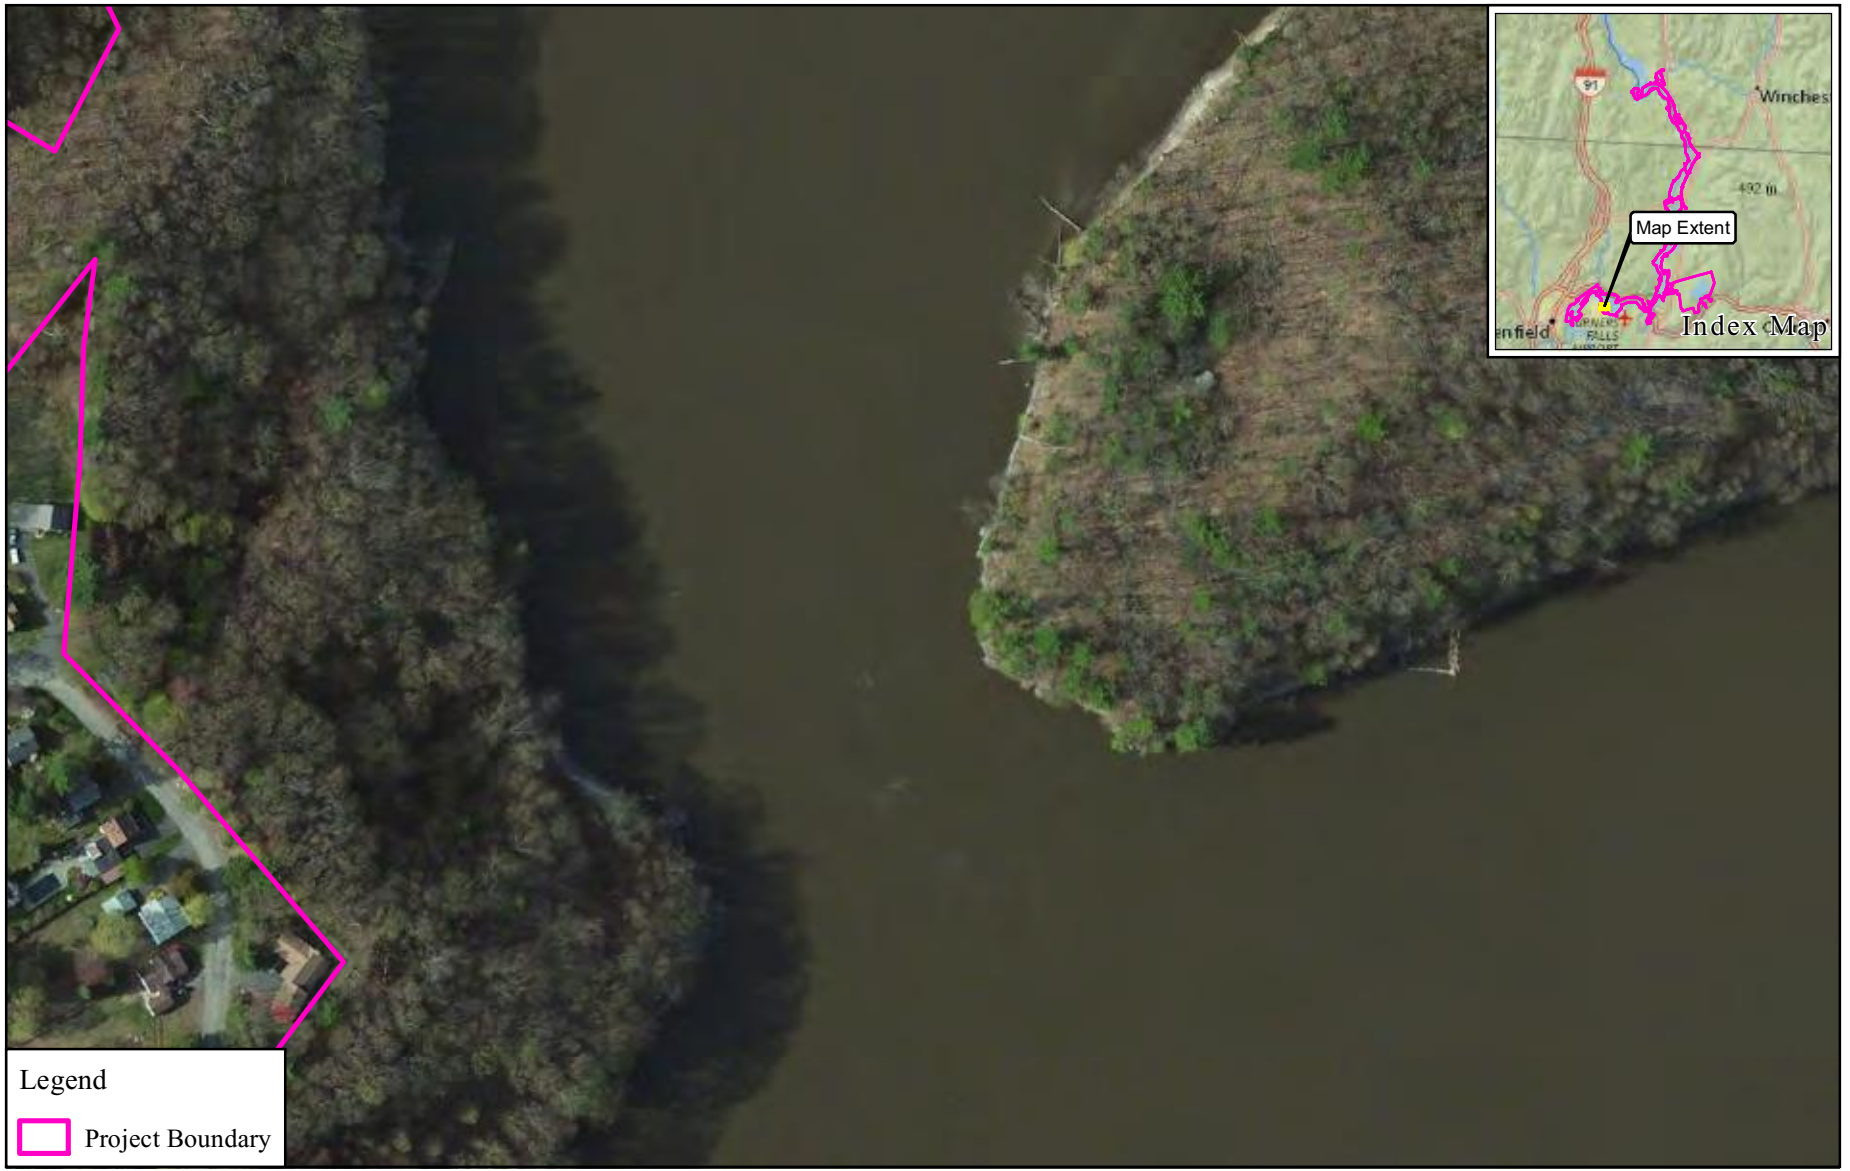
Campground Point is the peninsula that separates Barton Cove from the reach of river leading upstream to French King Gorge. Some erosion is evident in the earlier photographs such as 1952 continuing through the 2008 photograph, when it was stabilized as part of the ECP in 2008 as the Campground Point Site. The 2014 photograph shows an increase in vegetation on the stabilized site.

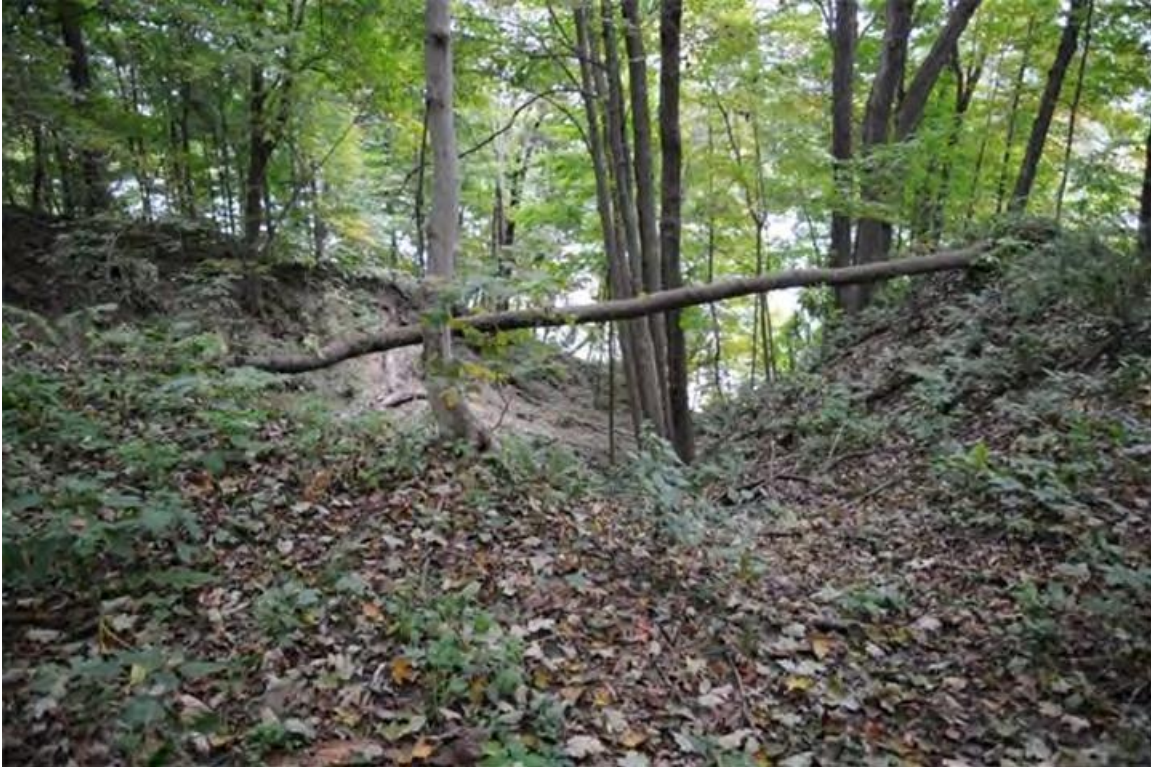
**Figure C-4. Looking downhill into ravine (Photo 272, 9/29/2015)**

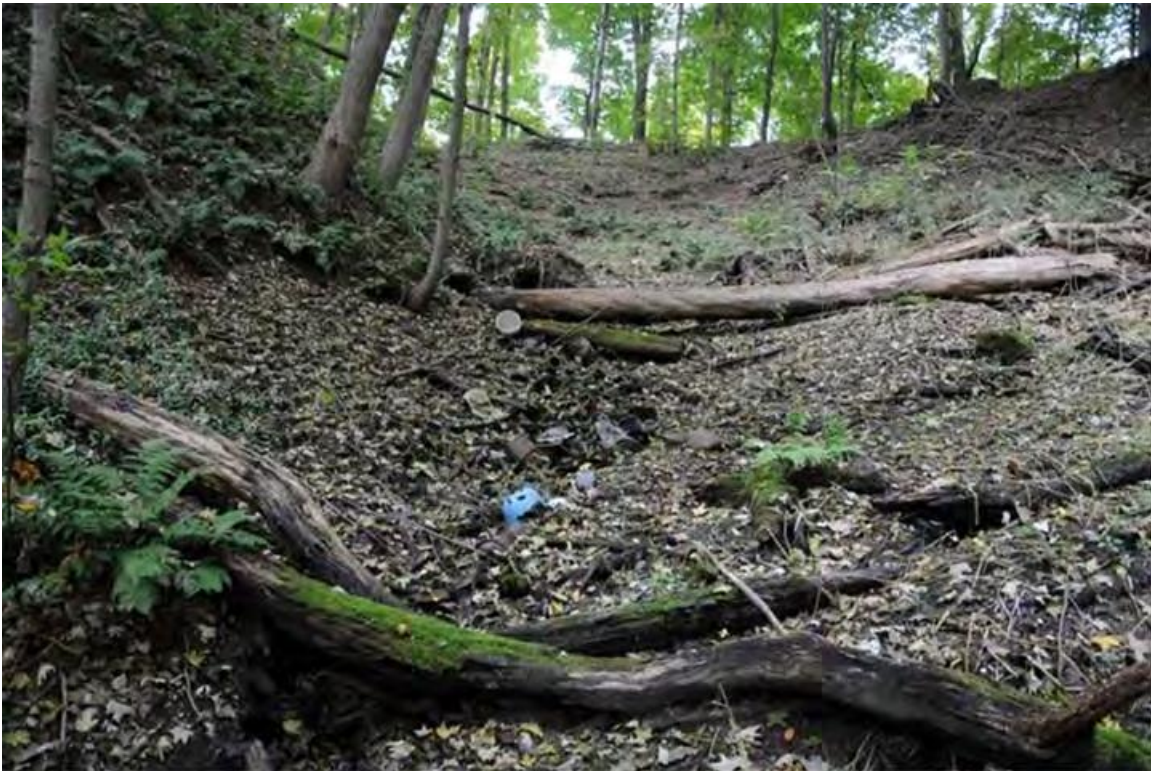
**Figure C-5. From ravine looking uphill (Photo 288, 9/29/2015)**

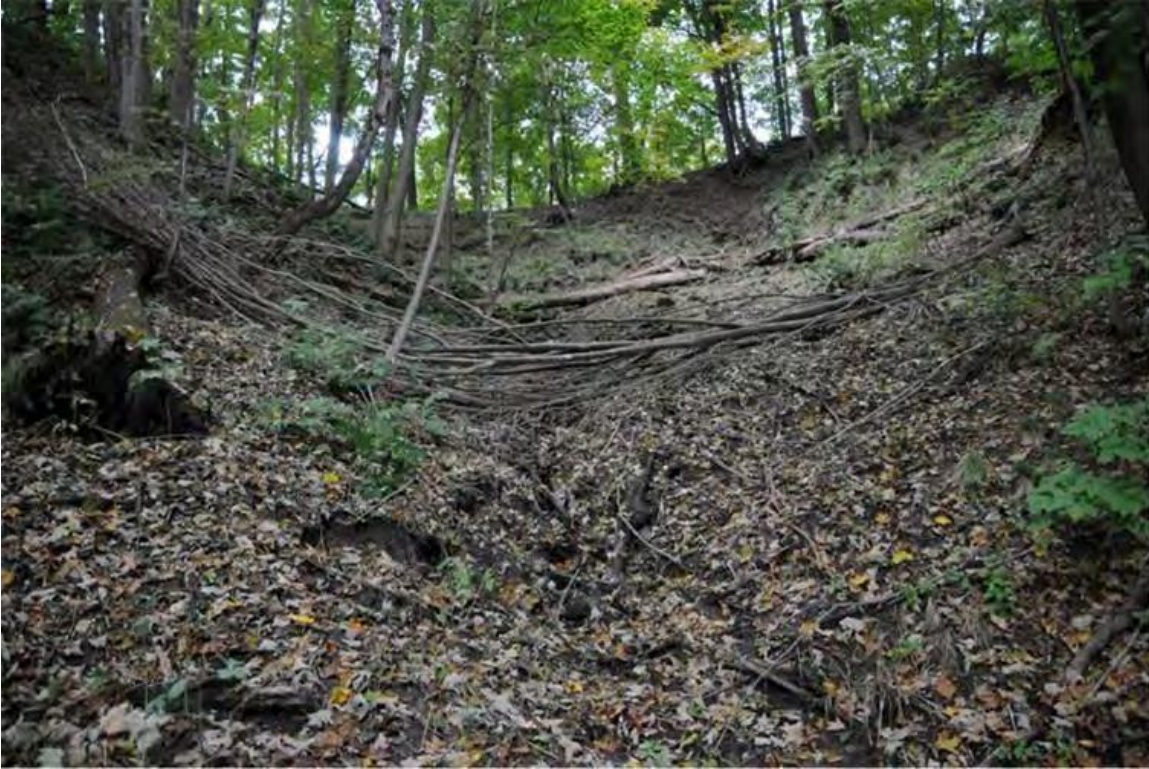
**Figure C-6 From second ravine looking uphill (Photo 316, 9/29/2015)**

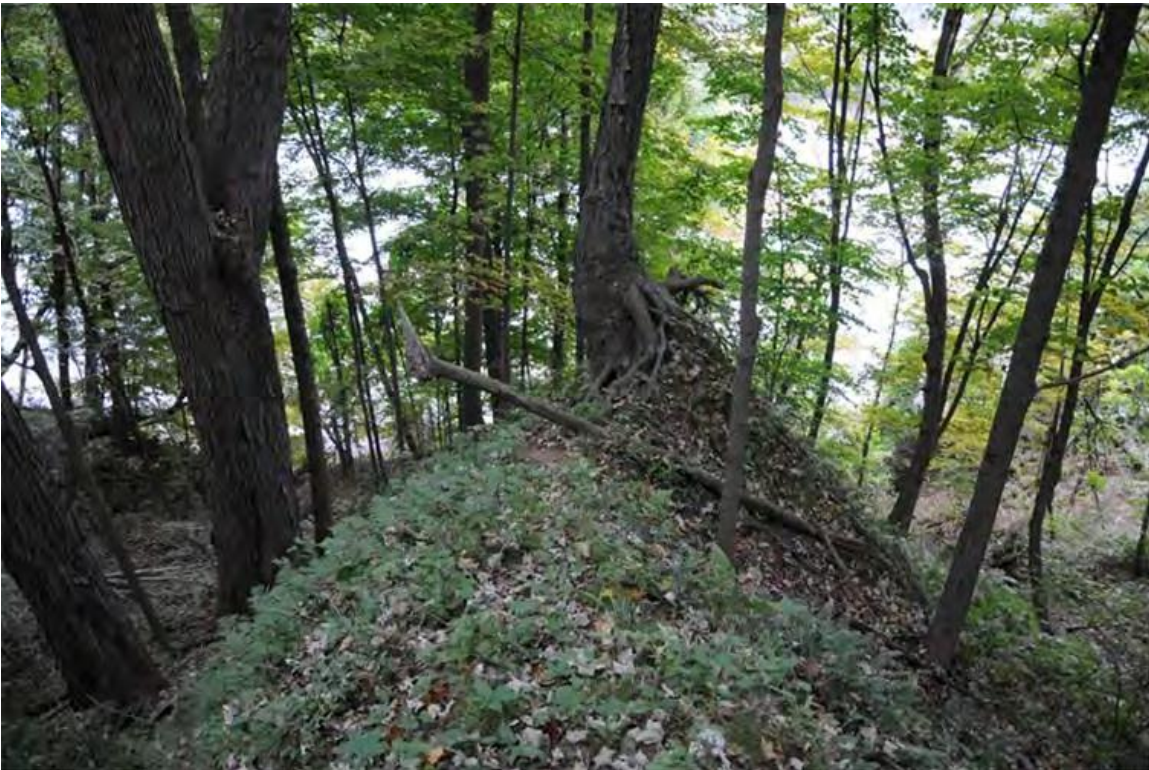
**Figure C-7 Divide between two ravines (Photo 325, 9/29/2015)**

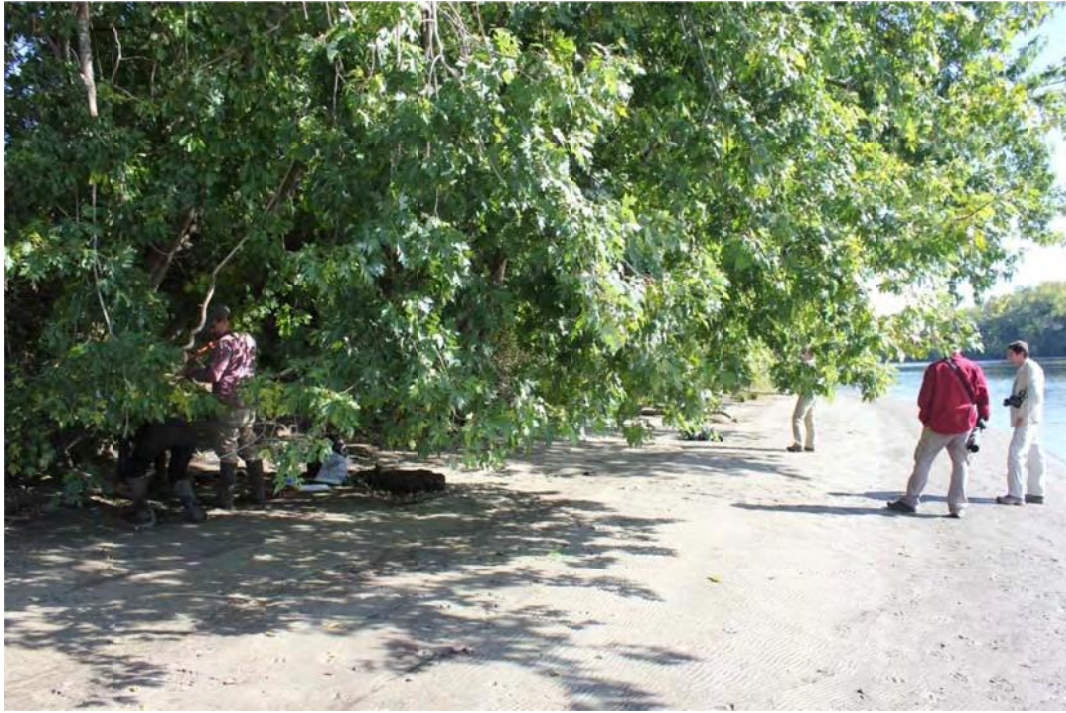
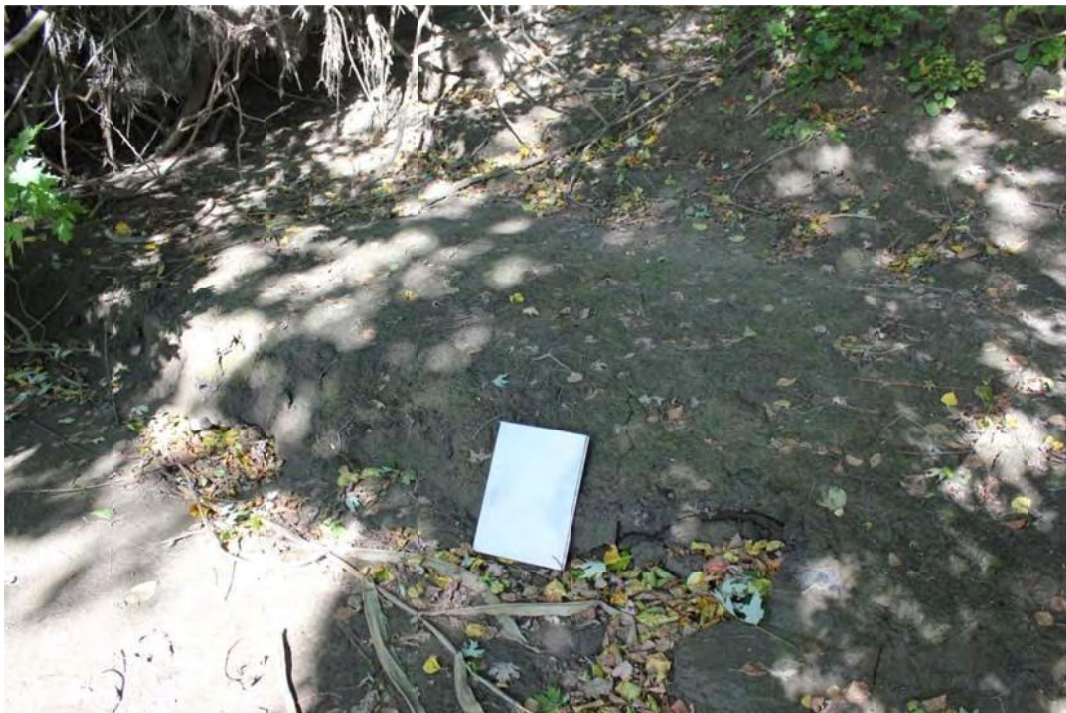
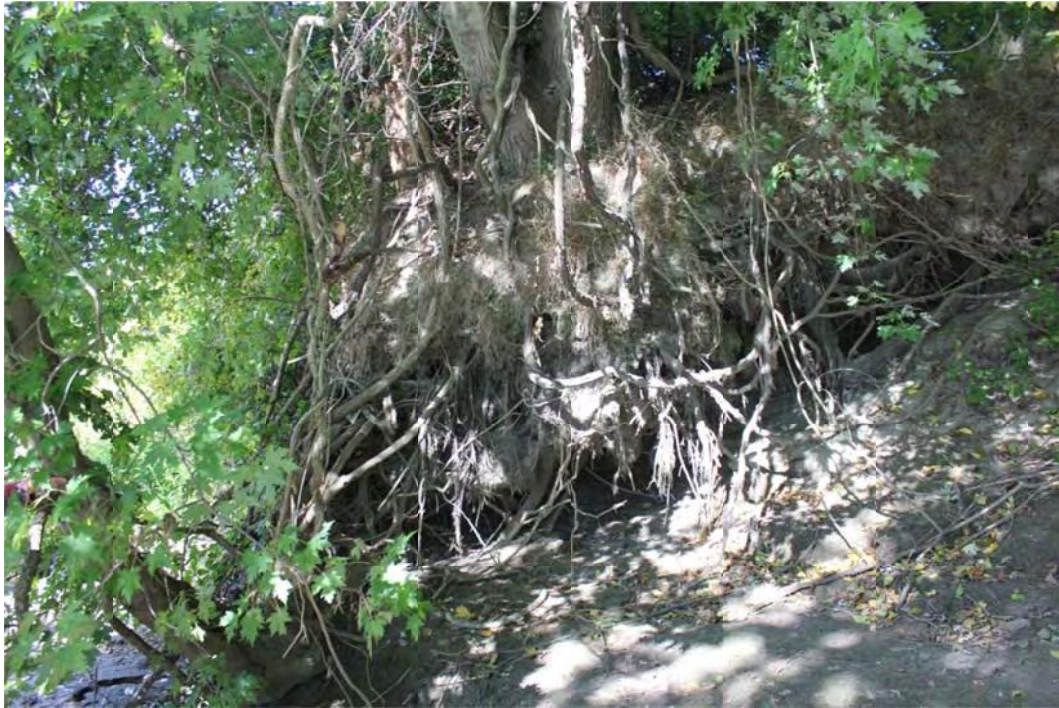
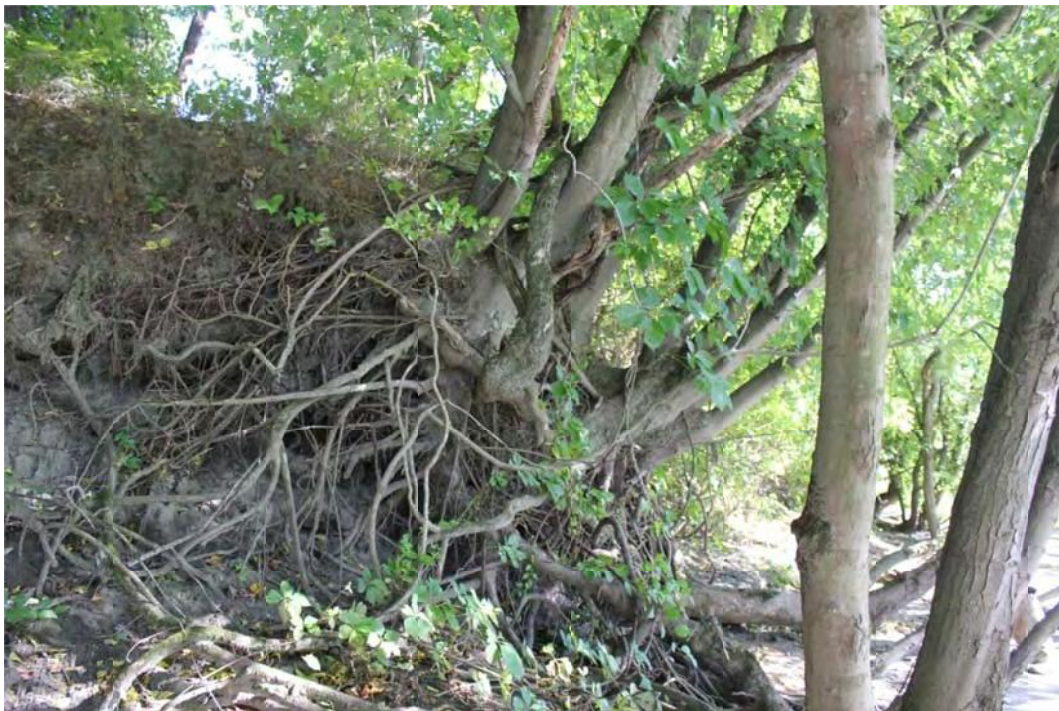
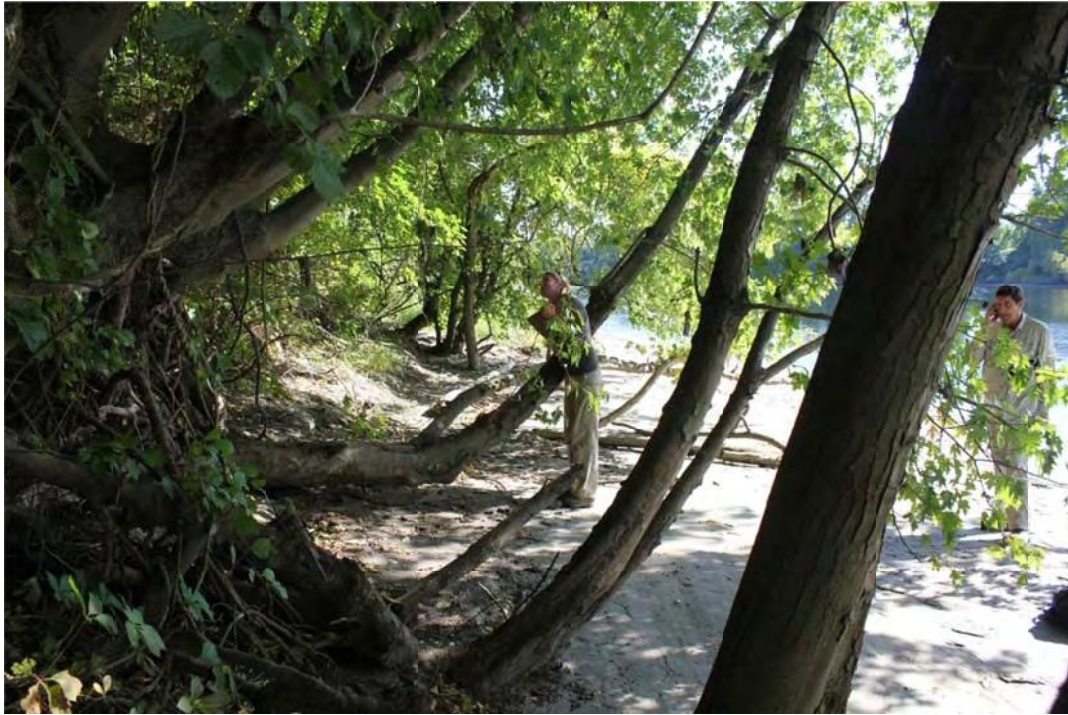
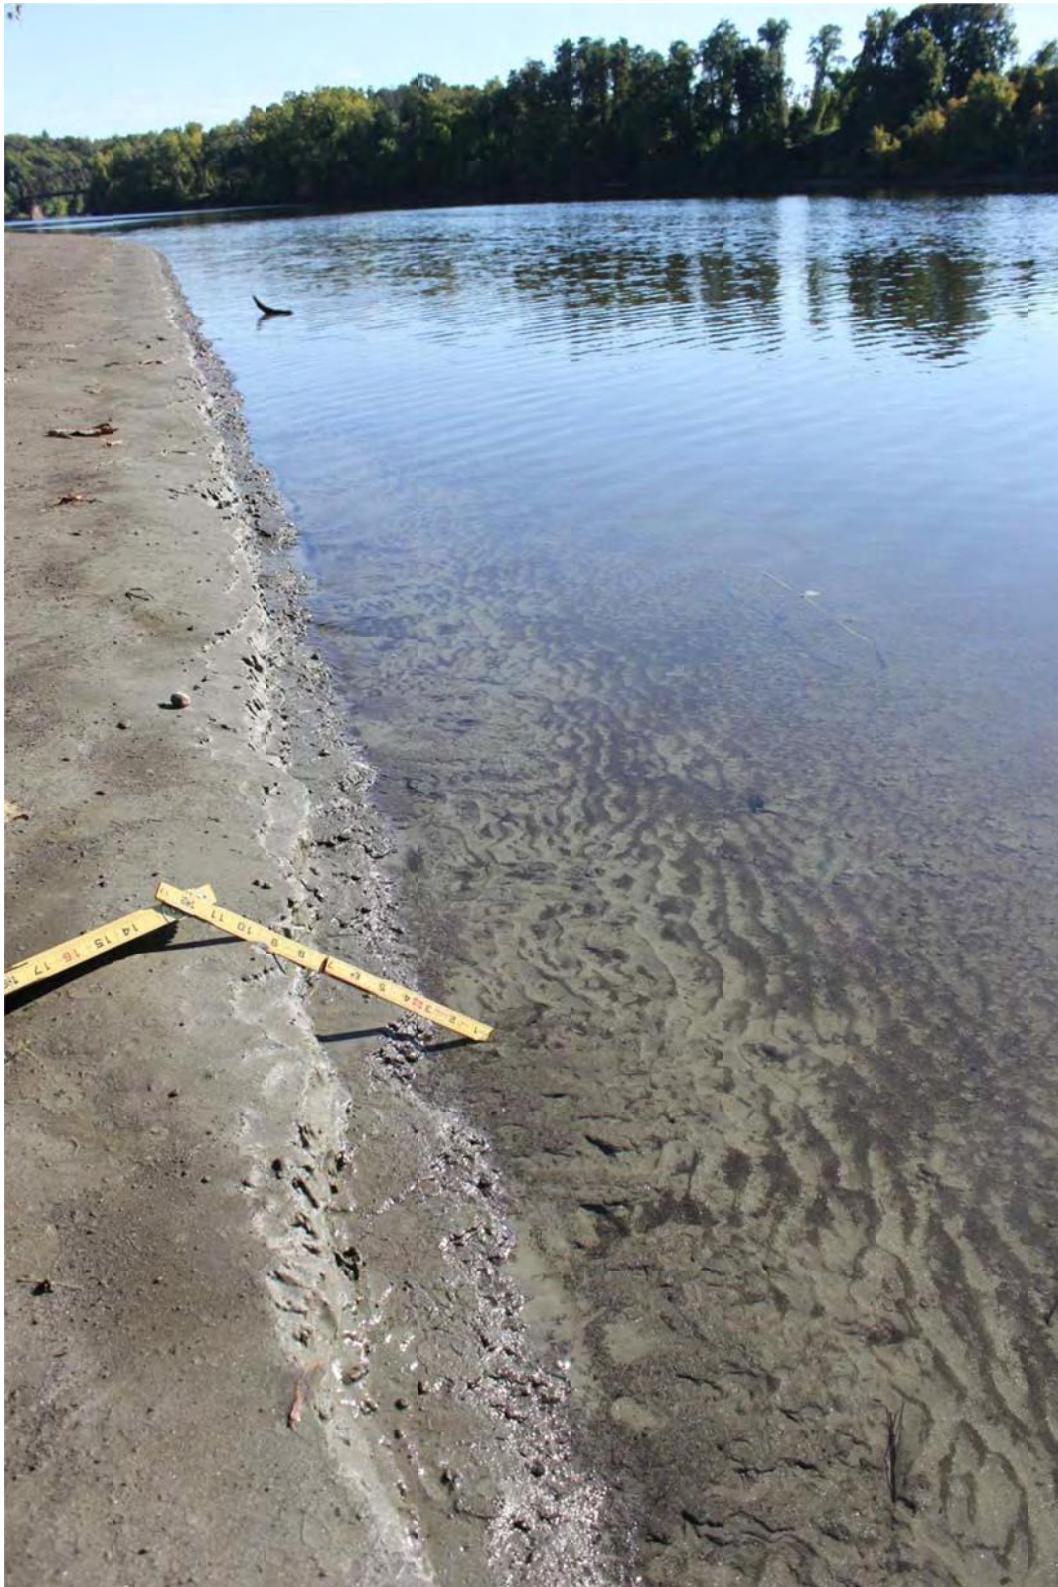
**2014 Connecticut River Detailed Site Assessments  
Land-Based Survey Photographs Reference No. 825 - 830  
Location ID 4AL – September 23, 2014**

- Steep slope, entire Upper Bank.
- Leaning trees and undercuts at toe of Upper Bank, some with exposed roots
- Overhangs with exposed roots near top of Upper Bank
- Significantly less recent sediment compared with Site 4L which is just 100 feet away. Little to no wetland vegetation on recent sediment.
- 6-inch deep erosion scarp at river level from boat waves

Exposed roots on bank face
