**2014 Connecticut River Detailed Site Assessments
Land-Based Survey Photographs Reference No. 850 - 854
Location ID 10R – September 24, 2014**

Connecticut River – Turners Falls Impoundment Riverbank Detailed Site Assessments

STUDY 3.1.2 NORTHFIELD MOUNTAIN / TURNERS FALLS OPERATIONS IMPACTS ON EXISTING EROSION AND POTENTIAL BANK INSTABILITY

Northfield Mountain Pumped Storage Project (No. 2485) and Turners Falls Hydroelectric Project (No. 1889)

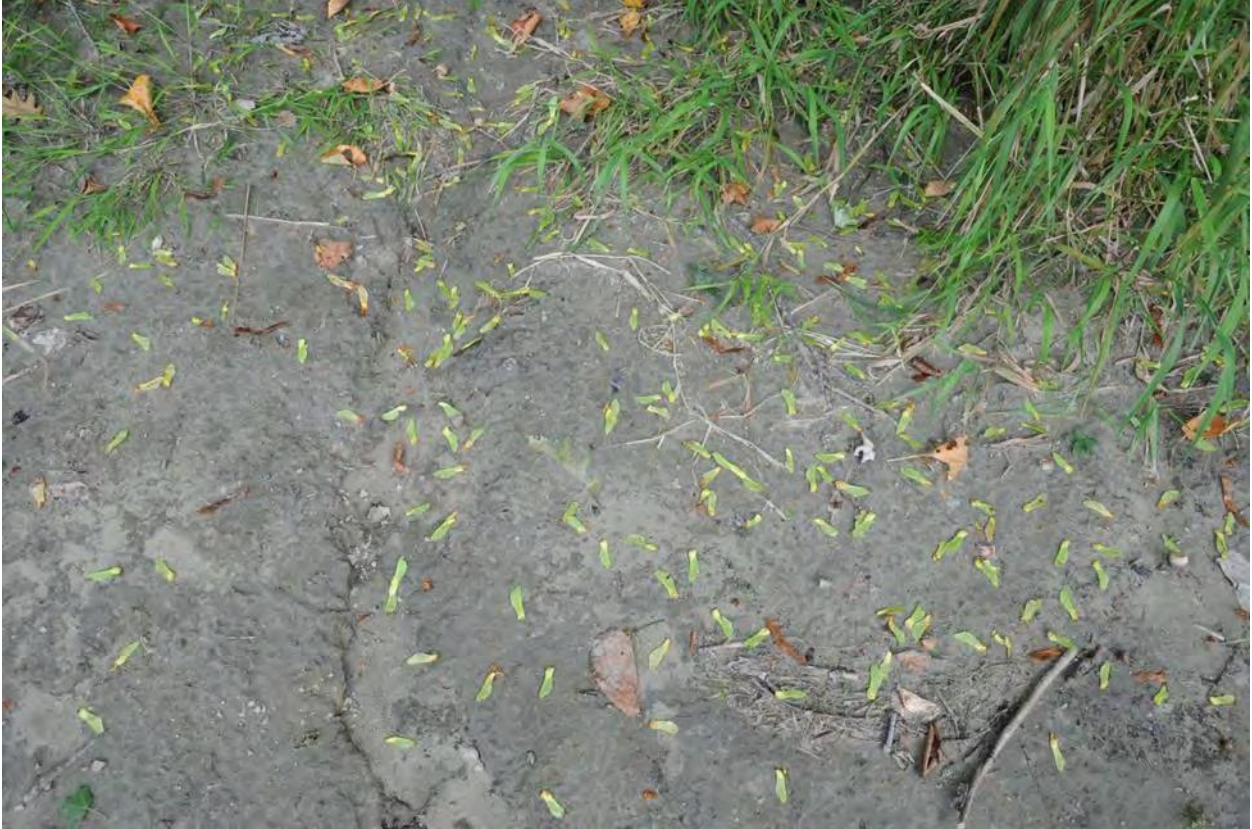
Figure J-4.1 Maple seeds (photo 0202, 9/28/2015)

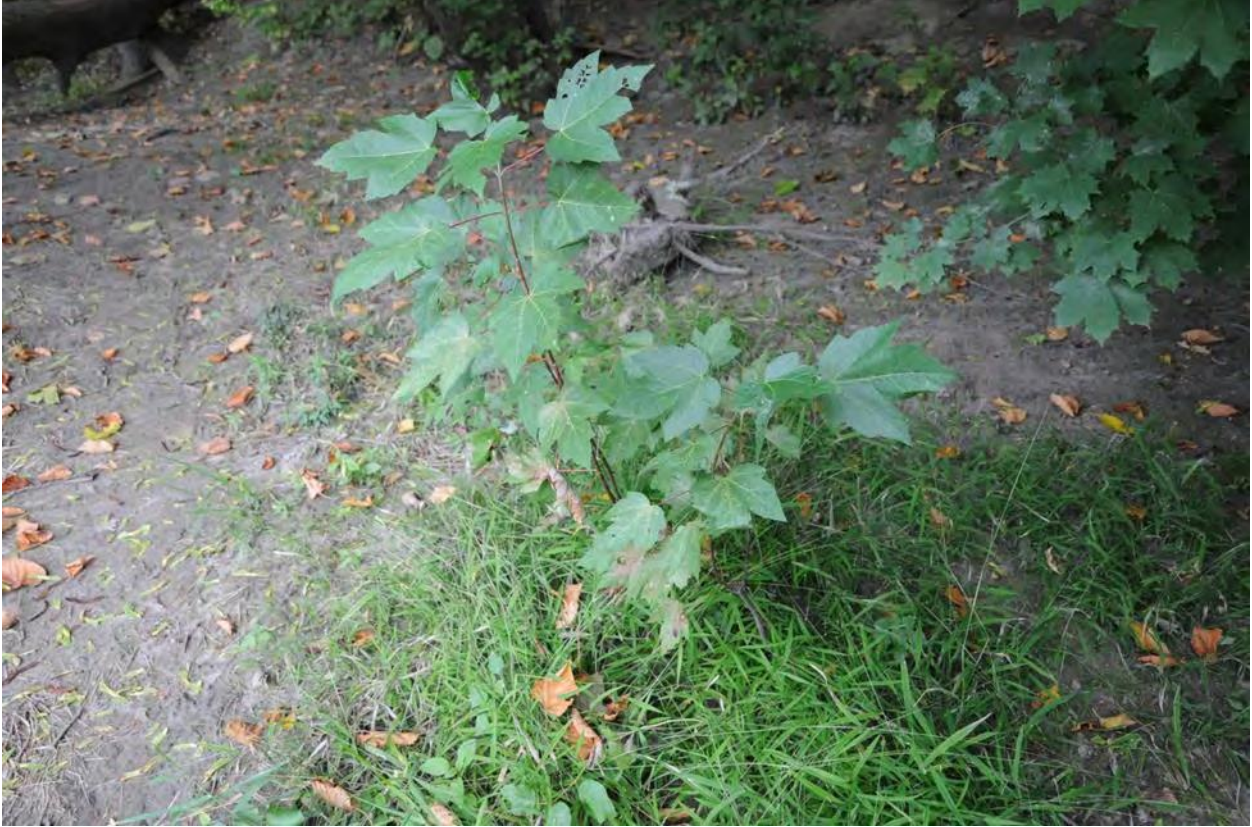
Figure J-4.3 Maple seedlings (photo 0203, 9/28/2015)

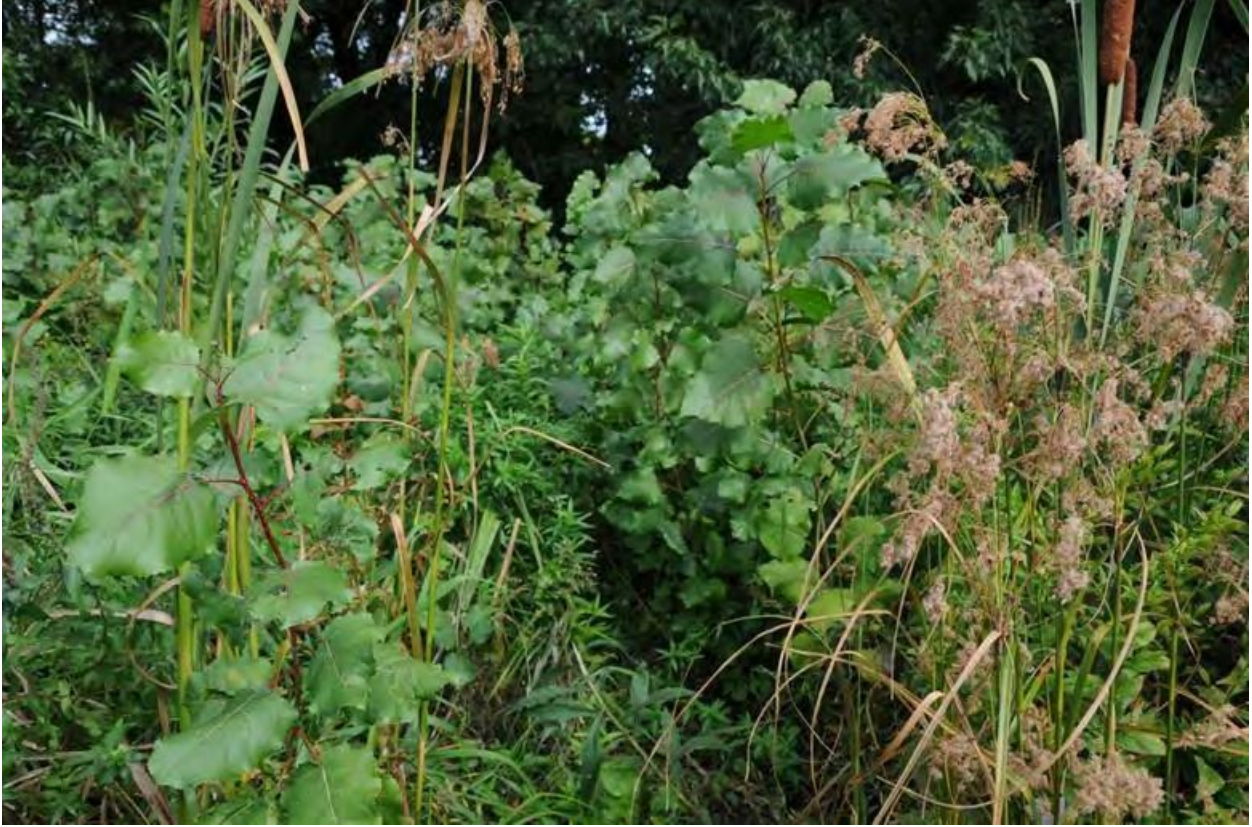
Figure J-4.5 Cottonwood seedlings (photo 0204, 9/28/2015)

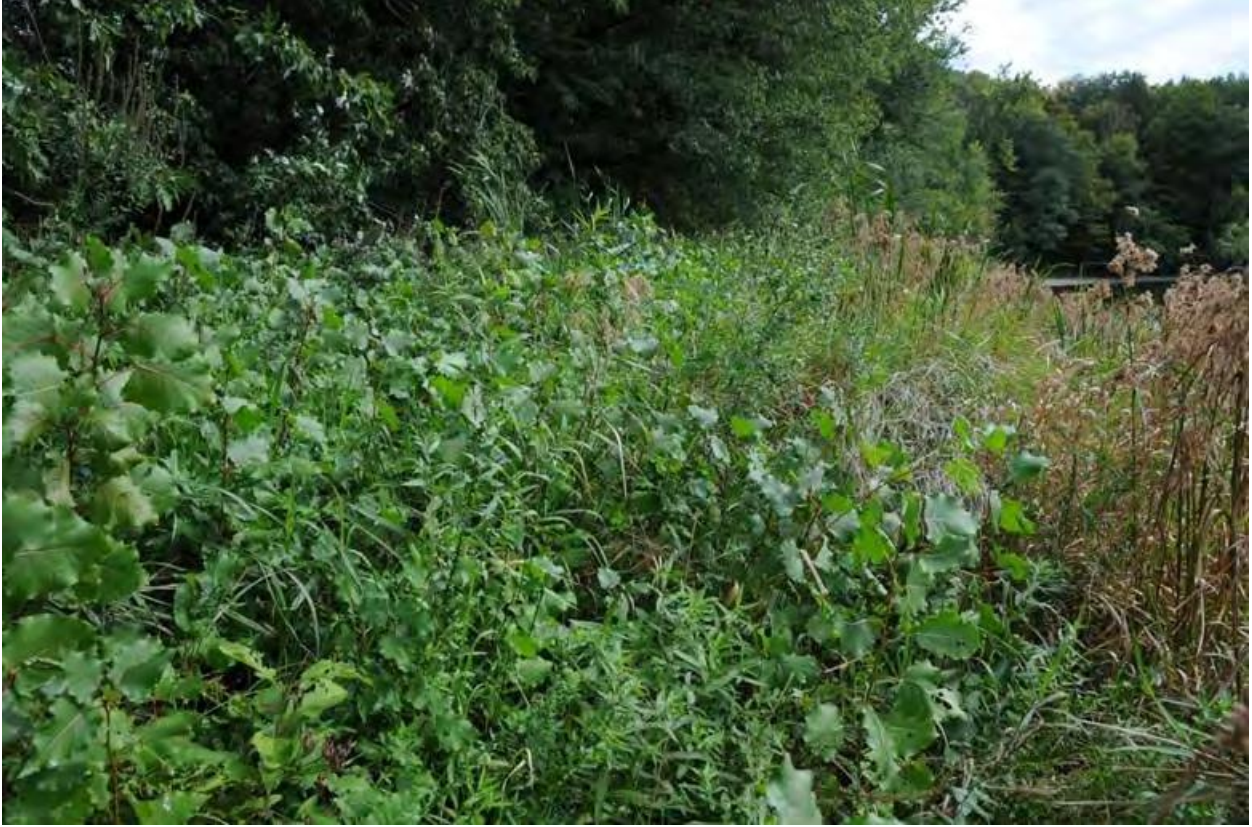
Figure J-4.7 Cottonwood seedlings (photo 0206, 9/28/2015)

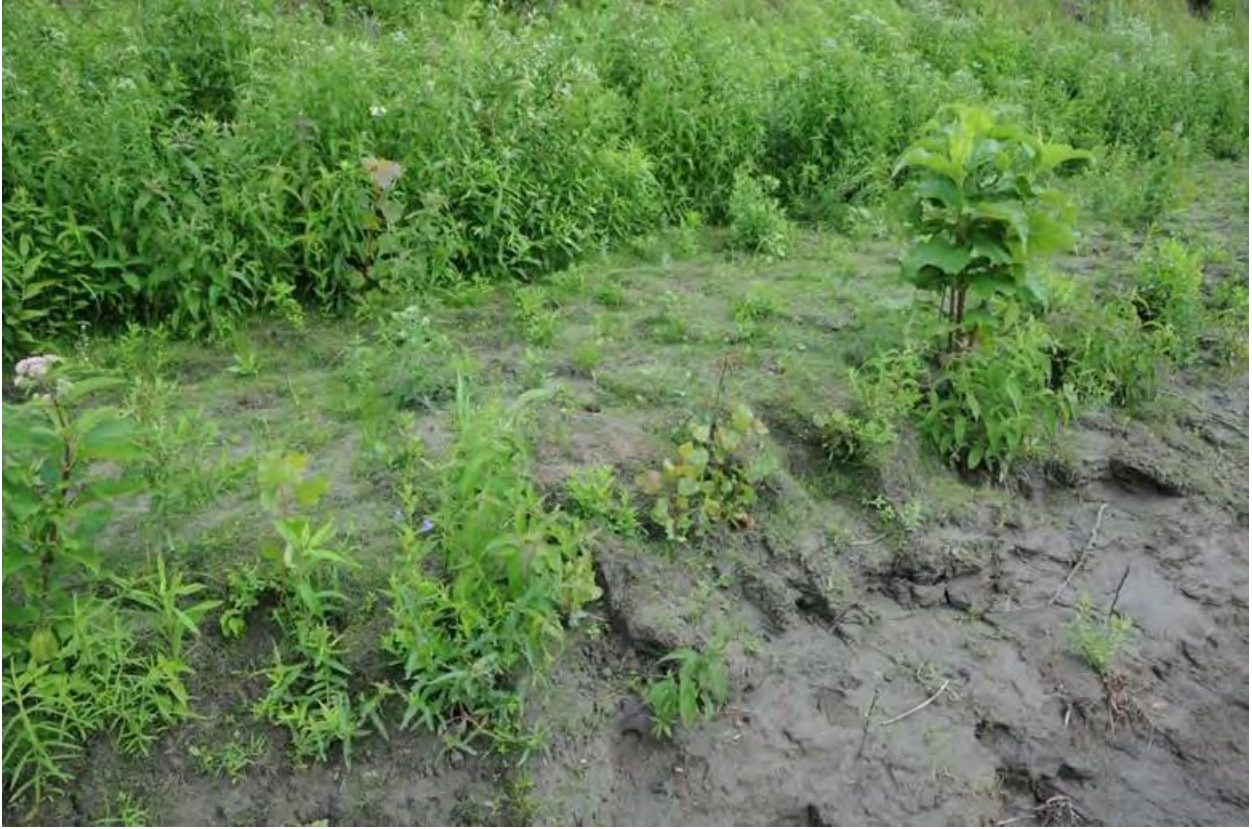
Figure J-4.9 Cottonwood seedlings (photo 6576, 7/15/2014)

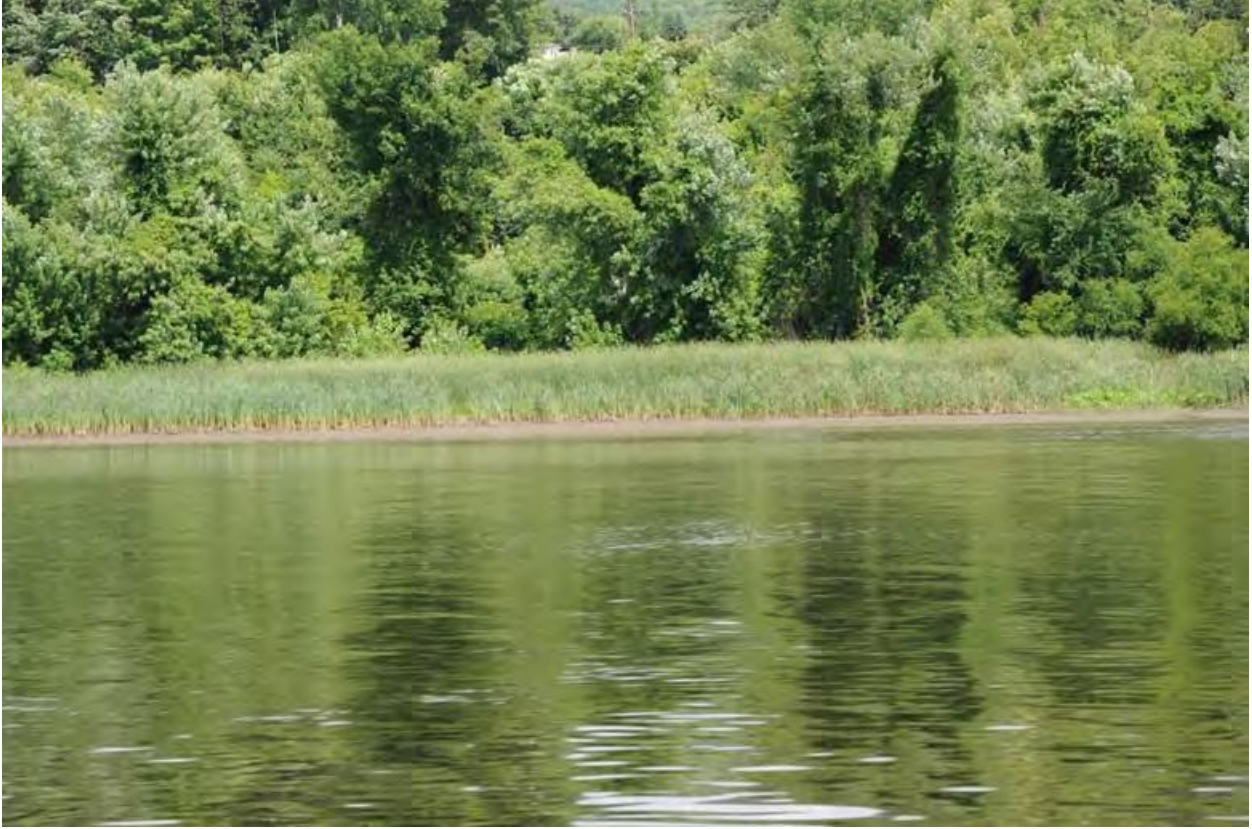
Figure J-4.11 Lower riverbank vegetation (photo 6779, 7/17/2014)

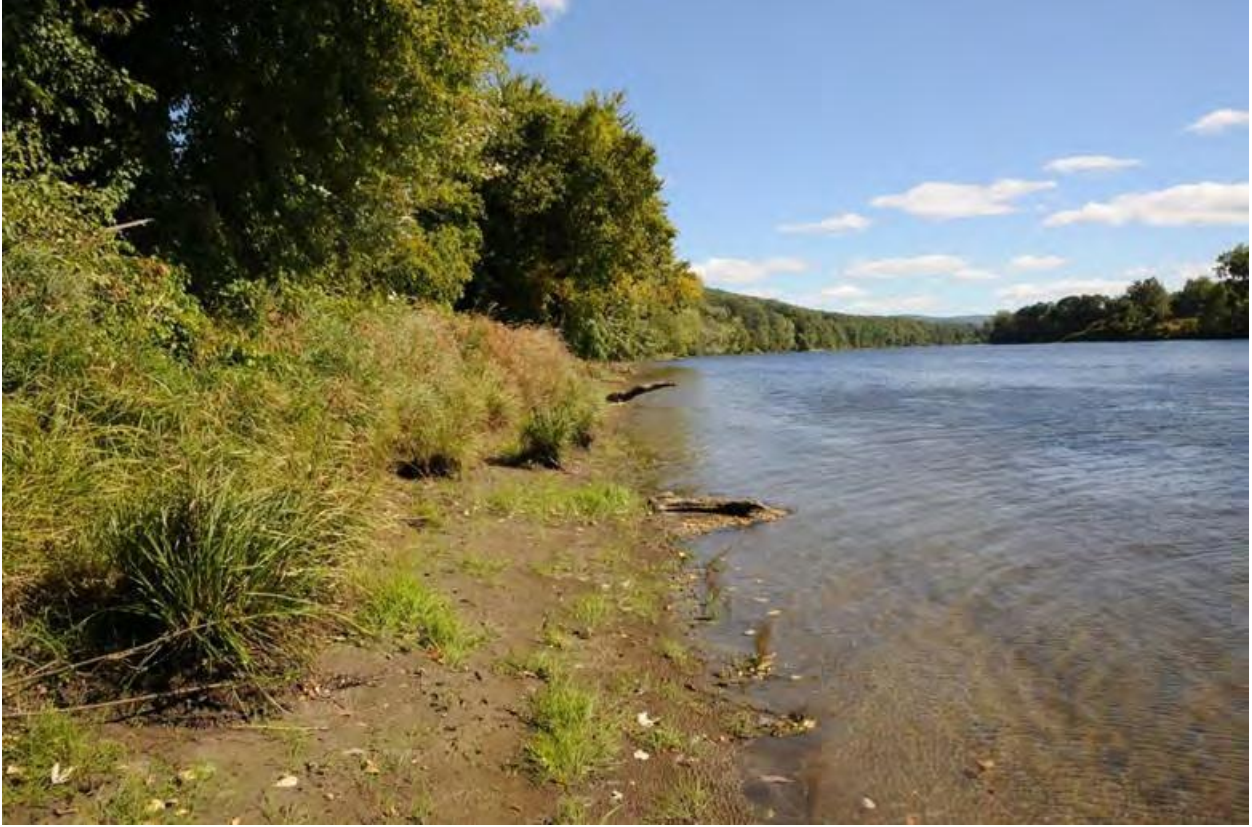
Figure J-4.13 Lower riverbank vegetation with seedlings (photo 9203, 9/22/2014)

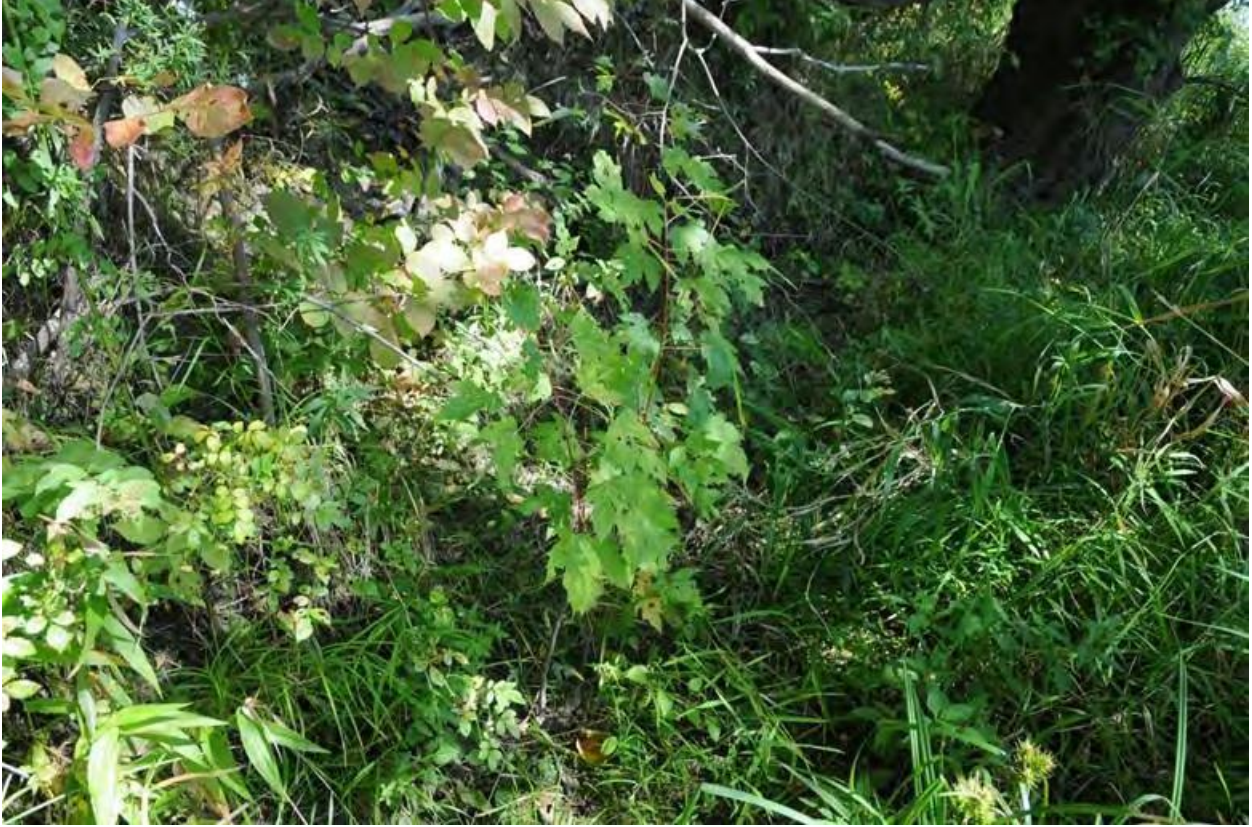
Figure J-4.15 Maple seedling (photo 9217, 9/22/2014)

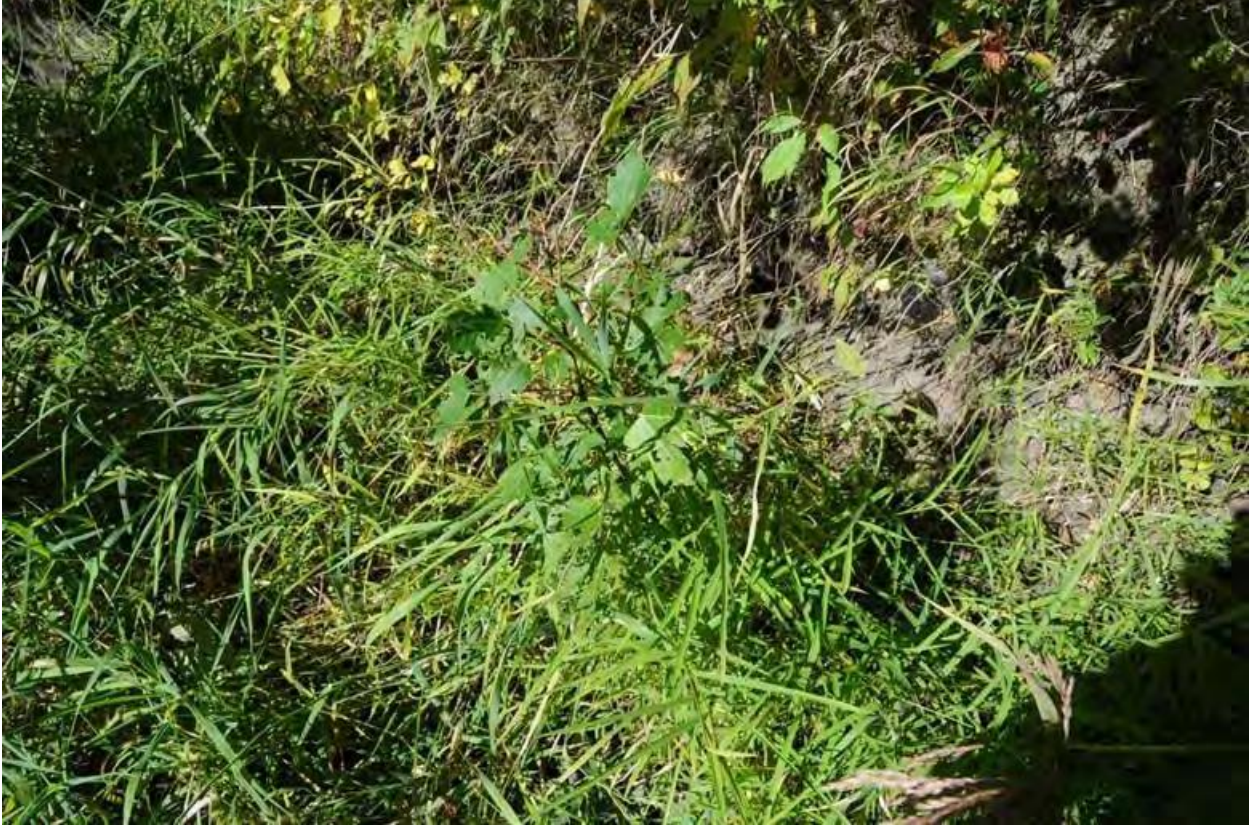
Figure J-4.17 Maple seedling (photo 9218, 9/22/2014)

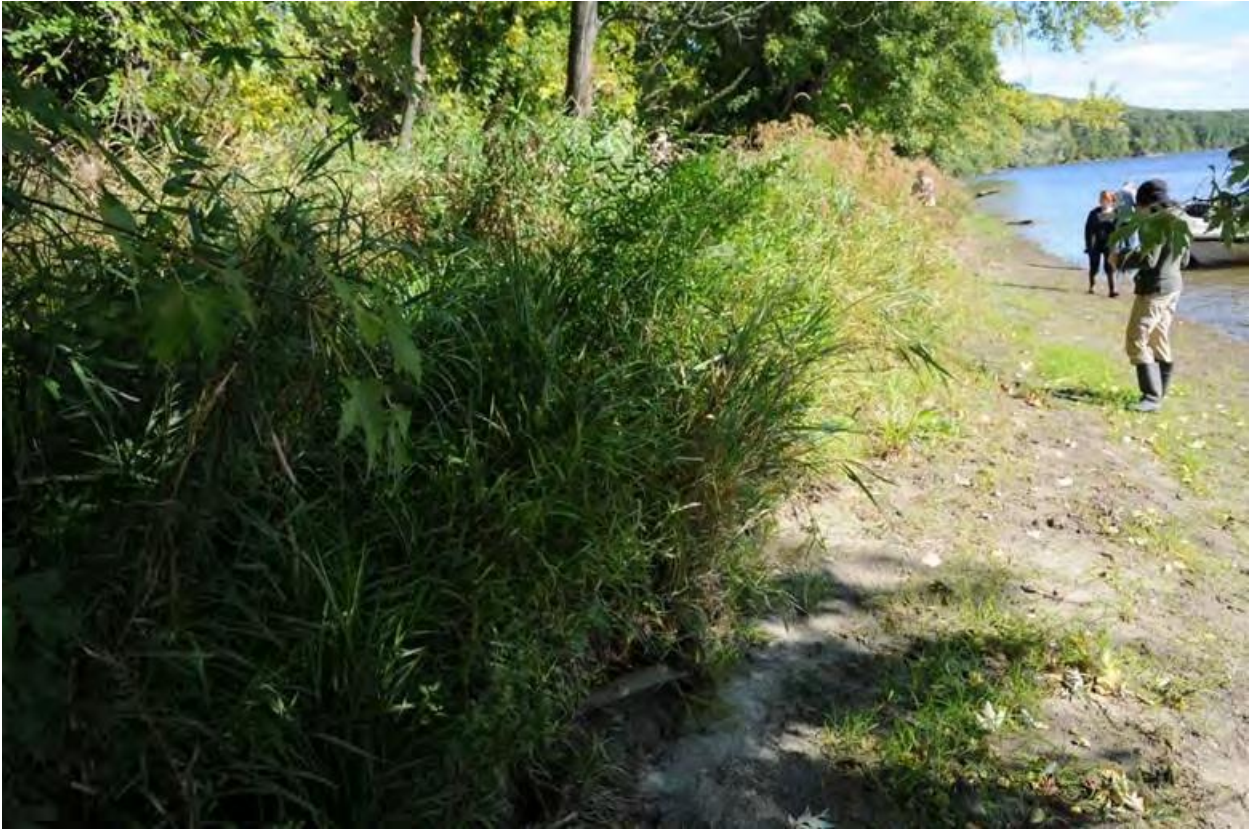
Figure J-4.19 Maple sapling (photo 9219, 9/22/2014)

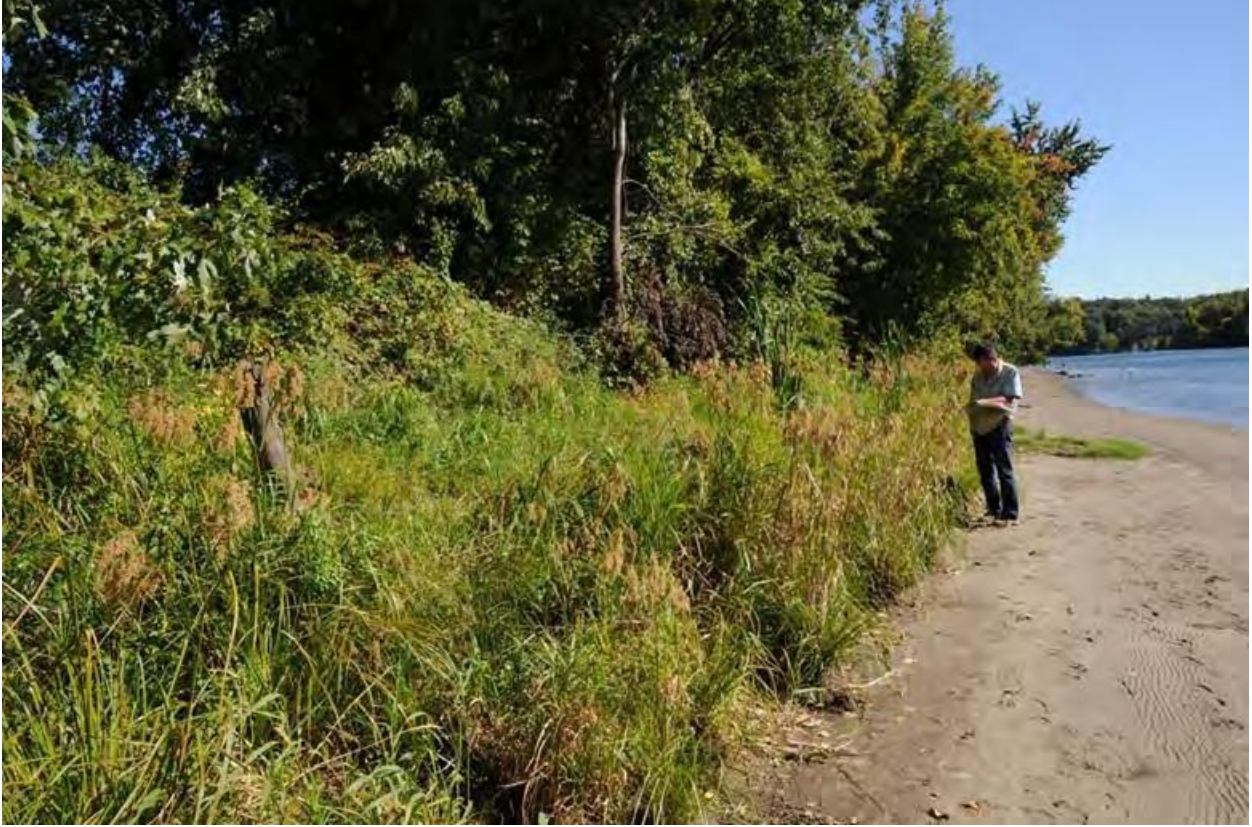
Figure J-4.21 Lower riverbank vegetation with seedlings (photo 9297, 9/23/2014)

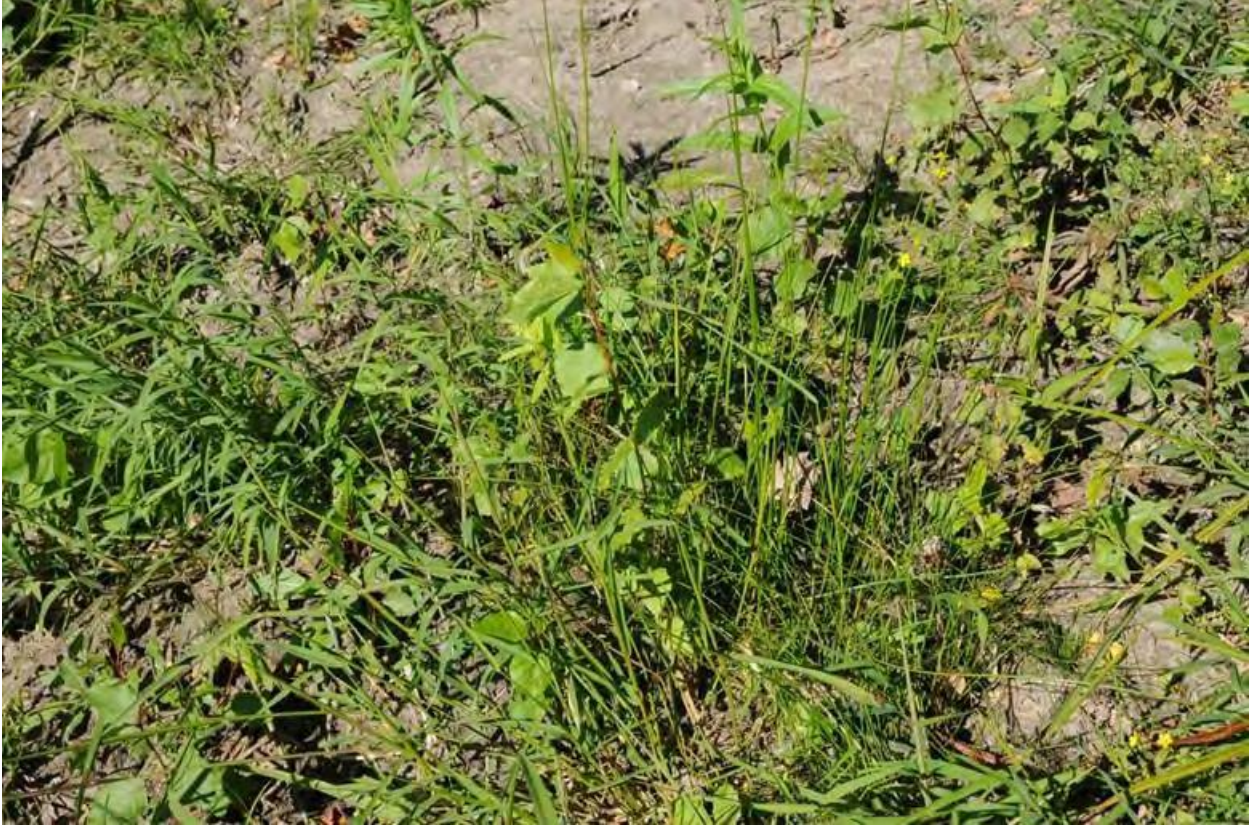
Figure J-4.23 Cottonwood seedlings (photo 9298, 9/23/2014)
