Riverbank Erosion Comparison along the Connecticut River

October 2012

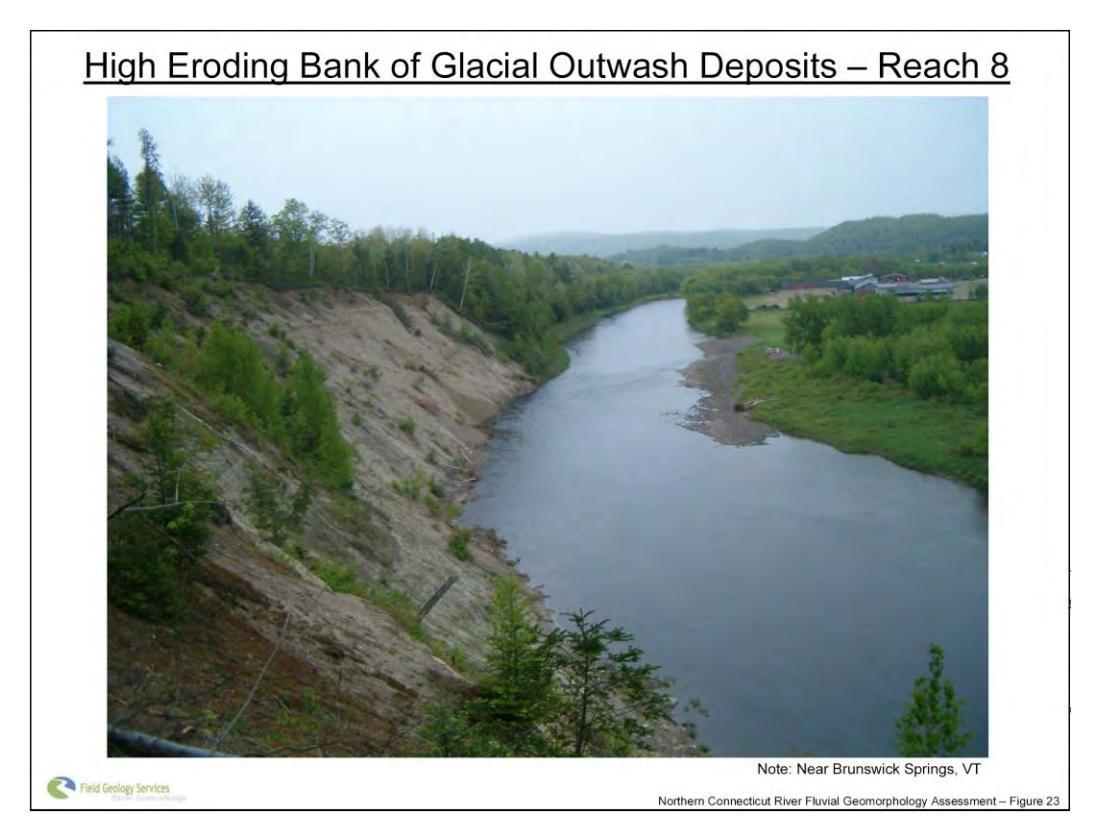
Figure 6. Erosion of glacial outwash deposit (after Field, 2004)

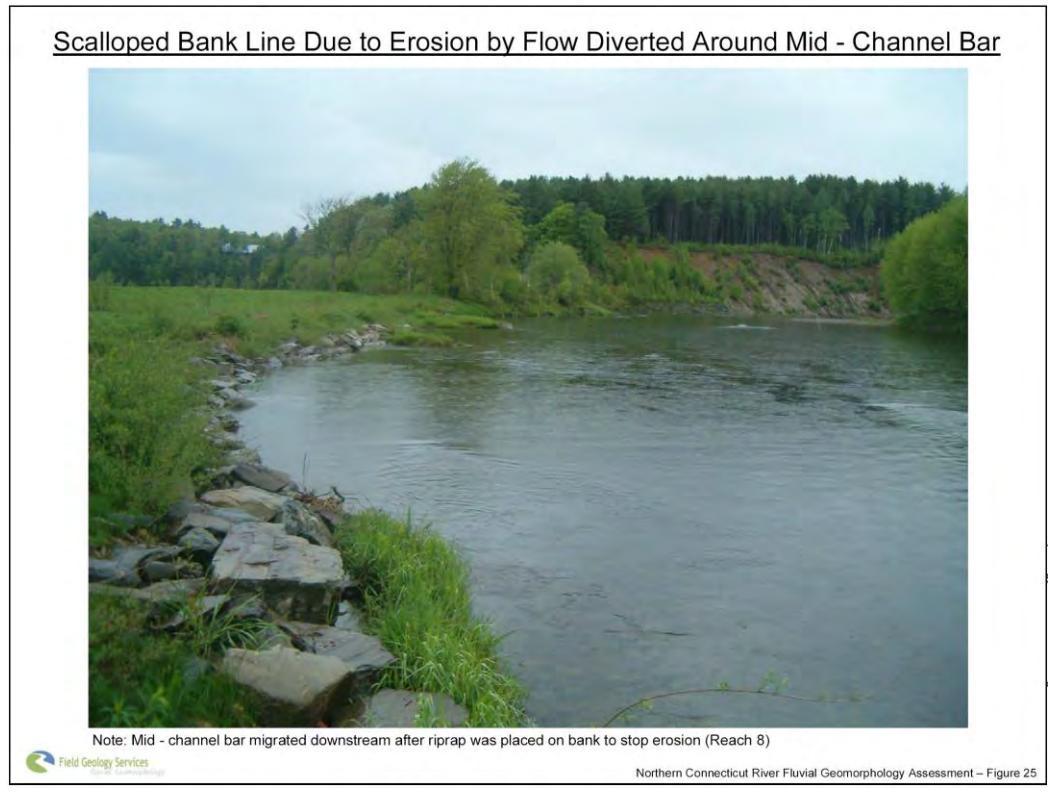
Figure 7. Erosion due to bar formation (after Field, 2004)

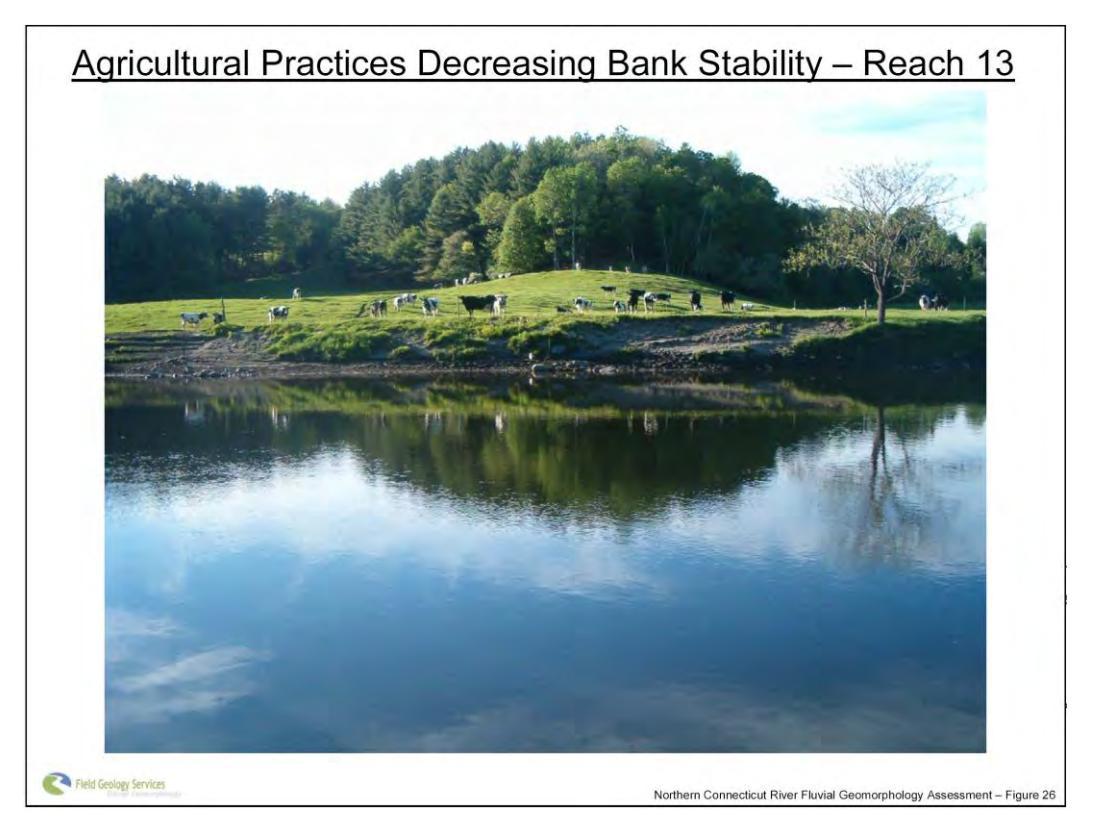
Figure 8. Erosion due to agricultural practices (after Field, 2004)

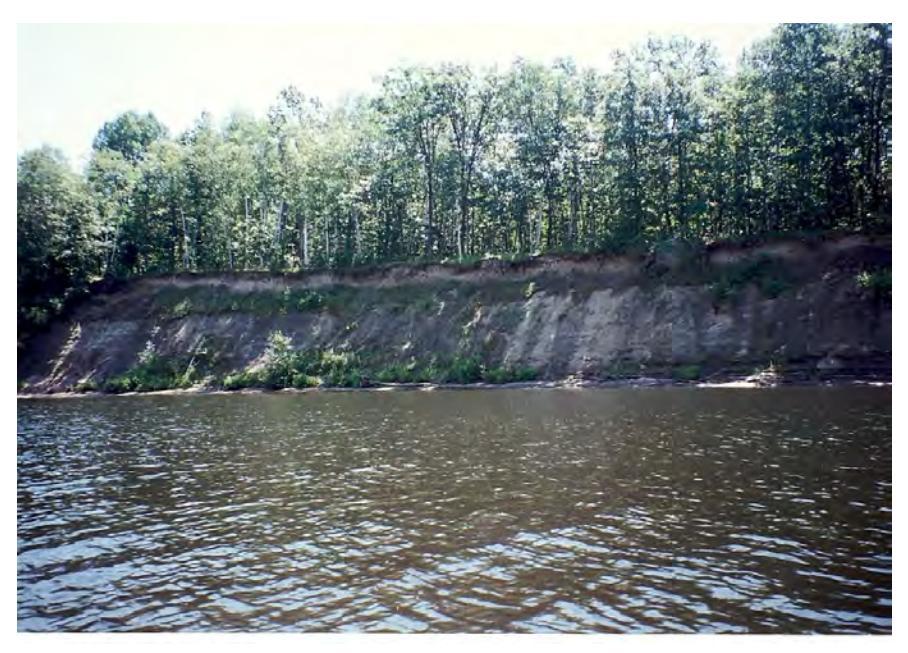
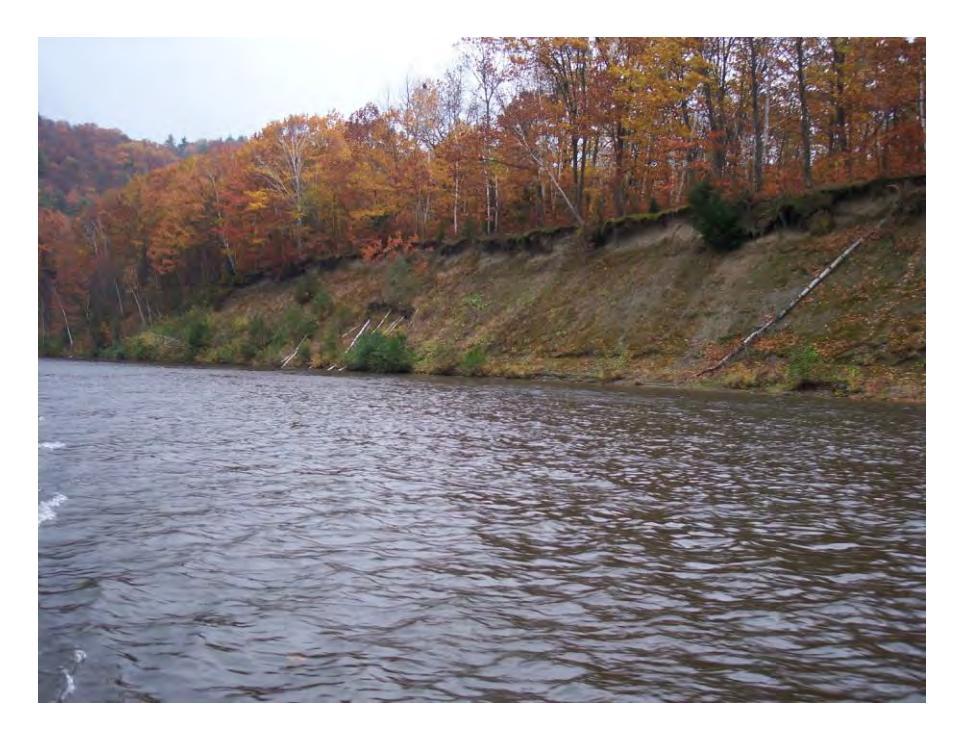
Bellows Falls Pool - Location 8

Figure 12. Riverbank erosion comparison, Bellows Falls Impoundment – Location 8 $% \left({{{\rm{B}}} \right) = 0} \right)$

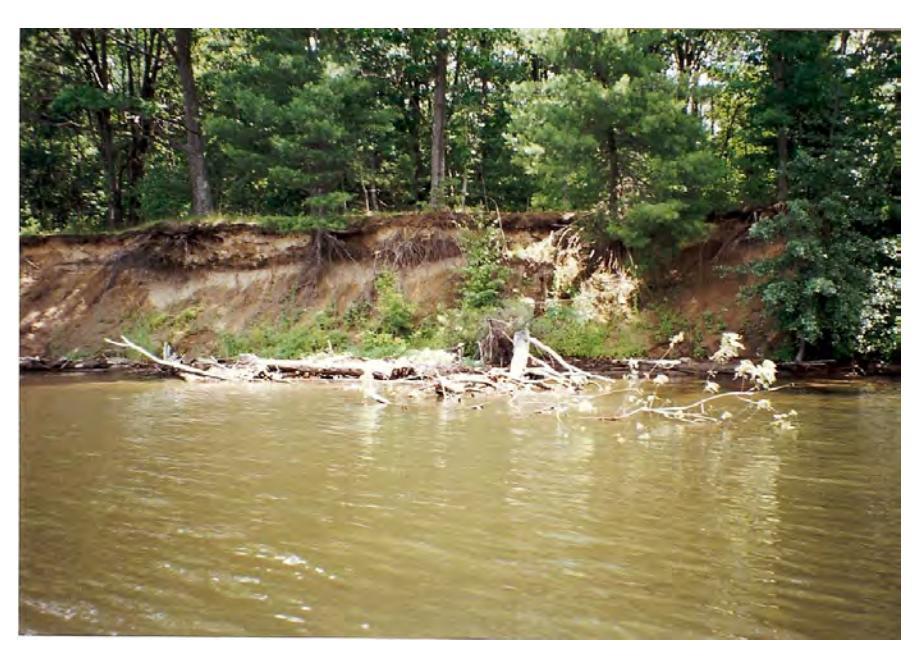
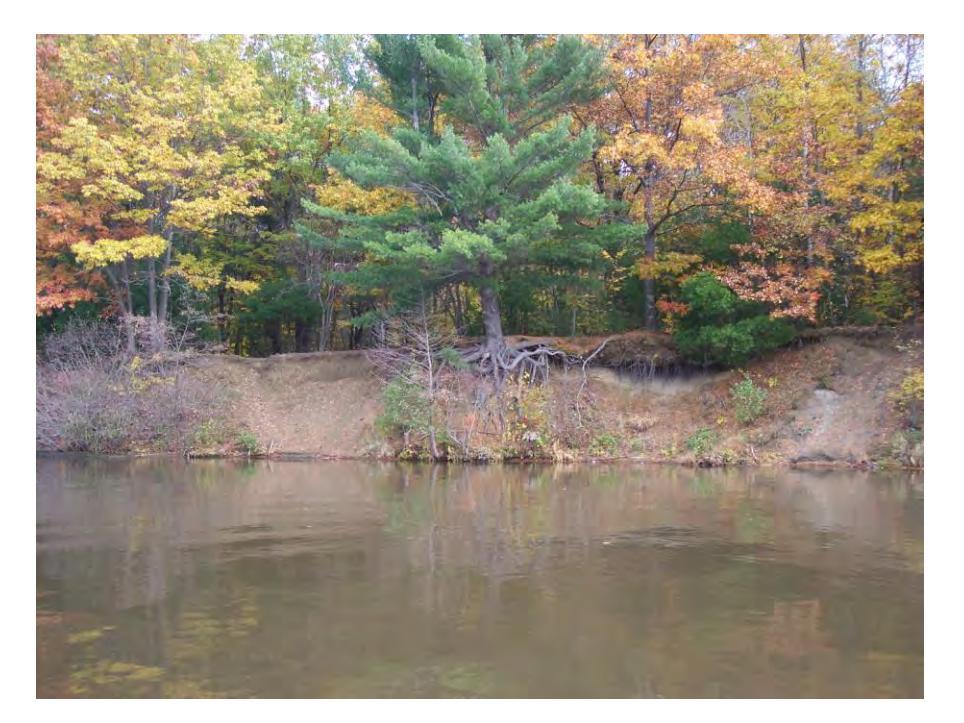
Vernon Pool – Location I

Similar to the Bellows Falls Impoundment, erosion sites along the Vernon Impoundment were also photographed in 1997 and again in 2008. The locations of the erosion sites and images of the sites are shown in Figure 13. Figure 14 presents a comparison of erosion at a location in the Vernon Impoundment in 1997 and 2008, and shows that there are similar erosion and riverbank characteristics over this decade (see Appendix E for a comparison of photos of erosion sites from 1997 to 2008 in the Vernon Impoundment). The various sites that had documented erosion in 1997 were still eroding in 2008. While no evaluation of the extent or percentage of riverbanks experiencing erosion is available, geo-referenced video tapes were taken to document riverbank conditions for this reach of river in 2008.

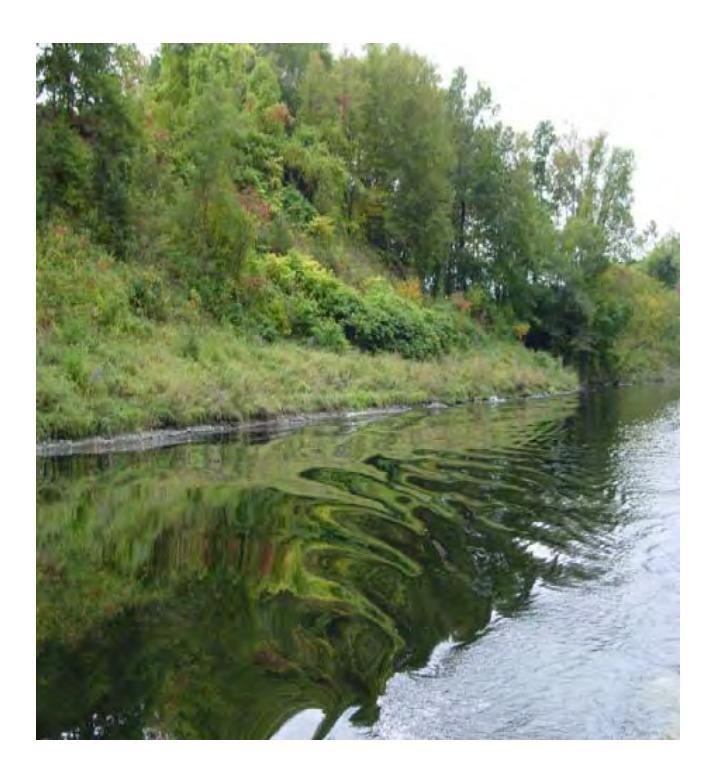
Site 6 – Skalski, 2008 (from Maintenance Inspection Report)

Figure 17. Comparison of Skalski Site pre 2004 to 2008

Photographs are available at several erosion sites in the Turners Falls Impoundment taken before and after riverbank stabilization projects that have occurred with implementation of the ECP. Many of the erosion sites identified in the ECP have been stabilized by a range of measures including placement of rock at the toe of the slope, coir logs, placement of large woody debris, various fabrics, and planting of vegetation including riparian and aquatic. Some re-shaping of riverbanks has also been conducted at some sites. An example of the transformation from an unstable, eroding riverbank to a stabilized riverbank is shown in Figure 17. As shown by this comparison of photos from before 2004 to 2008, the eroding bank has been stabilized by placing relatively small rock at the toe of the slope and planting vegetation above the rock on the formerly eroded bank. The 2008 photo shows the transformation from erosion to stabilization efforts in the Turners Falls Impoundment. From the commencement of implementation of the ECP to the present, approximately 14,000 feet of riverbank have been stabilized in the Turners Falls Impoundment.

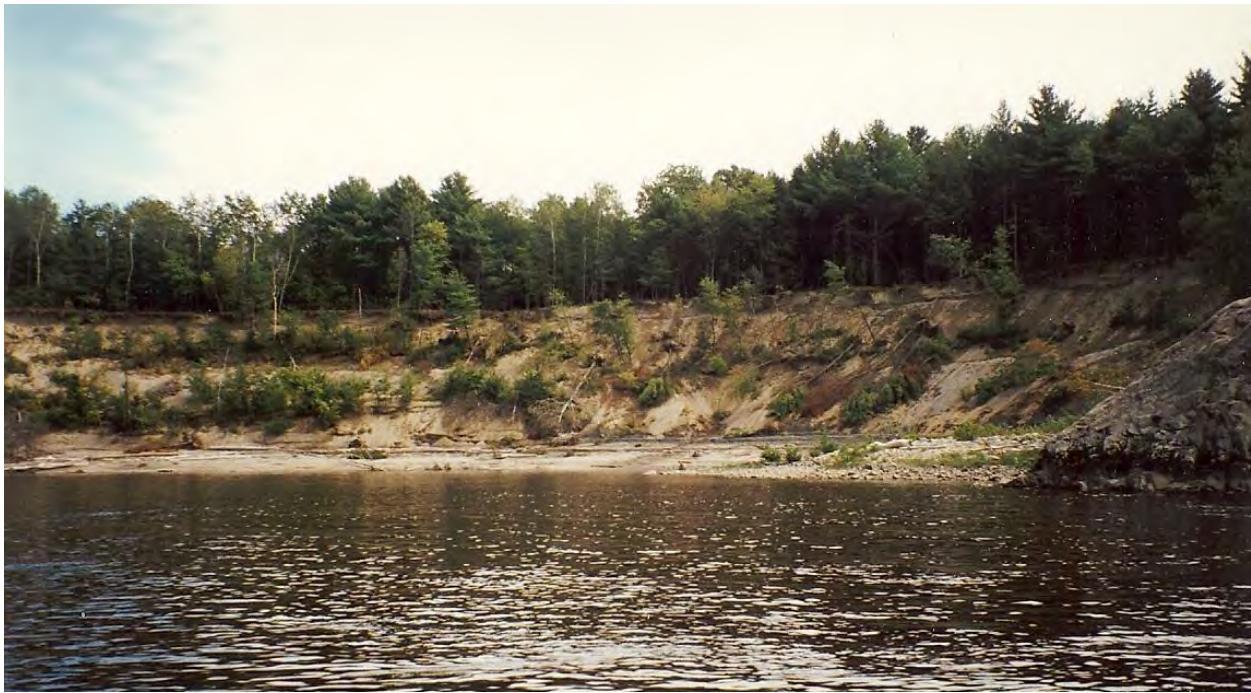
1996 - Eddy-induced erosion downstream of Vernon Dam

Figure 18. Natural stabilization processes 1996-2008 downstream of Vernon Dam

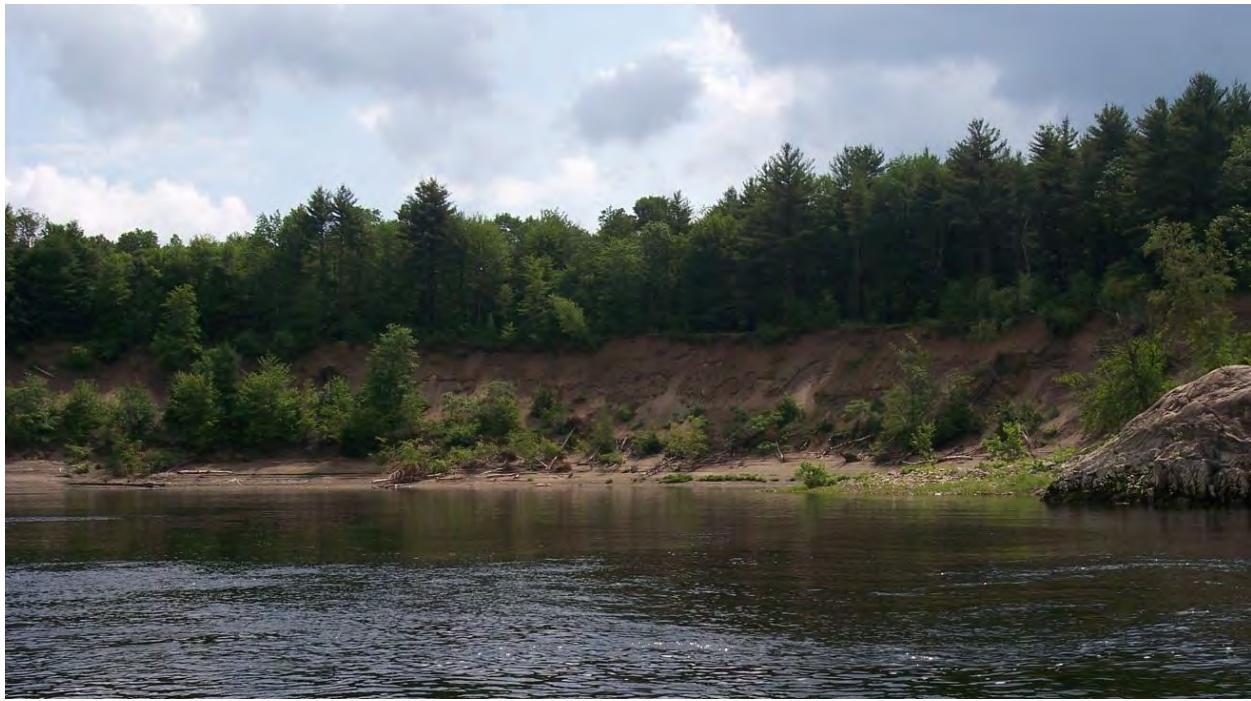
2008 – Eddy-induced erosion downstream of Vernon Dam

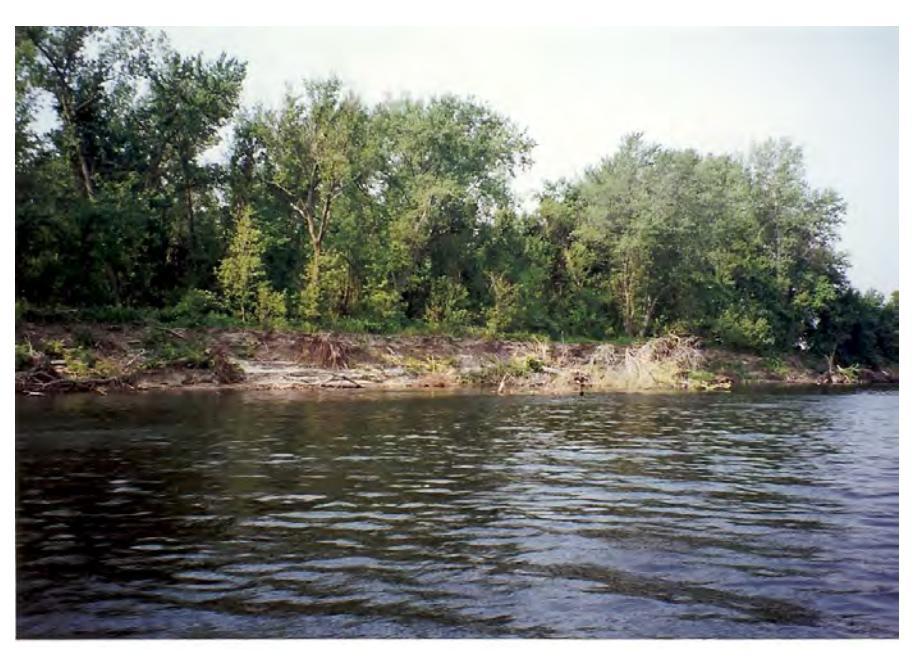
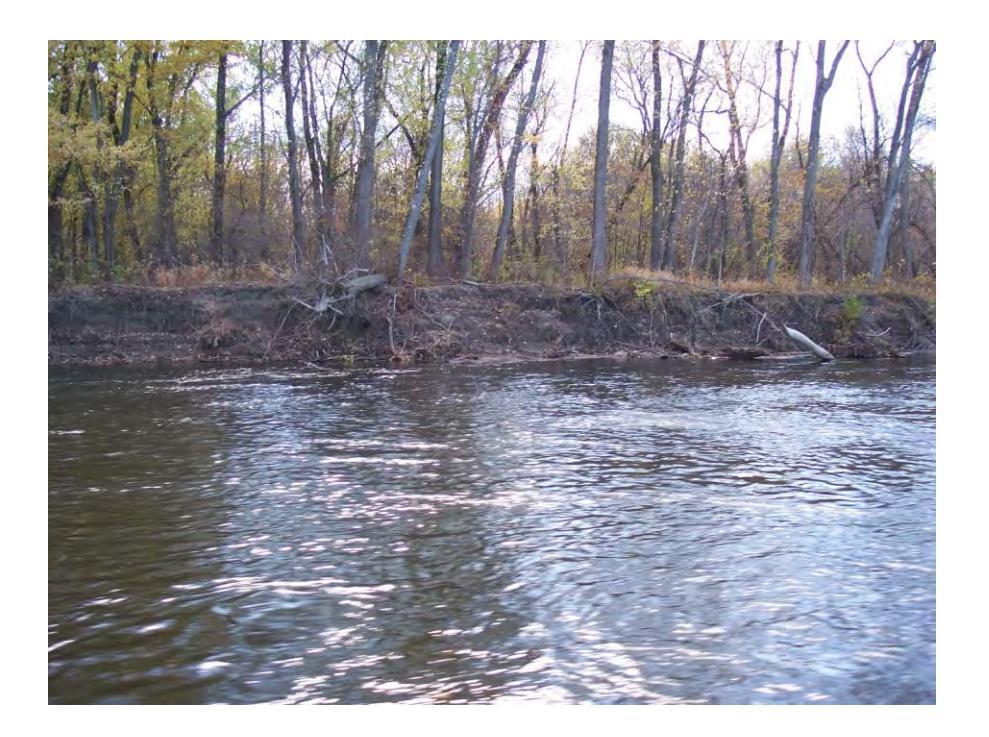
Holyoke Pool – Location D

Erosion sites identified in the Holyoke Impoundment were photographed in 1997 and again in 2008. The locations of the erosion sites are shown in Figure 19. An example of riverbank erosion in the Holyoke Impoundment from 1997 to 2008 is shown in Figure 20. The extent and severity of erosion is similar and has continued over this 11-year time period (see Appendix J for a comparison of photos of the various erosion sites from 1997 to 2008 in the Holyoke Impoundment). The various sites eroding in 1997 were still eroding in 2008. While no evaluation of the extent or percentage of riverbanks experiencing erosion is available, geo-referenced video tapes were taken to document riverbank conditions for this reach of river in 2008.

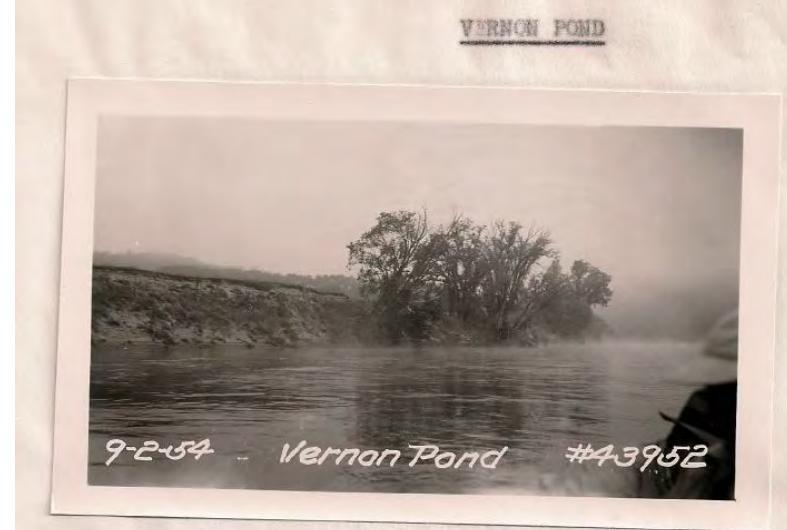
Picture No. 13952

Vt. bank Mile 30.5 W. S. Powers V-409

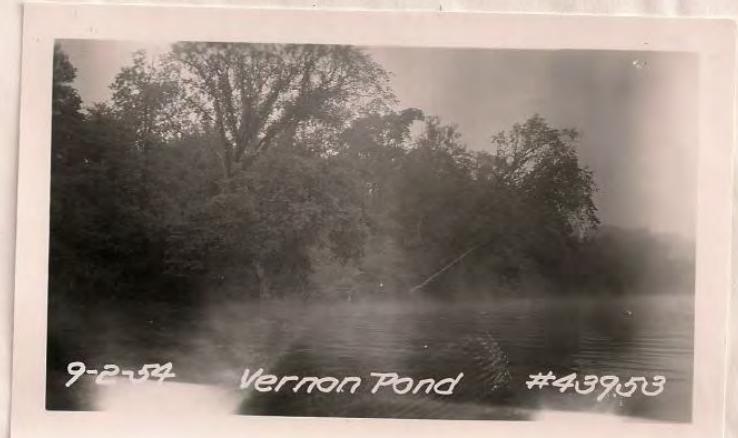
Picture No. 13953

Vt. bank Mile 28.35 Abenaque Machine Co. V-395

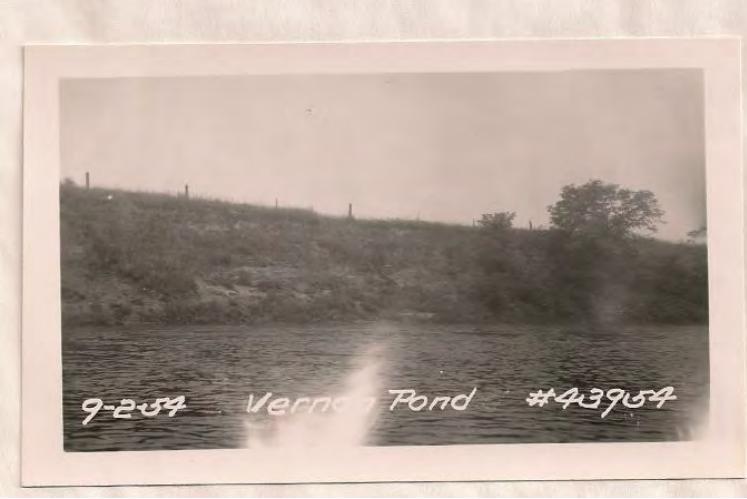
Ficture No. 43954

Vt. bank Mile 28.0 Anders Nelson V-394

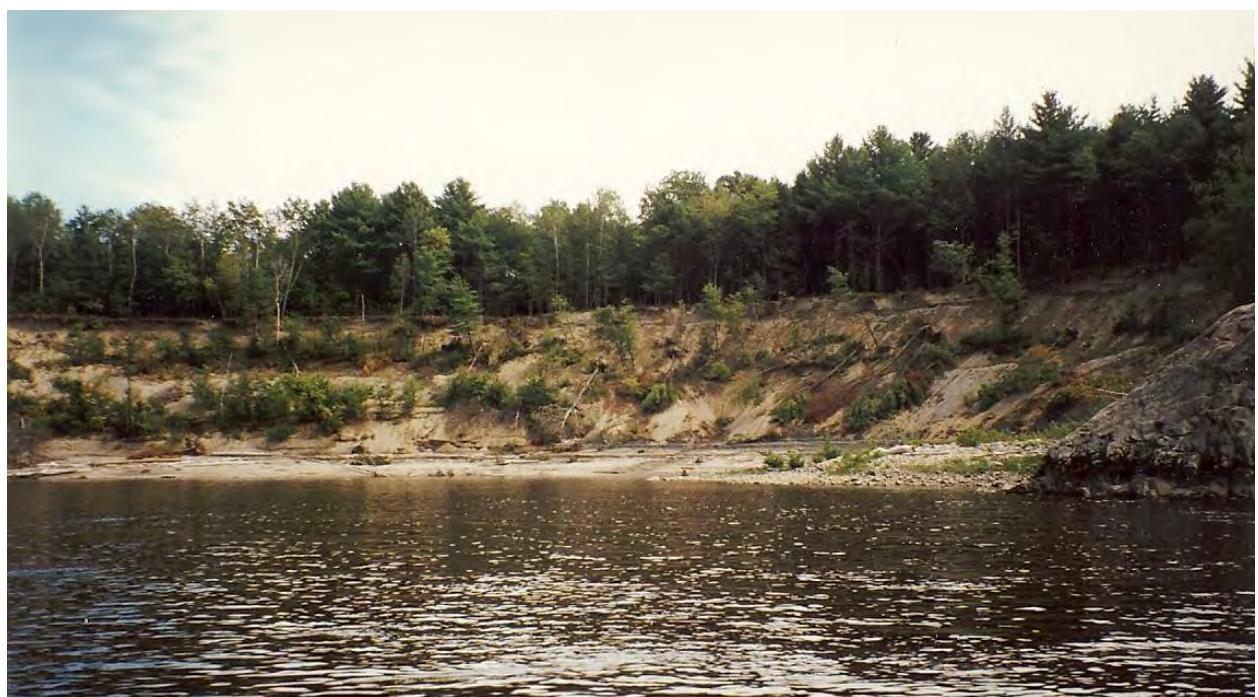
1996 - Eddy-induced erosion downstream of Vernon Dam

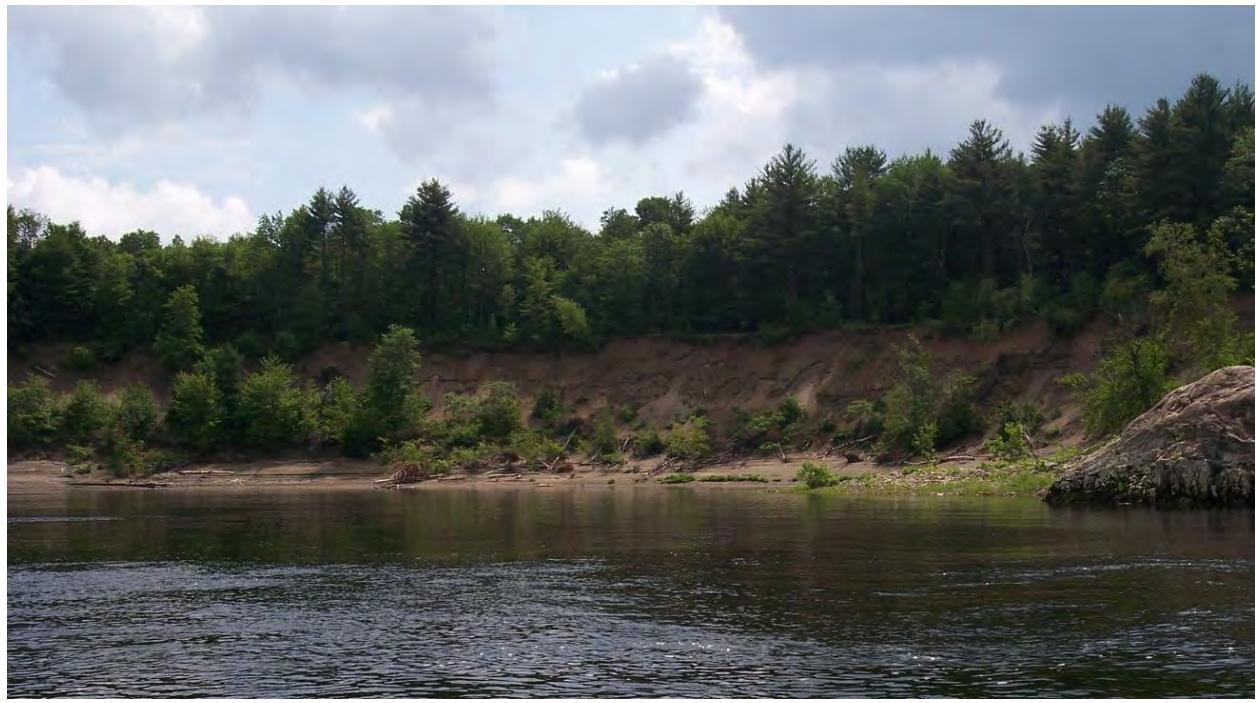
2008 – Eddy-induced erosion downstream of Vernon Dam

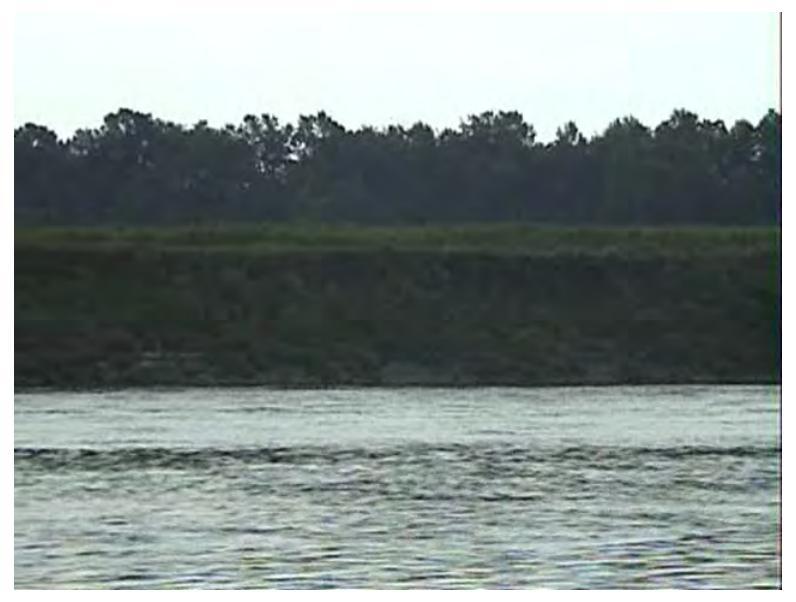
Right Bank near downstream end of Stebbin's Island - 1998

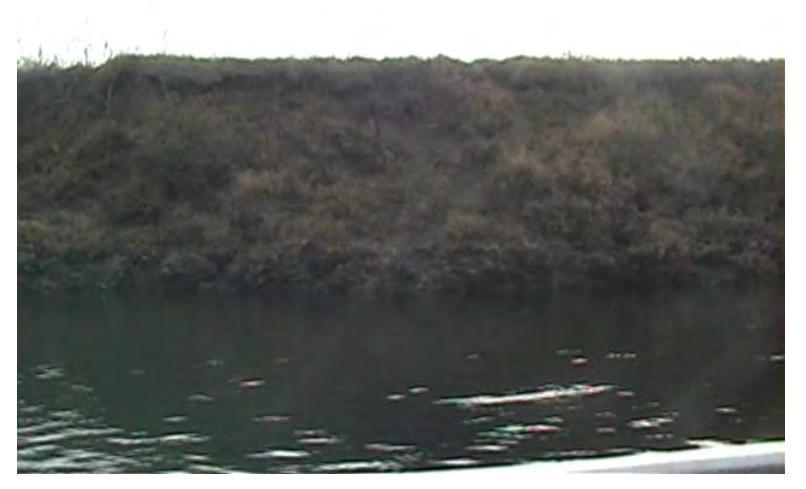
Right Bank near downstream end of Stebbin's Island - 2008

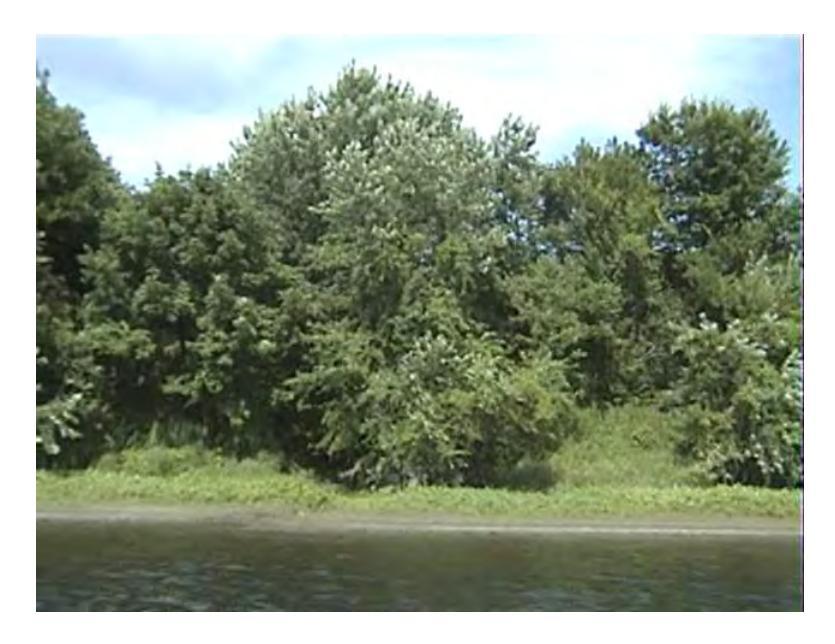
Riverbank Segment with some low bank vegetation - 1998

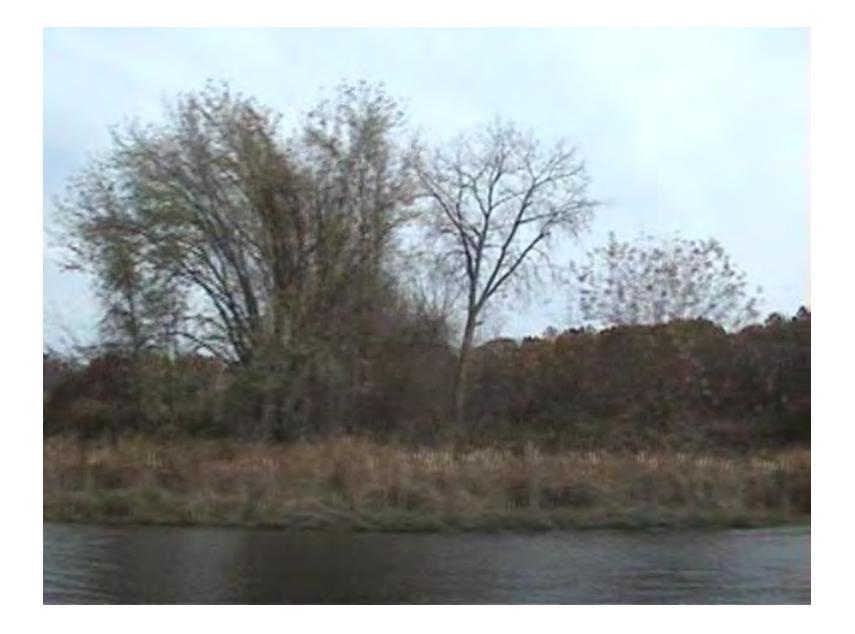
Riverbank Segment with dense low bank vegetation - 2008

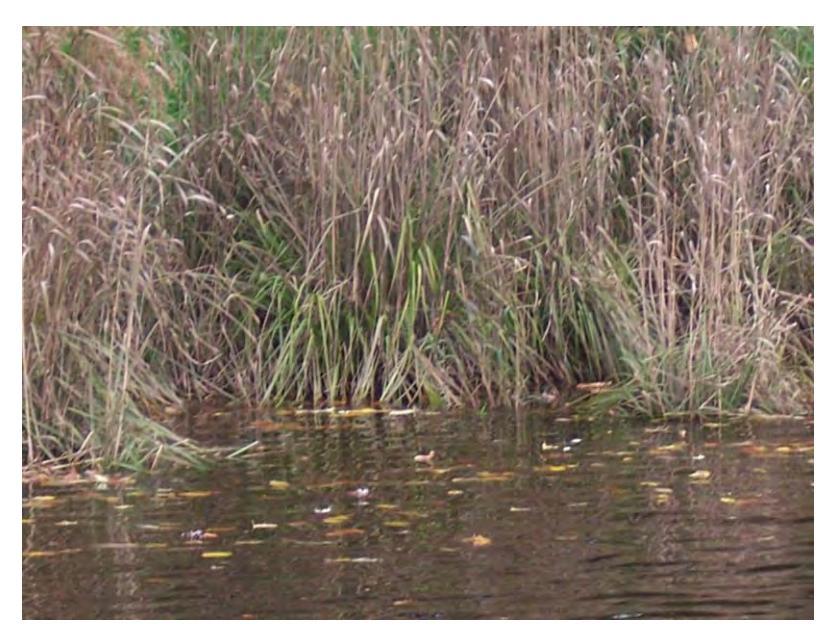
Close-up of low bank aquatic vegetation - 2008
