# CONNECTICUT RIVER RIVERBANK MANAGEMENT MASTER PLAN (DRAFT)

JUNE 1991

**NORTHROP, DEVINE & TARBELL, INC.**

**NORTHEAST UTILITIES SERVICE CO., INC.**

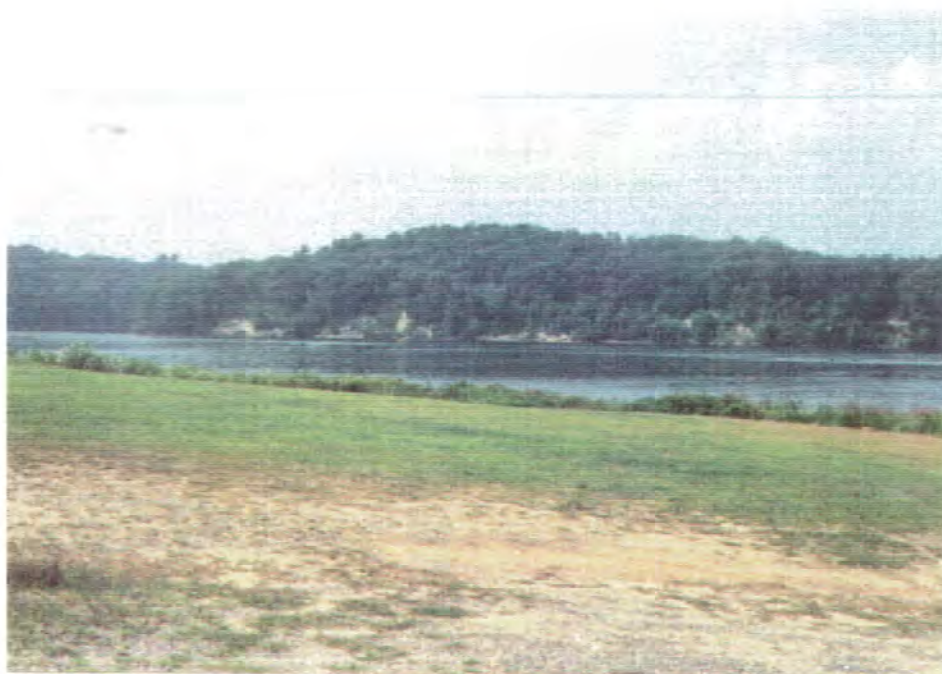
Slide erosion area across from Turners Falls Rod & Gun Club is visible looking north. (Viewpoint 4) - Aug. 17, 1990.

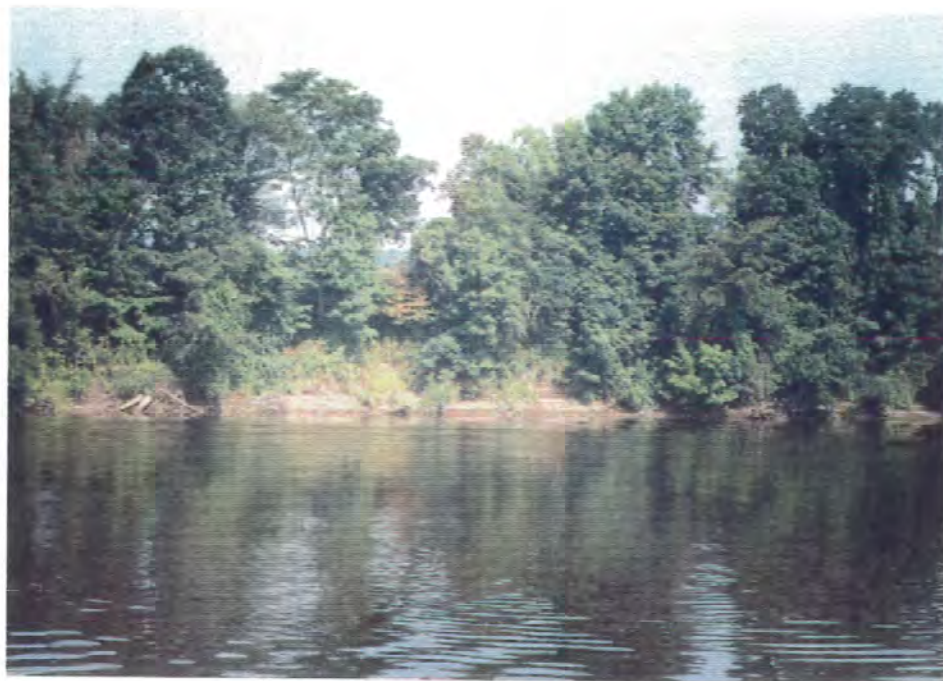
Site 53 - Low to moderate erosion - Aug. 17, 1990.

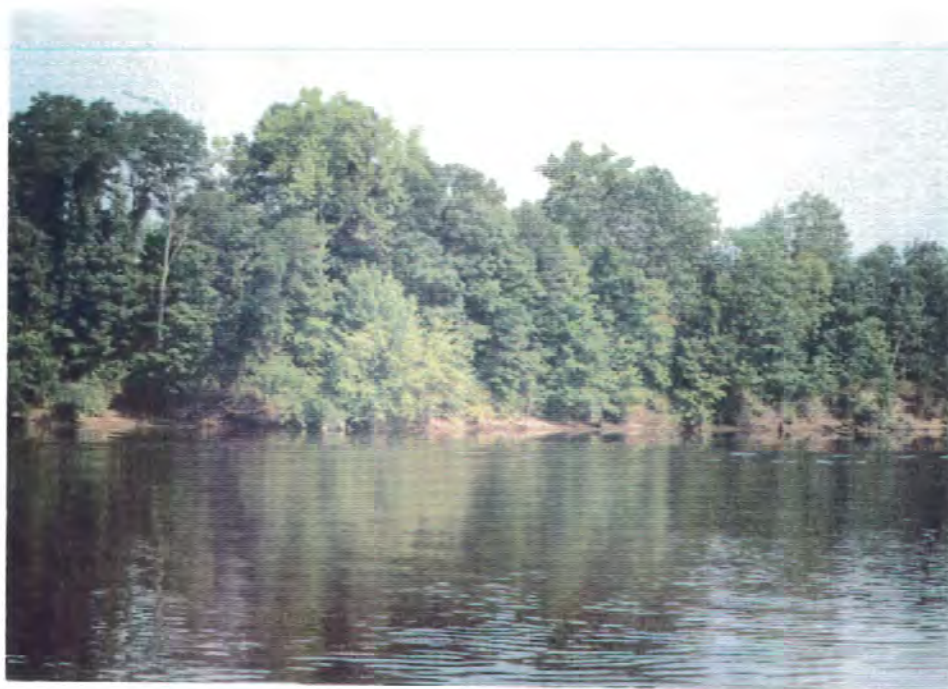
Site 53 - Upstream of Munn's Ferry; west bank - Aug. 17, 1990.

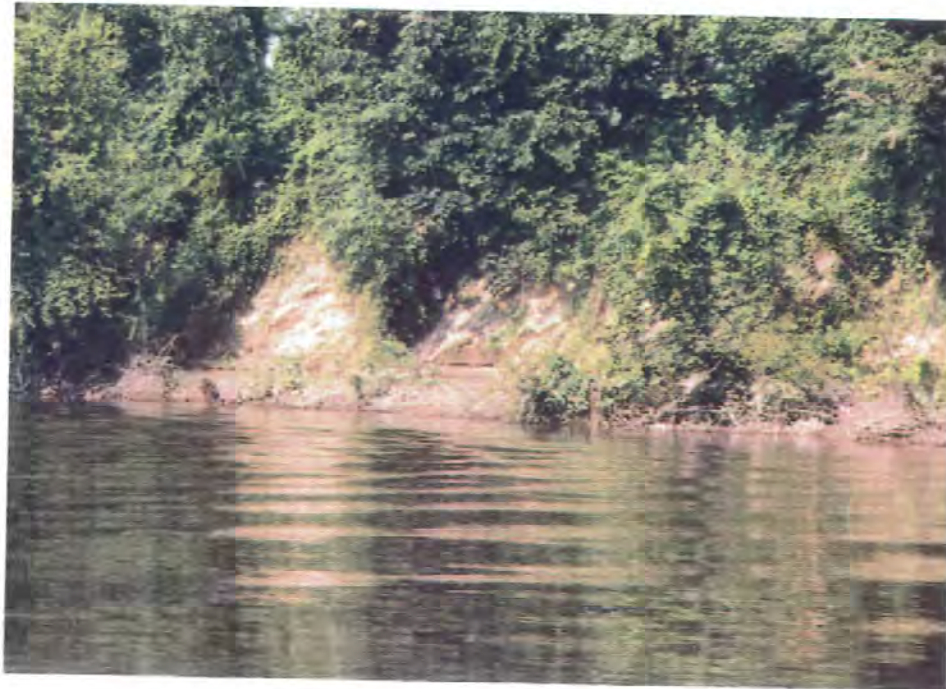
Site 57 - Moderate erosion. Across from the upstream end of Kidds Island; west bank - Aug. 16, 1990.

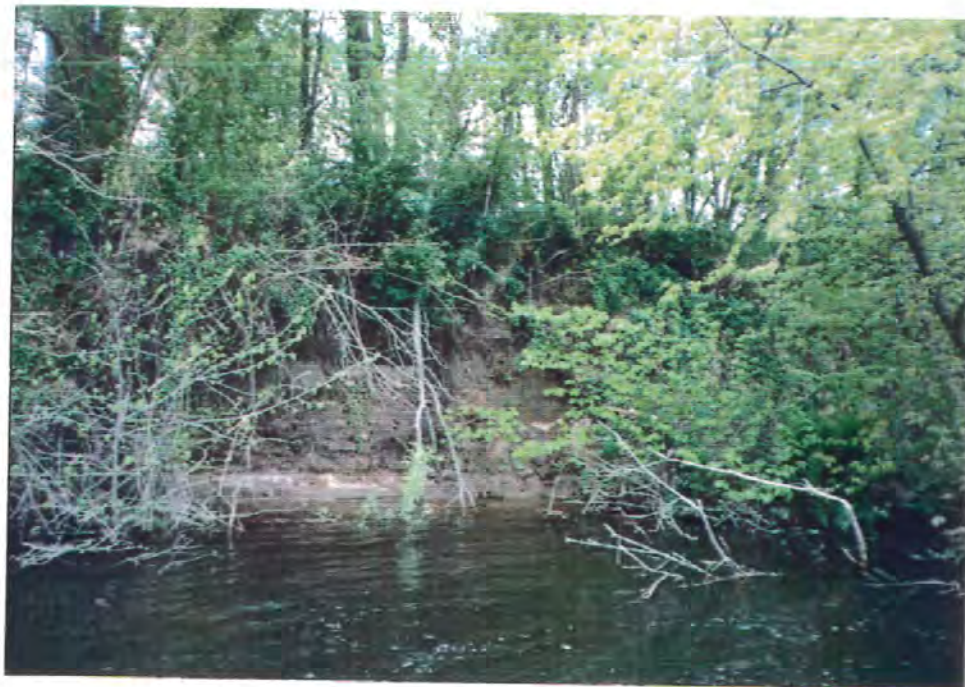
Site 42 - Moderate erosion. Downstream of the Rt. 10 bridge; west bank - May 22, 1990.

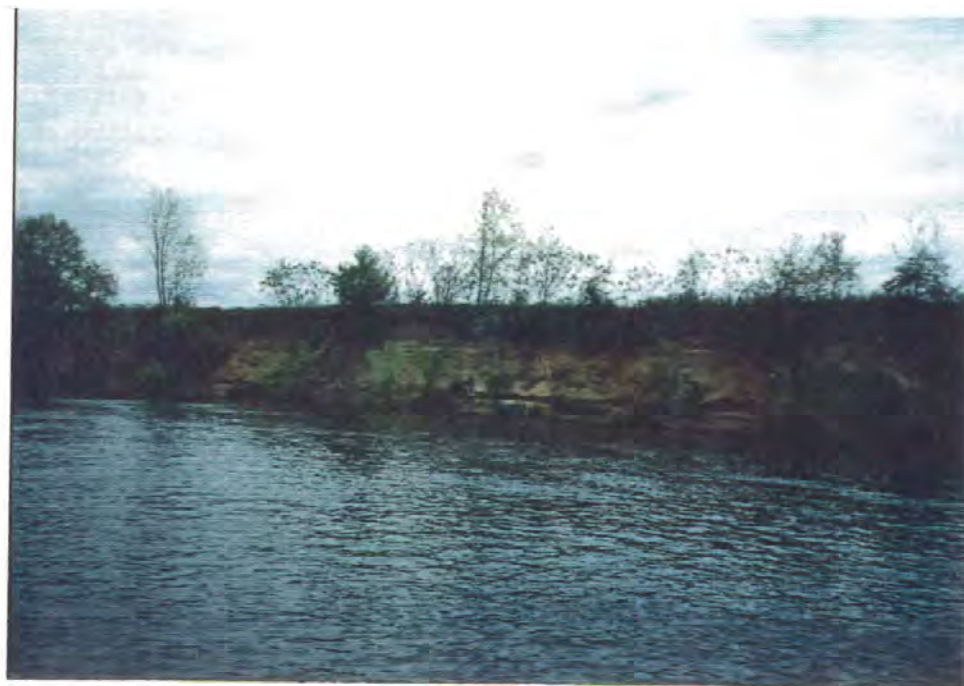
Site 63 - Moderate to severe erosion - May 22, 1990.

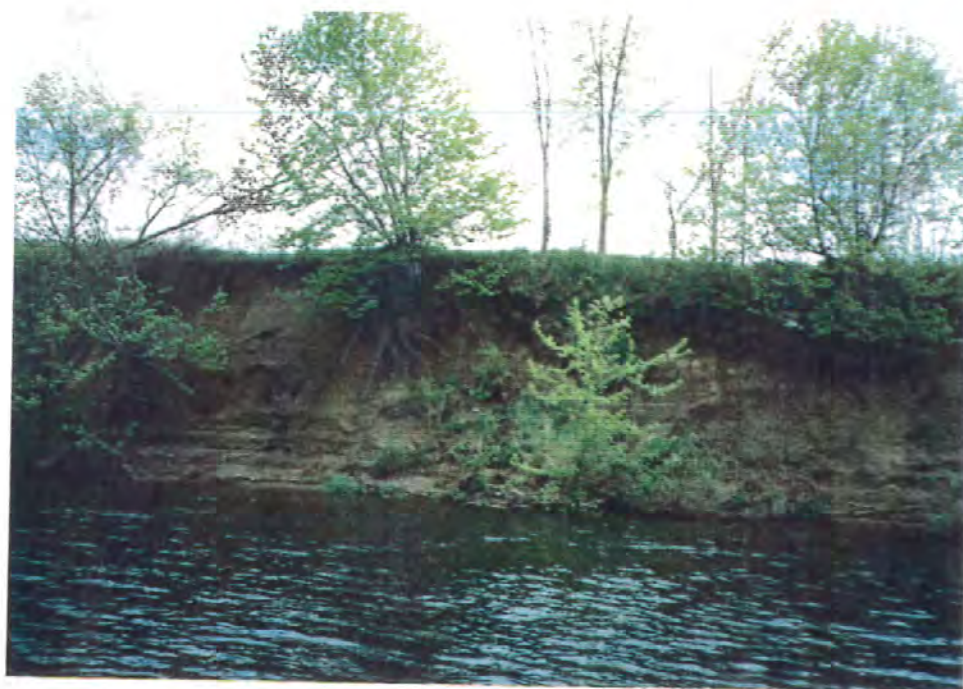
Site 63 - Downstream of Kidds Island, east bank - May 22, 1990.

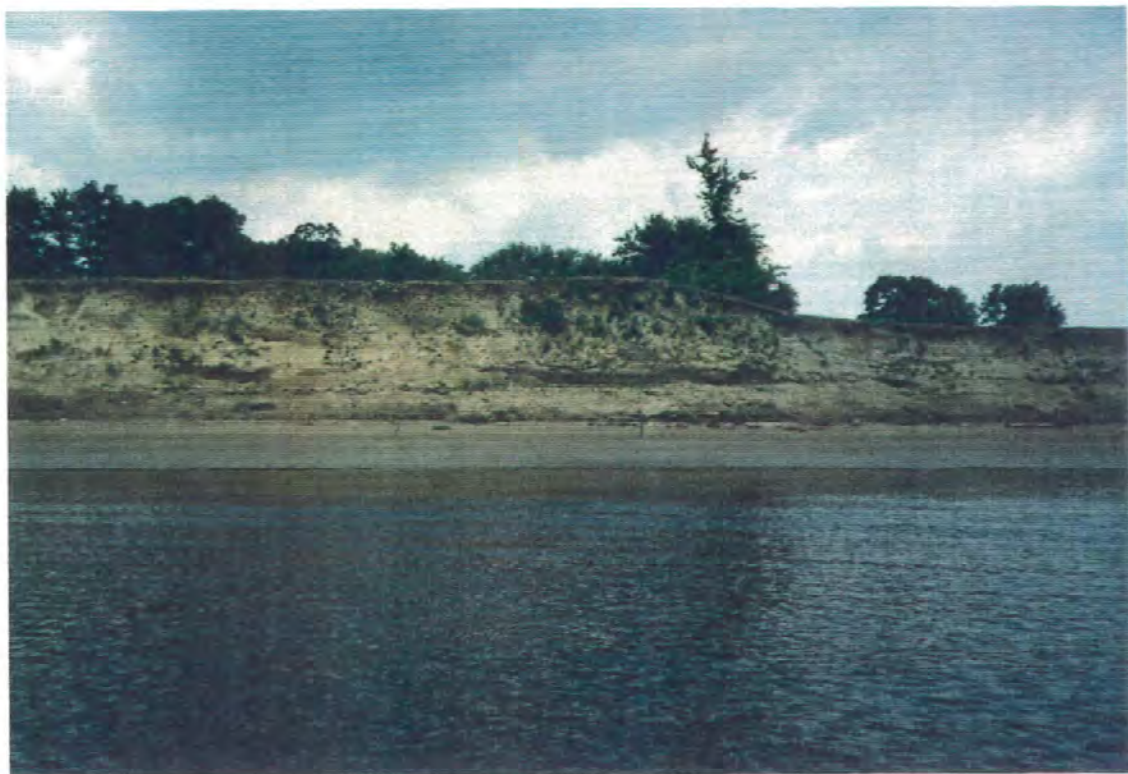
Site 60 - Severe erosion - Aug. 18, 1990

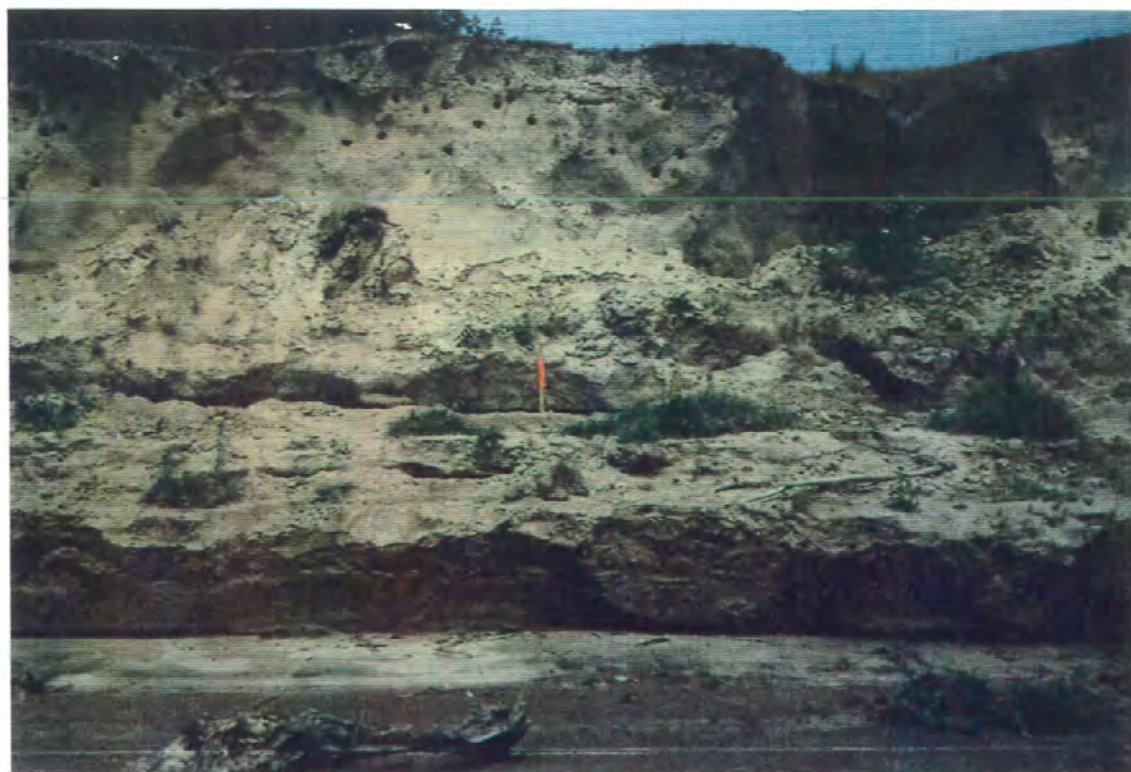
Site 60 - Across from Kidds Island, west bank - Aug. 3, 1990.

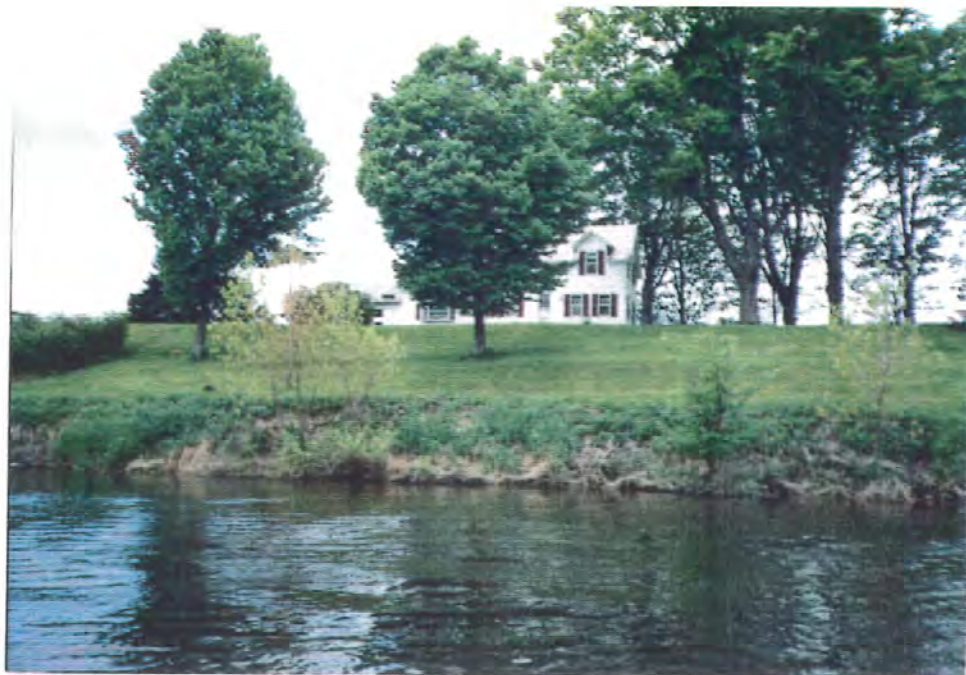
NUSCO installed 330 ft of riprap at this site  
across from Munn's Ferry in 1977 - May 22, 1990.

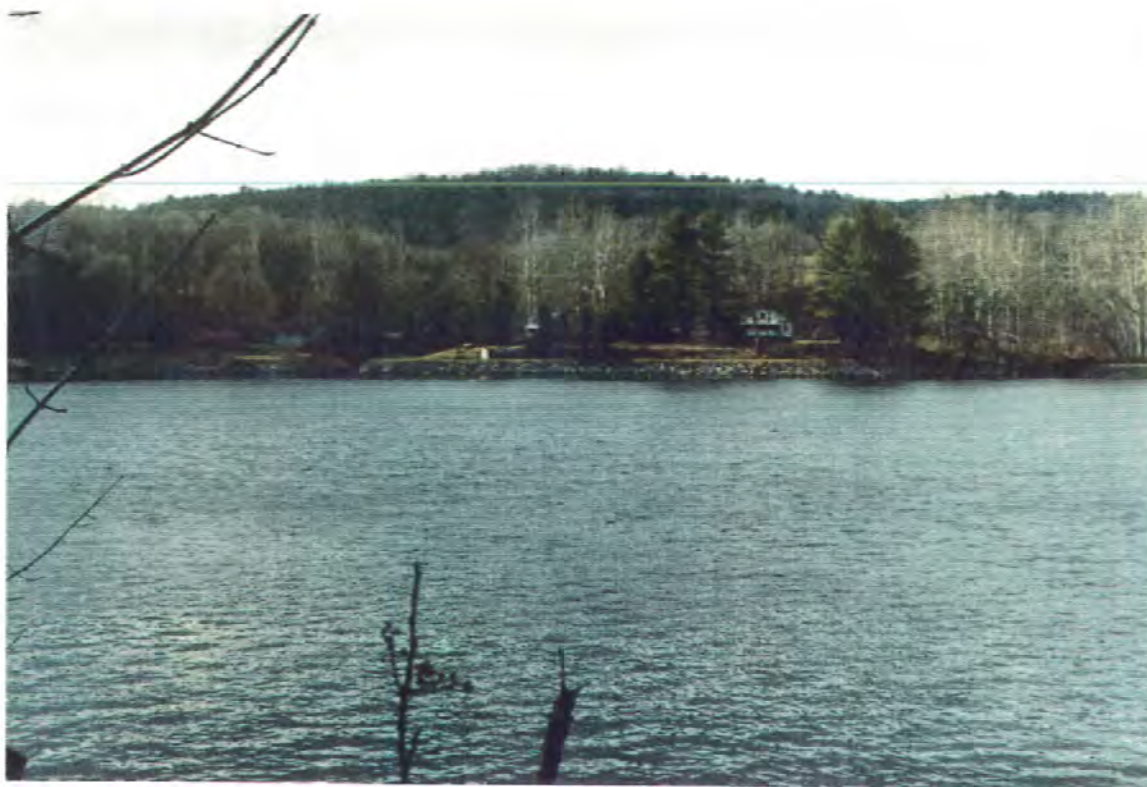
NUSCO installed 2,400 ft of riprap adjacent to  
Dry Brook between 1976 and 1978 - Nov. 19, 1990.

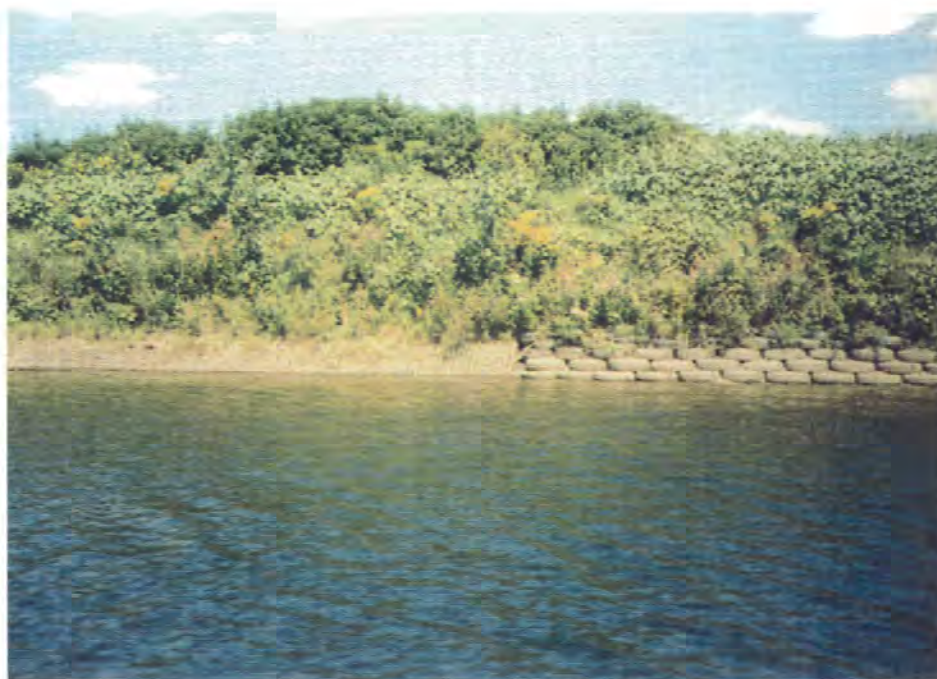
U.S. Army Corps of Engineers Demonstration  
Project - 6 years after completion (1987).

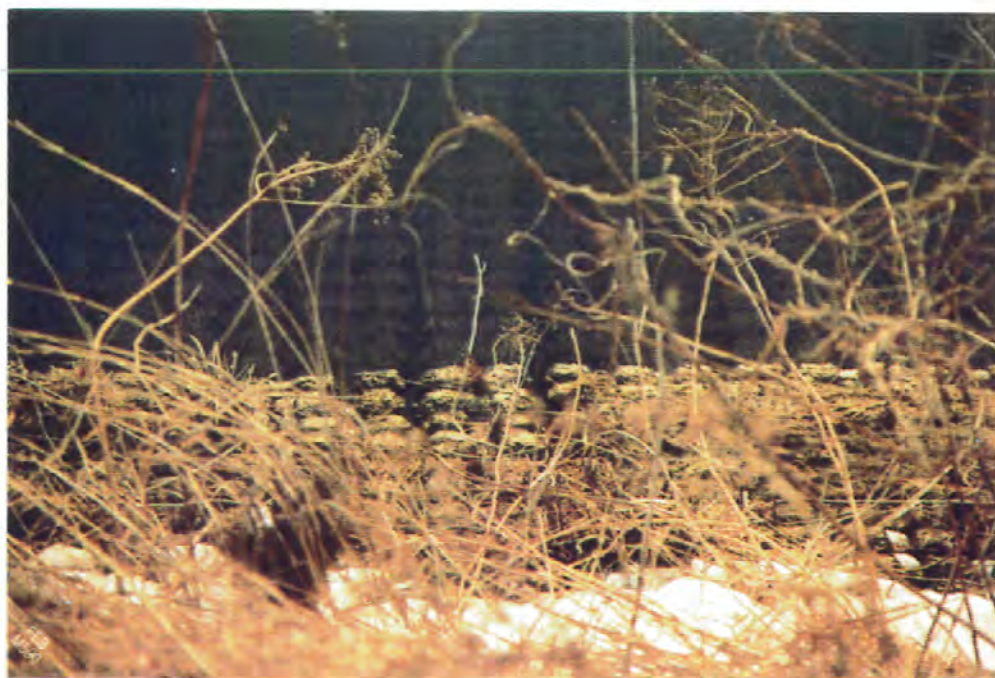
Close-up of Gobi matting at shoreline of Corps'  
Demonstration Project - Feb. 6, 1990.
